Resilience Analysis of Different Retrofitting Solutions for a Prestressed Concrete Viaduct

II Fabre Conference – Existing bridges, viaducts and tunnels: research, innovation and applications (FABRE24)

## Resilience Analysis of Different Retrofitting Solutions for a Prestressed Concrete Viaduct

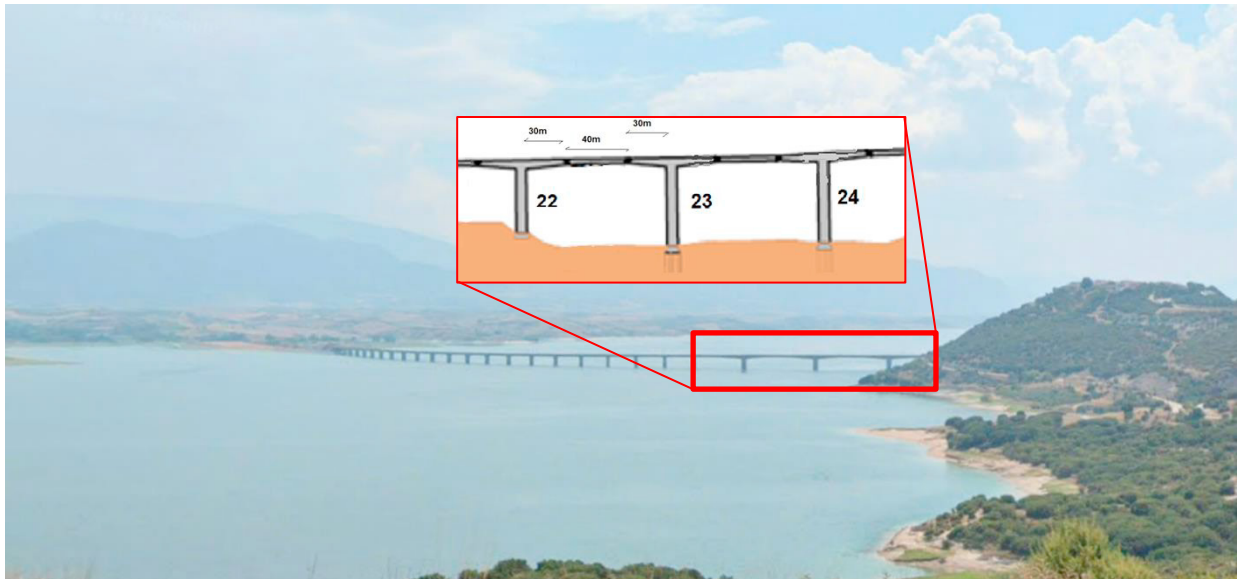
Fig. 1. General view of the Polyfytos lake and the bridge with the detail of Piers #22, #23, #24.

In Domaneschi et al. (2023) the bridge description with a focus on the part under evaluation in the present study (piers #22, #23, #24 with cantilever and precast beams connected by half-joints) is reported along with the construction technology adopted (prestressed concrete technique). Moreover, details on the geometry and the constitutive materials are also described, along with the performed analyses and the degradation assessment.
