Bridges monitoring and assessment using an integrated bim methodology

D. Rodriguez Polania¹ · F. Tondolo¹ · A. Osello¹ · M. Piras² · V. Di Pietra² · N. Grasso²

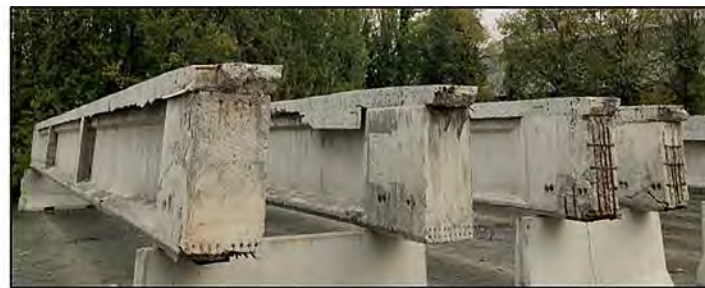
Fig. 4 (a) Dismantled beams collected in the inspection site. (b) Example of inspection sheet produced after the inspection procedure in an I-shaped beam element

and considering that the overpass presented severe damage, it was demolished in 2019. In the context of the research project BRIGE|50 a group of beams were dismantled and moved to a storing site to be examined [46]. A total of 25 I-shape precast prestressed concrete beams, 4 edge precast pre-stressed box beams and 2 prestressed pier-caps coming from four decks of the viaduct are used for the project. A photograph of a group of I-shape beams in the storing site can be seen in Fig. 4a. The BIM methodologies tested in this work focus on a single I-shaped beam and a single pier cap beam.

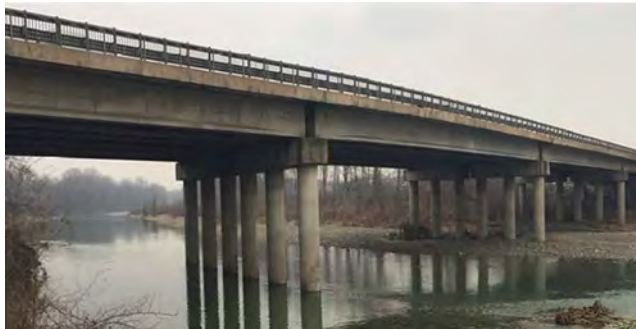
Fig. 5 Photograph of the first 3 spans of the Stura river bridge (Turin-Caselle direction)

0.175 m concrete deck. The longitudinal beams rest on rubber supports above prestressed pier caps located atop three piers of variable height. The superstructure of each bridge features a cross-section accommodating a double lane for a single direction of travel, equipped with a barrier system at the ends corresponding to a steel parapet (Fig. 5).

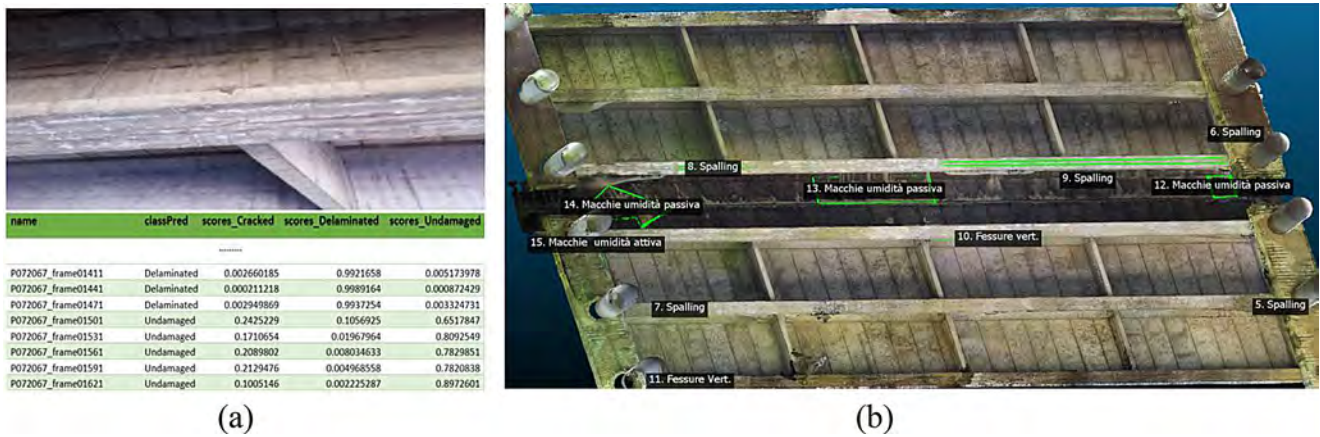
Fig. 9 (a) Example of an input image used for CNN analysis, along with the defect classification scores generated by the network. (b) Mesh model during the visual inspection process, showing isolated defects and areas of defect marked for defects of greater extent

To avoid the interoperability issues of having a no-colored block in the BIM platform it was decided to avoid the mesh passage to BIM software and produce a double model for the bridge database: One for visualization purposes (the mesh-model) and one for data collection (BIM model). This decision implies that the damage inspection is performed directly in *CloudCompare* software, and it is later transferred into a BIM model (a simple parametric model of the bridge created on a previous work). *CloudCompare* allows the insertion of points and polylines that can only be assigned ID information; therefore, the characterization of the defect in terms of extension, intensity and criticality is not possible. Consequently, this type of information needs to be added in the BIM platform during the communication phase between software. The intrados of the bridge was visually inspected supported by the application of a convolutional neural network (CNN) for automatic classification of damage developed by Savino and Tondolo [50] (Fig. 9).

where a pretrained GoogLeNet network was used to classify the model images into three classes: “undamaged”, “cracked”, and “delaminated”. As an output, the network generates a score for each image, indicating the probability the image belongs to a particular class. Details concerning the network training parameters (learning rate, batch size, number of epochs, accuracy) are found in the original publication [50].

The network analyzed the drone and 360 laser scanner images used to create the mesh model, validating defect recognition and minimizing potential human errors. For other defect types not addressed by the CNN, a visual inspection of the model was performed. Markers were added to the model using *point picking* tool for single isolated defects, while the *polyline* tool was used to delineate defects spanning larger areas. A summary of the identified defects is shown in Table 4. Additionally, a text file including the defect name as well as its coordinates (area coordinates for the defects of large extent) was also obtained as an output.
