Bridges monitoring and assessment using an integrated bim methodology / RODRIGUEZ POLANIA, D., Osello, A., Tondolo, F., Piras, M., Grasso, N., DI PIETRA, V.. - In: INNOVATIVE INFRASTRUCTURE SOLUTIONS. - ISSN 2364-4176. - ELETTRONICO. - 10:(2025), pp. 1-18. [10.1007/s41062-025-01864-8]

Bridges monitoring and assessment using an integrated bim methodology

D. Rodriguez Polania¹ · F. Tondolo¹ · A. Osello¹ · M. Piras² · V. Di Pietra² · N. Grasso²

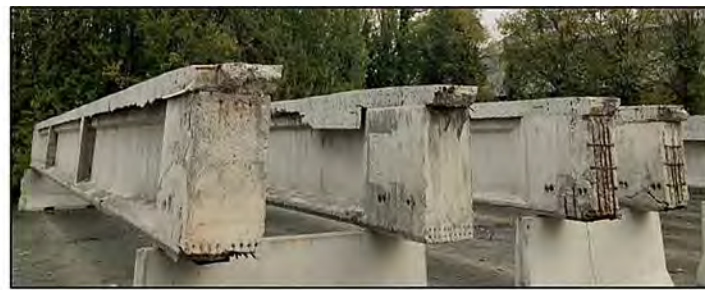
Fig. 4 (a) Dismantled beams collected in the inspection site. (b) Example of inspection sheet produced after the inspection procedure in an I-shaped beam element

An initial inspection phase was conducted for all elements, resulting in a unique damage sheet for each beam. This damage sheet includes photographs and a CAD drawing of each planar face of the beam, with the respective damage accurately marked. The defects surveyed during this inspection for the selected I-shaped beam are detailed in Table 2, while an example of the damage sheets produced during the inspection phase is shown in Fig. 4b.
