Resonance Frequency as an Indicator of the Damage in Carbon Composite Plates: Analysis on Composites Prepared with Conventional and Sustainable Resins Subjected to Impact Tests

Abstract: This paper experimentally investigates the impact response of composite laminates made with conventional and bio-based epoxy resin. Drop tower impact tests were conducted at varying energy levels, including repeated low-energy impacts, to evaluate perforation resistance. The laminates' residual strength and damage tolerance were assessed using the Damage Index (DI) and by analysing the resonance frequency variations through the Impulse Excitation Technique (IET). The study demonstrates a strong correlation between the DI and the resonance frequencies of the specimens, suggesting that IET can effectively track damage progression in composite laminates. Bio-based resin laminates exhibited higher energy absorption at perforation and lower damage progression during repeated impacts due to the higher ductility of the resin. This method of using resonance frequencies to assess impact damage progression directly in composite laminates throughout the IET technique has not been previously reported in the l

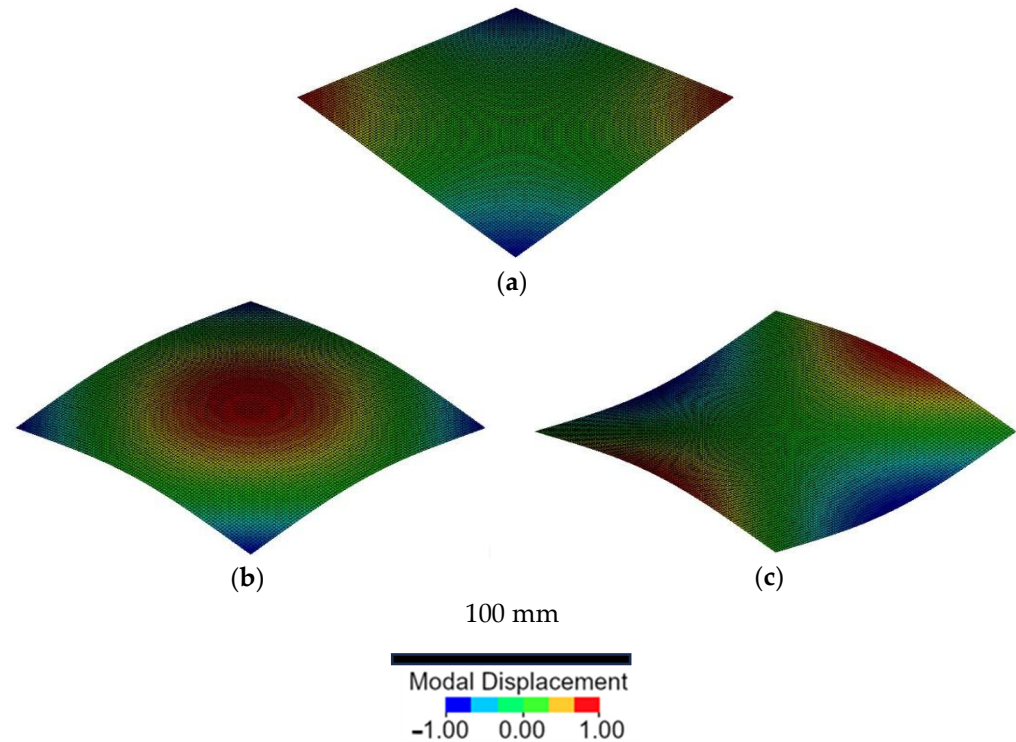
Figure 1. Mode shapes for the assessment of the elastic properties: (a) torsional mode, (b) O mode, (c) X mode.

In this study, the IET was employed to compare the material properties of the two composites. It was assumed that the elastic properties in the two principal directions were equivalent and that the plate was perfectly square with its in-plane material principal directions aligned to the plate edges. Under these assumptions, the equation $\frac{a}{b} = \left(\frac{E_{11}}{E_{22}}\right)^{\frac{1}{4}}$ was satisfied, where a and b are the plate dimensions, and E_{11} and E_{22} represent the in-plane Young's moduli [41]. Consequently, we decided to use the torsional, O (ring) and X modes to determine the elastic properties of composite plates. Figure 1 illustrates the considered

torsional (Figure 1a), O (Figure 1b) and X modes (Figure 1c). The red colours indicate the higher displacements of these vibrational modes.

Figure 7a,b show the normalised values of the acquired resonance frequencies for the repeated impacts. The normalised values were computed using the ratio $\frac{f_n}{f_0}$, where f_n is the frequency of the repeated impact and f_0 is the initial frequency of the undamaged specimen, to show whether the frequency decreased or increased while damage progressed. As reported in Section 2.3, the torsional mode, the O mode and the ring modes, namely f_{tor} , f_O and f_X , were computed and were reported for both the laminates under repeated impact at 5 and 7 J. The green curves represent the bio-based laminates in Figure 7a,b, while the black curves represent epoxy. The torsional mode frequency for both laminates prepared with conventional and bio-based resins presented an increasing value or values after the first impact that then decreased before the failure. The increase in the frequency of the f_{tor} mode was expected. As shown in Figure 1, this modal shape has nodal zones where the damage

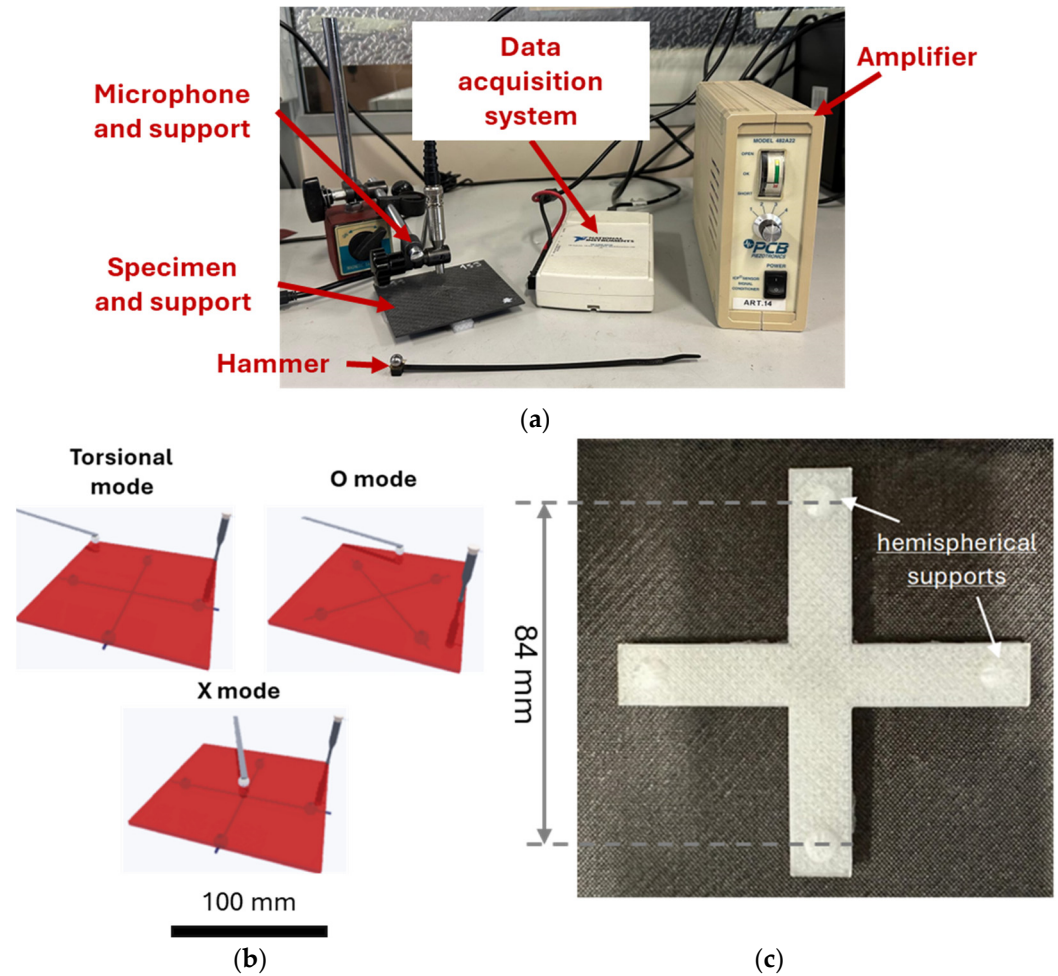
Figure 2. (a) Testing apparatus and data acquisition system, (b) positions of the specimens and microphones for the three investigated modes, (c) base of the specimens.

Figure 2 shows the IET system that has been used to assess the frequencies of undamaged and damaged plates. As illustrated in Figure 2a, the plates under investigation were supported on a base, and the microphone was opportunely positioned to detect a specific mode. The microphone signal was amplified and recorded using a data acquisition board, then analysed with Fourier Transform-based software, Buzz-O-Sonic (BuzzMac International, Portland, OR, USA) to evaluate the frequency response. The acquisition board, the NI USB-6210 system (National Instruments, Austin, TX, USA), was used for analog-to-digital conversion of the amplified signal. The position of the microphone supports and impact points where the hammer struck the plates allowed the excitation of a specific mode of vibration. In particular, the configurations for the torsional, O and X modes are shown in Figure 2b. These conditions are defined in the Software manual Buzz-O-Sonic [42]. The support is shown in Figure 2c. The hemispherical supports allowed the limit of the contact region, which should be as small as possible. The plate was moreover supported where nodal points were expected for a specific mode of vibration. In this way, the investigated mode was isolated, with a consequent limited influence of the other modes on the acquired signal. The distance between the sphere centres was 0.84 of the total length of the specimen, i.e., 84 mm.

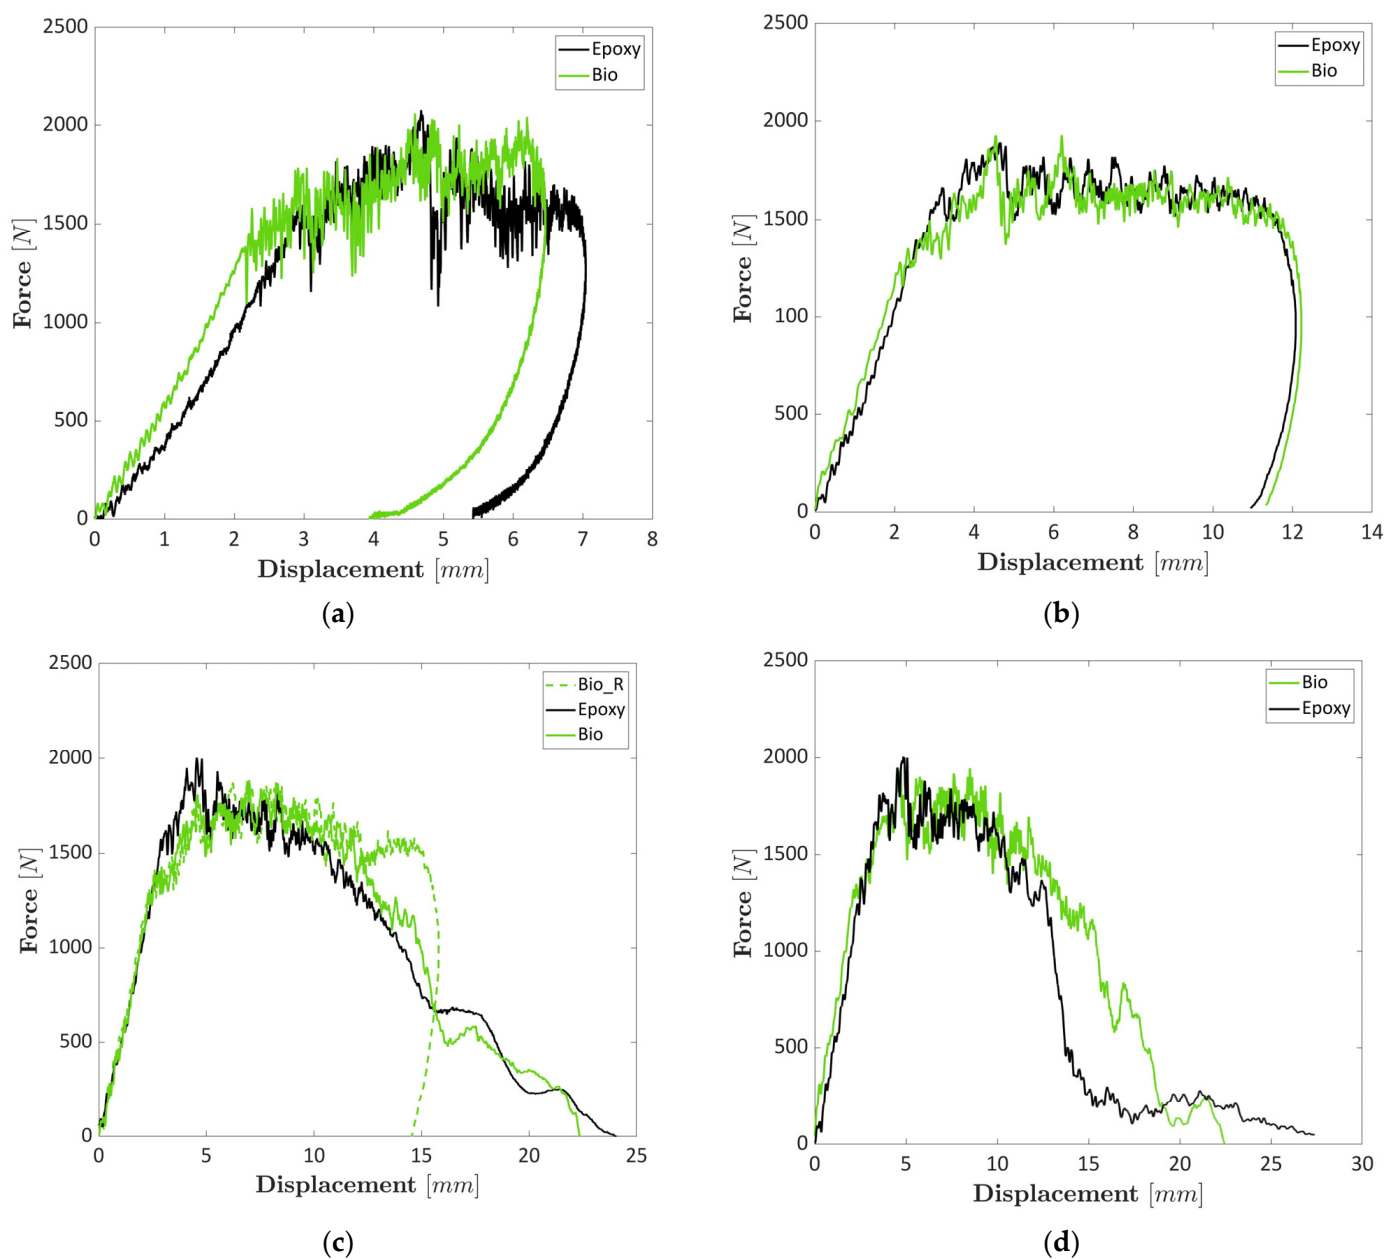
Figure 3. Impact tests conducted at 7 J (a), 15 J (b), 20 J (c) and 30 J (d).

Figure 3 shows representative force–displacement curves at different increasing impact energies of 8.6 J, 16.5 J, 23.5 J and 33.5 J. Representative curves are shown due to the limited scatter between the curves of the same set of samples as it is indicated by the error bars of the charts in Figure 4. The impact energy took into account the energy computed with the velocity when the impact started (namely 7, 15, 20 and 30 J) plus the energy added due to the displacement of the dart within the specimen during the tests. The force–displacement curves of laminates prepared with both epoxy and bio-epoxy resins presented a very similar behaviour in all four analysed cases with a slight difference at higher impact energy, 20 and 30 J, when the perforation of the composite laminates and the falling dart experienced a rebound due to the elastic energy of the specimen. The rebound was visible by analysing the force–displacement curves, which ended with a negative displacement. Impacts carried out at 7 and 15 J, Figure 3a and Figure 3b, respectively, could not perforate the specimens. However, at 15 J, the displacement was almost doubled compared to the impact at 7 J, while the maximum forces remained practically constant. At 20 J, Figure 3c, two curves over three are shown for the specimens prepared with the bio-based epoxy resin because two different behaviours were obtained. For this reason, a bio curve representative of the specimens that presented the rebound is also reported in Figure 3c. Indeed, the composite laminates prepared with bio-resin experienced a rebound in two out of three cases. This behaviour indicated that these specimens still present a residual elastic energy compared to the laminates prepared with the conventional epoxy resin. An explanation of this property can be related to the higher displacement and deformation that the bio-resin exhibits over the conventional resin, as shown in a preliminary work of the same authors [12], especially in flexural tests. The higher ductile behaviour of the resin explains why the composite prepared with bio-resin can bear a higher load before perforation. Figure 3d illustrates that 30 J was enough to perforate both types of laminates. However, the specimens prepared with bio-resin presented a final drop of the load at 20 mm, while the epoxy-based laminates presented a drop close to a 15 mm load drop. These different drops led to a higher value of the absorbed energy for specimens prepared with bio-resin.

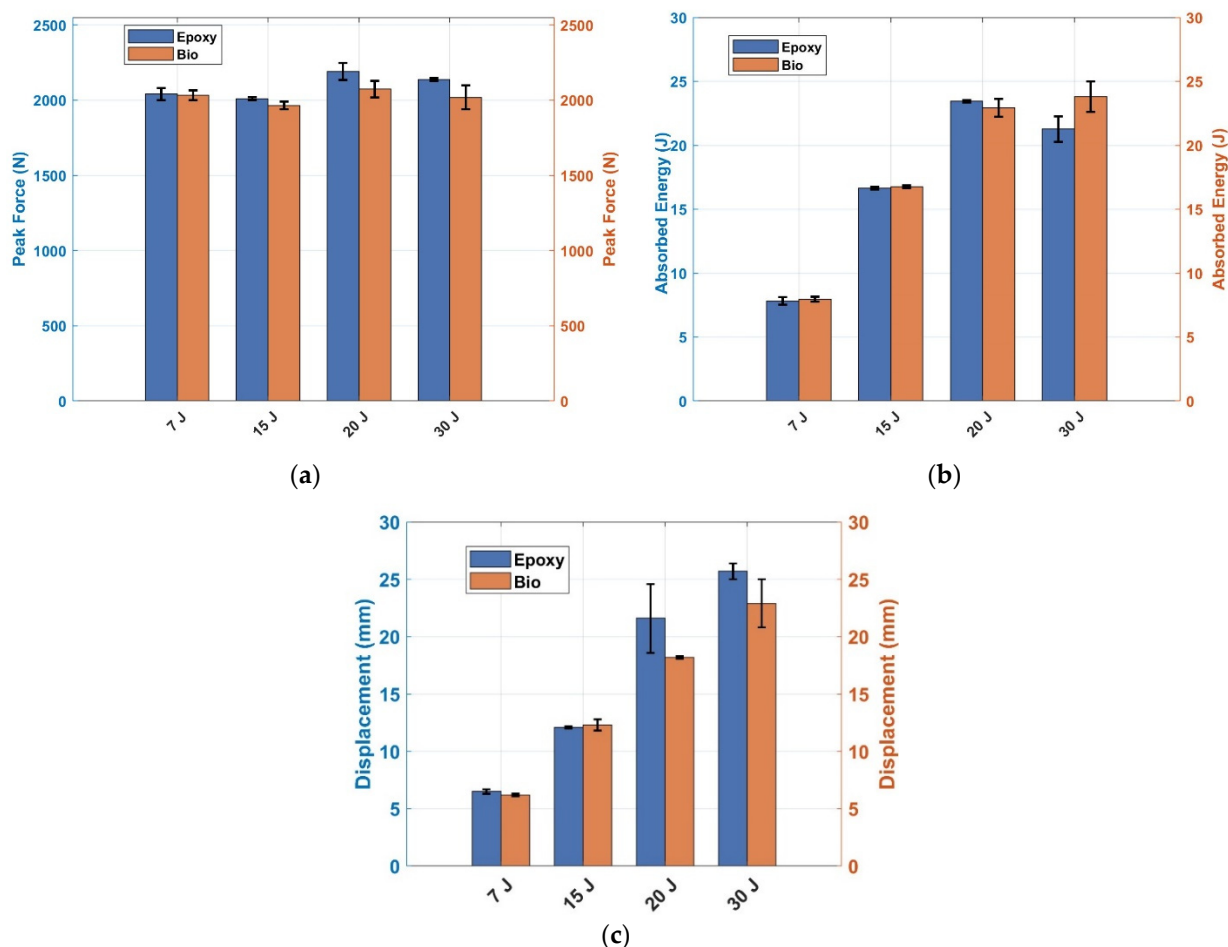
Figure 4. (a) Peak forces of bio and epoxy composites; (b) absorbed energy of bio and epoxy composites; (c) maximum displacements of the composite laminates prepared with bio and epoxy resins.

Figure 4a–c summarise the experimental activity shown in Figure 3. Figure 4a and Figure 4b show the values of the forces and the absorbed energy, respectively, for composite laminates prepared with bio-based resin and epoxy resin, respectively. The maximum force, around 2000 N, did not change significantly for any of the two types of specimens and the four analysed impact energies. This trend can be explained by considering that the fibre contents were similar. As shown in Figure 3, the damage was also triggered in laminates impacted at 7 J, as shown in the load–displacement curves. Indeed, load–displacement curves in Figure 3a do not show a perfectly elastic rebound since the displacement did not reach 0 mm after the impact. Thus, the values were similar, having the same number of layers for both conventional epoxy resin and bio-resin. Contrarily, comparing absorbed energies at different impact energy levels presented increasing values. Similar values at 7 and 15 J, where both specimens experienced a rebound, were obtained. Comparable values were also obtained at 20 J. However, the comparison is unfair in this case since two specimens out of 3 for the laminate prepared with bio-resin experienced a rebound.

Ultimate displacements are shown in Figure 4c. At 7 and 15 J, the ultimate displacements of both specimens prepared with the two resins were the same due to the rebound. At 20 J, the bio-based laminate presented lower displacement values due to the rebound of the specimens prepared with bio-resins. At 30 J, the displacement values of the specimens prepared with epoxy resin looked larger. However, the main significant drop occurred before 15 mm, and then the load remained constant between 100 and 200 N before going to 0 N. The specimens prepared with bio-resin presented a significant drop in the load at around 20 mm, which allowed them to absorb more energy during failure.

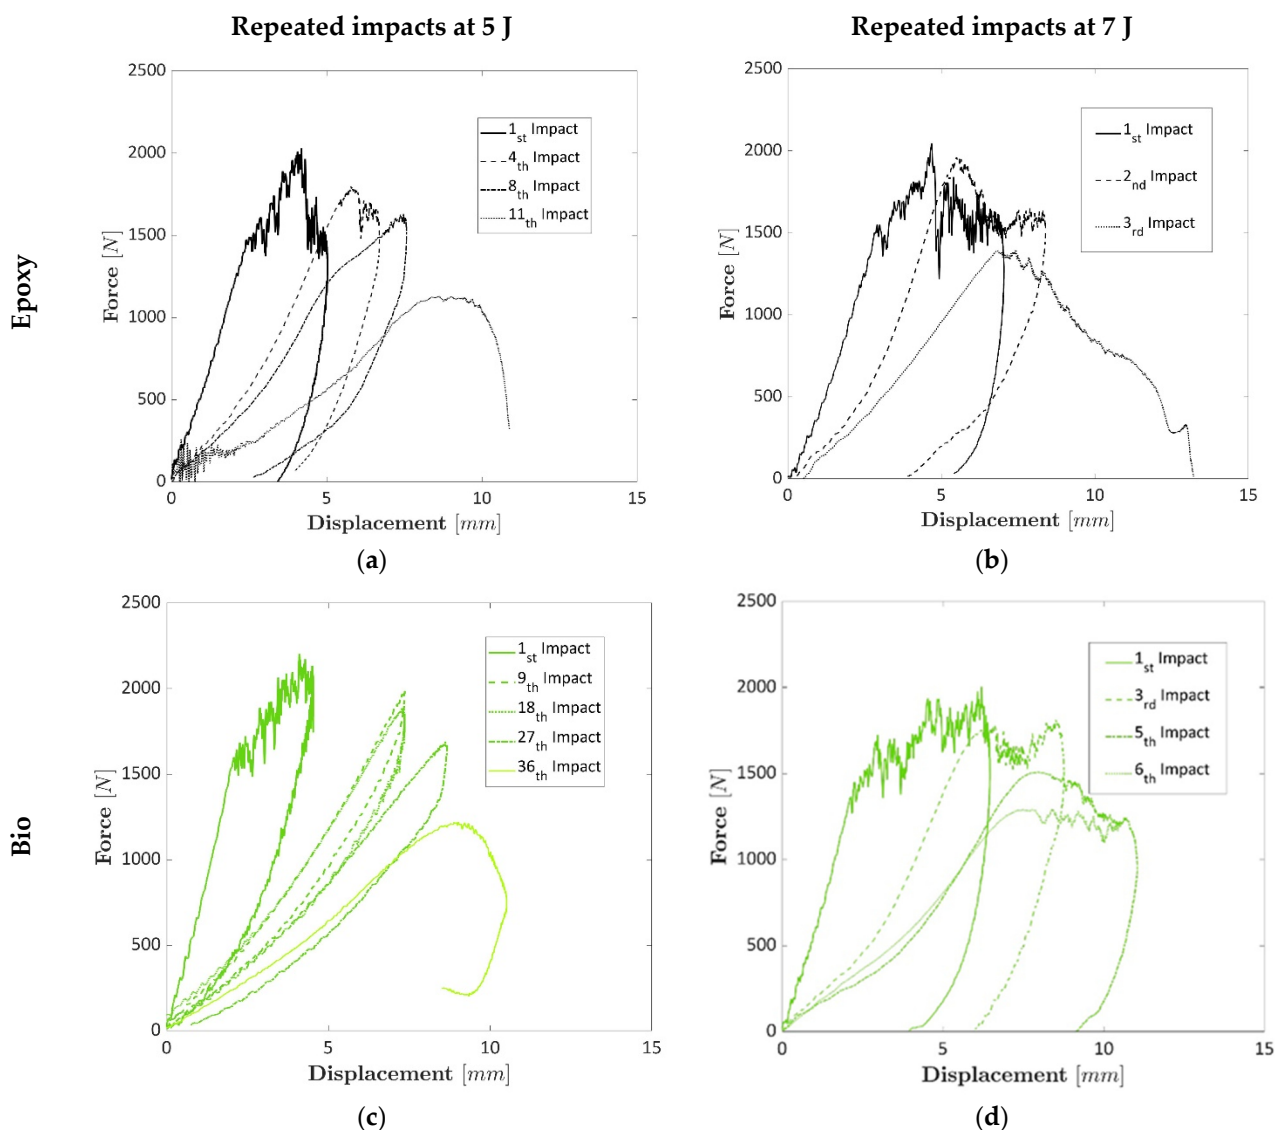
Figure 5. (a) Representative load–displacement curves for the laminates prepared with the epoxy resin at 5 J; (b) Representative load–displacement curves for the laminates prepared with the epoxy resin at 7 J; (c) Representative load–displacement curves for the laminates prepared with the bio-resin at 5 J; (d) Representative load–displacement curves for the laminates prepared with the bio-resin at 7 J.

Repeated tests were carried out to assess whether the specimens prepared with bio-resin presented higher resistance at repeated impacts due to the larger displacements they presented in the perforation tests. Figure 5a and Figure 5b show the repeated impact tests for the epoxy-based laminates at 5 J and 7 J, respectively. Figure 5c and Figure 5d display the repeated impact tests for the epoxy-based laminates at 5 J and 7 J, respectively. Different representative curves were chosen for each laminate due to the different numbers of obtained repetitions to highlight the damage progression among the different impacts. The damage progression can be shown by the decreased stiffness value (initial trend of the curves) and the increased displacement during repeated tests. The repeated impacts showed that at 5 J, the epoxy-based laminates bore 11 impacts, while the bio-based laminates reached 36 impacts. At 7 J, the conventional epoxy-based laminates bore three impacts, while the composite bio-based resin failed after six repeated impacts. The most significant differences between laminates prepared with epoxy and bio-resins can be found in the first drop of mechanical properties when the first peak was reached at both 5 and 7 J and the rebound of the dart that was identified with the values of the negative displacements in the load–displacement curves. The first curve of the epoxy laminates impacted at 5 J and 7 J showed a slight drop before 5 mm, Figure 5a,b, that was not present in the specimens prepared with bio-resin, Figure 5c,d. During the damage progression, the laminates prepared with bio-based resin exhibited higher force values sustained over more significant displacements, indicating superior residual elastic properties and lower damage levels than those made with epoxy resin under the same number of impacts. This

highlights the ability of bio-based resins to maintain a more consistent and elevated load capacity over repeated impacts. This trend is visible when comparing the first and the last curves of epoxy and bio-based epoxy at both 5 J and 7 J. Contrarily, the curves of the epoxy-based laminates present lower values of the forces after the maximum peak, which leads to a lower absorbed energy. Finally, the bio-based composite plates presented a higher rebound up to the failure, which means a higher residual energy. The meaning of this behaviour is attributed to the higher deformation that the epoxy bio-based resin can offer before failure, with a consequent higher number of impacts for the resin prepared with the bio-based resin.

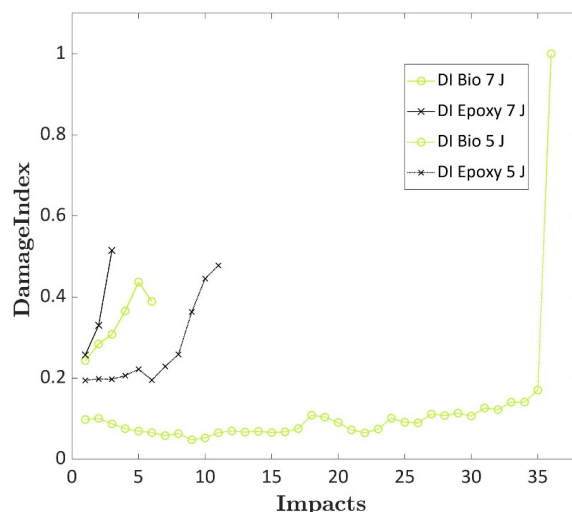
Figure 6. DI computed for the epoxy and bio laminates at impact energies of 5 J and 7 J.

The DI was computed to analyse the damage progression of the epoxy and bio-based laminates to repeated impacts, and the curves are shown in Figure 6. Usually, the last impact that is carried out on the laminates presents low absorbed energy due to the limited residual strength or a very high energy based on the extensive displacement that the specimens can reach after failure with a force increase due to the friction of the dart and

the fractured specimens. A DI of 1 was assigned to the last impact for this latter case. The DI computed for the laminates impacted at 5 J showed that both laminates presented very different DI values due to the different damage progression depicted for the two types of specimens. In particular, the DI of the biospecimen impacted at 5 J presented an initial value that was half the epoxy specimen value when impacted at the same energy. Then, when damages started to increase, the DI values significantly increased for both laminates before failure. This increase was more evident for the epoxy specimen, where the DI value rose from an average value of 0.2 to a maximum value of 0.5.

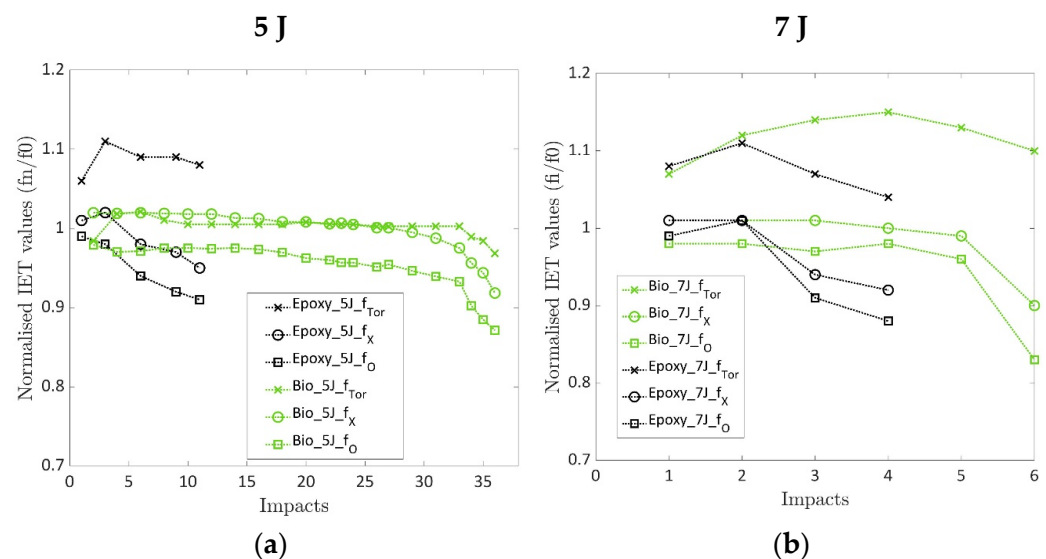
Figure 7. (a) Normalised IET computed for the epoxy and bio laminates at an impact energy of 5 J; (b) Normalised IET computed for the epoxy and bio laminates at an impact energy of 7 J.

occurred. The presence of damage in areas that did not participate in the vibration was not detectable. Moreover, the presence of damage prevented the vibrations, thus extending the nodal zone and causing an increase in resonant frequency f_{tor} . The same phenomenon happened for f_X in the case of impacts at 5 J, and it could be due to the same reason. On the contrary, the damage induced by the 7 J impacts extended into the non-nodal region, thus participating in the mechanical vibration and causing a decrease in the resonant frequency. On the other hand, the f_O Mode showed a decreasing trend for both laminates impacted at 5 J and 7 J. This decrement was expected since the maximum modal displacement occurred at the location of the damage, as shown in Figure 1, and no nodal points were present in the damaged zone. The values of the normalised frequencies at first for the impacts carried out at 5 and 7 J did not show significant differences. This can be attributed to the limited size of the damage that does not influence the vibration of the specimens. Contrarily, the final values of the normalised frequency for epoxy and bio-based epoxy laminates were the same at the last impact. This result is very positive since the specimens reported similar failure surfaces, as noted in Section 3.6, and the final value could be used to assess the damage level of composite laminates if a complete characterisation of the materials is available. By considering the final values at rupture, the bio-resin specimens presented normalised frequency values higher than the ones prepared with the conventional epoxy resin. This behaviour depends on the larger damaged area these specimens undergo, as explained in Section 3.6. Further, the normalised IET values presented a plateau area and a decreasing area during the steady damage progression and before failure, similar to the IET index.

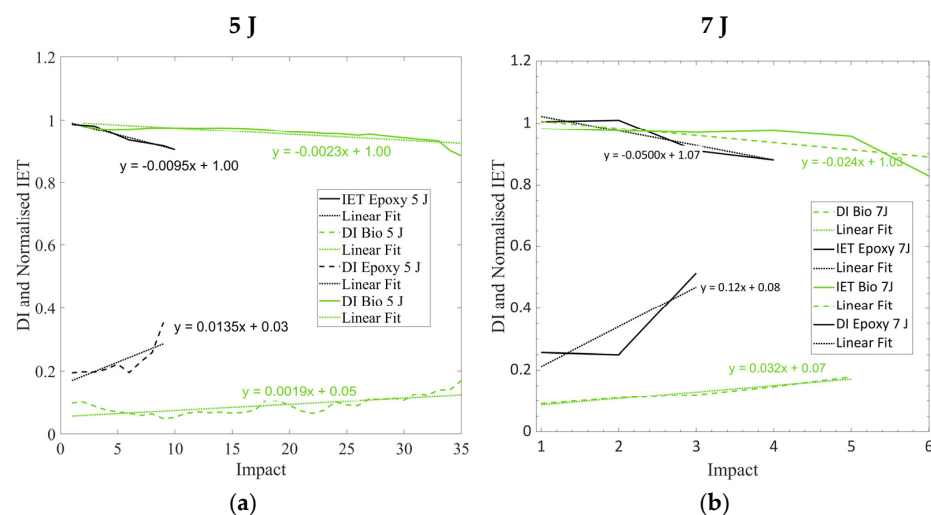
Figure 8. (a) Comparison between normalised IET and DI computed for the epoxy and bio laminates at an impact energy of 5 J; (b) Comparison between normalised IET and DI computed for the epoxy and bio laminates at an impact energy of 5 J.

The comparison between the DI values and normalised frequency (f_O) is reported in Figure 8a and Figure 8b for 5 J and 7 J impacts, respectively. The dashed lines report the DI values, while the solid lines report the normalised IET values. A linear regression of both the DI and normalised IET, with respect to the number of impacts, was carried out and is reported with dot lines. Only DI values up to 0.4 were chosen to consider the linear regression similar to what was undertaken by [30]. As shown in Sections 3.3 and 3.4, the normalised IET showed a decreasing trend, while the DI showed an increasing trend as the damage progressed. The interpolating equations are also reported in Figure 8a,b. The DI and Normalised IET presented very similar slopes, especially for the specimens impacted at 5 J, which presented a steady damage progression before failure.

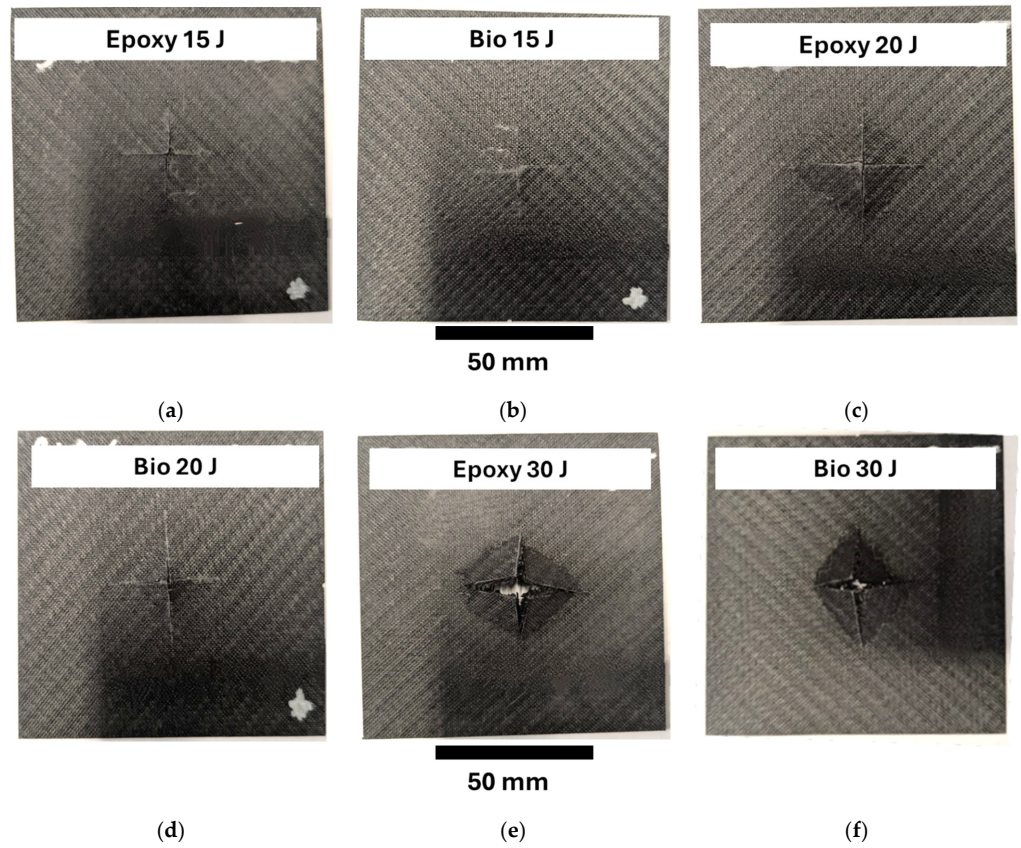
Figure 9. Fracture surfaces for the specimens impacted at 15 J, 20 J and 30 J: (a) Bio 15 J, (b) Epoxy 15 J, (c) Bio 20 J, (d) Epoxy 20 J, (e) Bio 30 J, (f) Epoxy 30 J.

Figure 9 displays the representative fracture surfaces of the perforation tests at 15 J, 20 J and 30 J for the plates prepared with epoxy and bio-resins. The fracture surface at 7.5 J has not been reported since tiny indentations were detected. The surfaces of the specimens impacted at 15 J, Figure 9a,b, showed that the plate prepared with epoxy resin presented split cracks in two directions, while the specimens prepared with bio-based resin presented closed superficial cracks. The epoxy and bio-based impacted specimens at 20 J, Figure 9c,d, showed that the damaged area presented similar sizes. However, the specimens prepared with epoxy resin presented an evident open indentation related to the failure of the laminates. On the other hand, the biospecimens experienced a rebound at 20 J, as reported in Section 3.1. Finally, the specimens impacted at 30 J showed that both specimens prepared with epoxy and bio-based resins, Figure 9e,f, presented similar failure surfaces, sizes, and opened cracks. However, the open patches were smaller and less open for the specimens prepared for the bio-based resin.

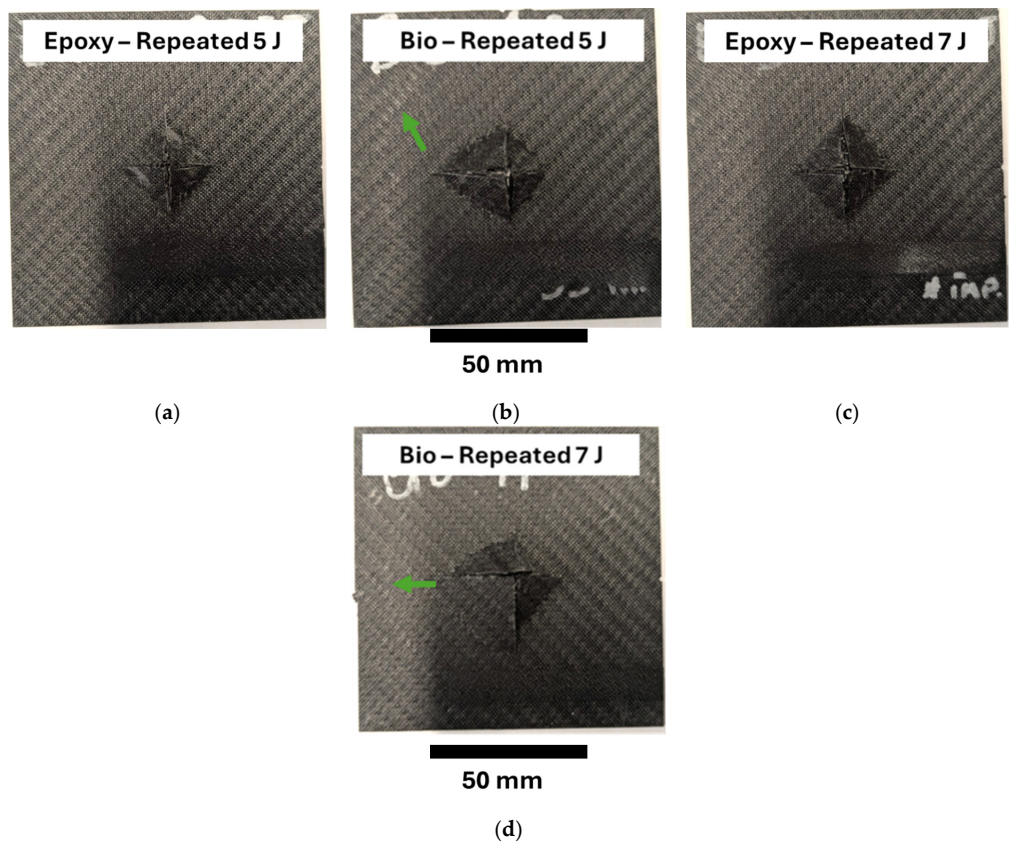
Figure 10. Fracture surfaces for the specimens subjected to repeated impact tests at 5 J and 7 J: (a) Epoxy 5 J, (b) Bio 5 J, (c) Epoxy 7 J, (d) Bio 7 J.

Figure 10 reports the specimens subjected to repeated impact tests at 5 J, Figure 10a and Figure 10b, and at 7 J, Figure 10c and Figure 10d, respectively, for plates prepared with epoxy and bio-resins. Figure 10 shows that the plates prepared with the epoxy resin and impacted at 5 J and 7 J presented similar fracture surfaces. The size of the damaged area and the shape were symmetric and quite close to the specimens impacted at 30 J, where complete perforation occurred. On the other hand, the plates prepared with the bio-based resin and impacted at 5 J and 7 J presented similar damage areas that were slightly longer on the left side, Figure 10b,c. This indentation was the result of the higher number of impacts that these specimens bore. The damaged area was slightly higher for bio-based due to the higher displacement that these specimens bore. Likely, the ductile behaviour of the plates prepared with bio-based resin triggers a different damage mechanism, and the interlaminar crack propagates before the final fragile failure. This behaviour involved a wider part of the plates in the damage progression. Indeed, the plates presented a tiny indentation close to the circular support, as shown by the green arrow. The frequencies computed throughout the IET also showed that this technique could detect greater damage. Indeed, the specimens impacted at 5 J presented a final value of 0.86 and 0.90 for the specimens prepared with bio and epoxy resins, respectively. The final values for specimens impacted at 7 J were 0.82 and 0.88, respectively, for the bio and epoxy resins. Thus, the plates with greater damage, the biospecimens, presented a higher drop in frequency.

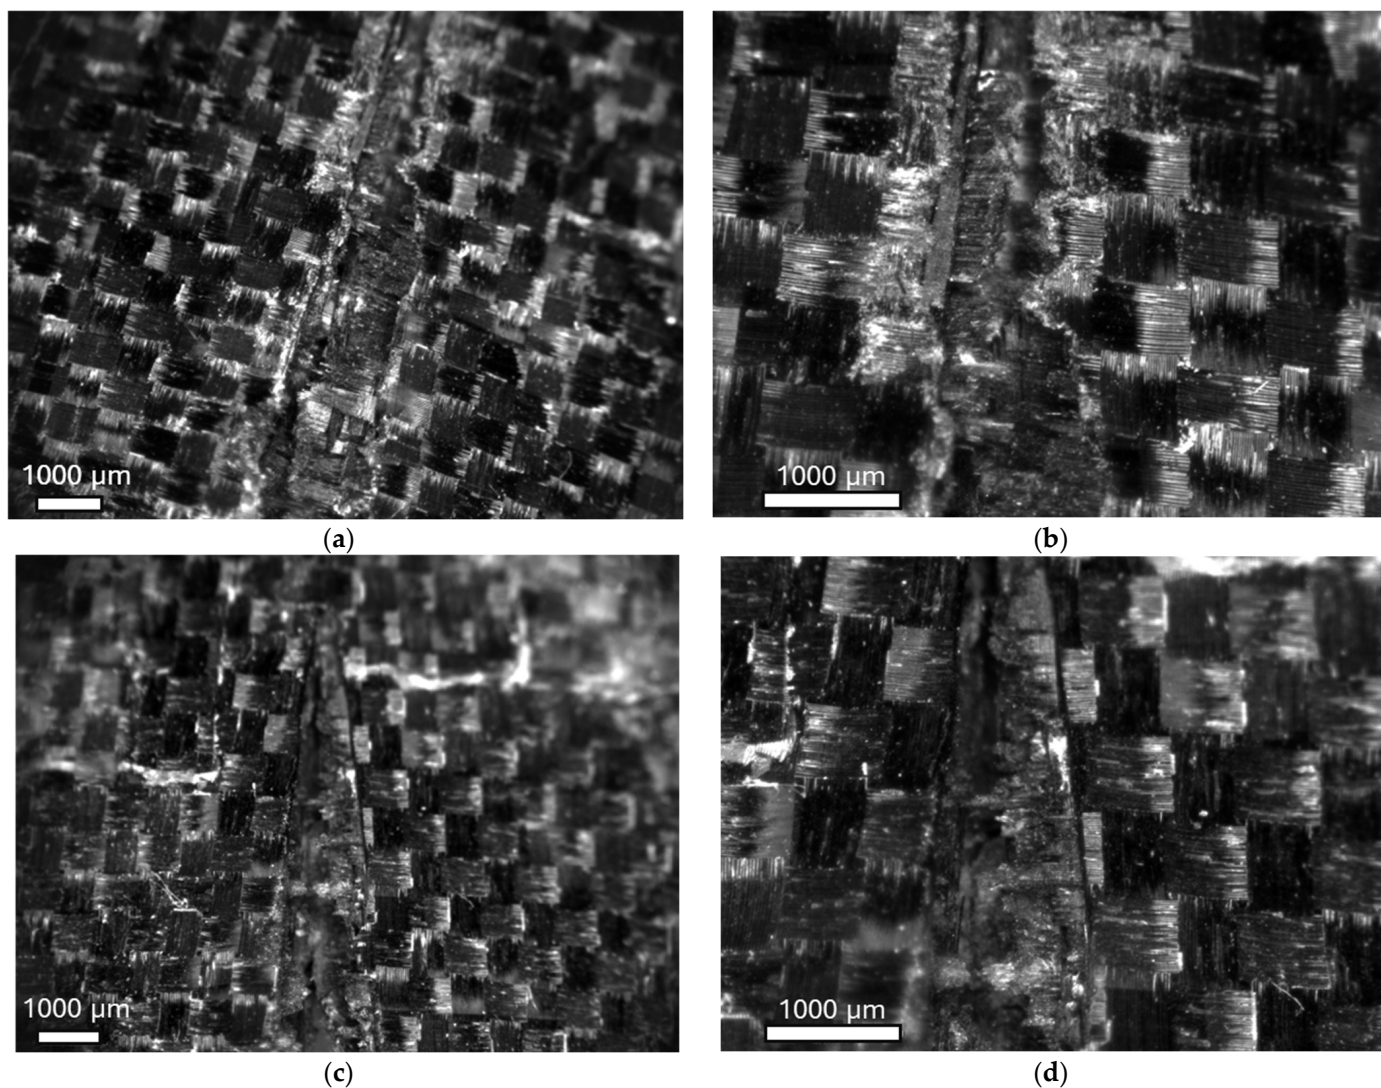
Figure 11. Micrography of the epoxy specimens at two different magnifications, $1\times$ (a) and $200\times$ (b); Micrography of the epoxy specimens at two different magnifications, $1\times$ (c) and $200\times$ (d).

Figure 11a,b report a micrograph of the fracture surfaces of the epoxy laminate at a point where the crack of the laminate failed at two different magnifications ($1\times$ and $200\times$). Thus, an evident crack was visible in the centre of the specimen. Figure 11c,d present micrographs of the fracture surfaces of the bio laminate at the same location at two different magnifications ($1\times$ and $200\times$). This analysis was carried out on specimens impacted at 30 J and are reported as representative surfaces since all the tests led to perforation and presented similar failure surfaces. For both specimens, good adhesion between the matrix and fibres was observed since no evident areas were pulled out from the matrix observed.
