Resonance Frequency as an Indicator of the Damage in Carbon Composite Plates: Analysis on Composites Prepared with Conventional and Sustainable Resins Subjected to Impact Tests

Abstract: This paper experimentally investigates the impact response of composite laminates made with conventional and bio-based epoxy resin. Drop tower impact tests were conducted at varying energy levels, including repeated low-energy impacts, to evaluate perforation resistance. The laminates' residual strength and damage tolerance were assessed using the Damage Index (DI) and by analysing the resonance frequency variations through the Impulse Excitation Technique (IET). The study demonstrates a strong correlation between the DI and the resonance frequencies of the specimens, suggesting that IET can effectively track damage progression in composite laminates. Bio-based resin laminates exhibited higher energy absorption at perforation and lower damage progression during repeated impacts due to the higher ductility of the resin. This method of using resonance frequencies to assess impact damage progression directly in composite laminates throughout the IET technique has not been previously reported in the l

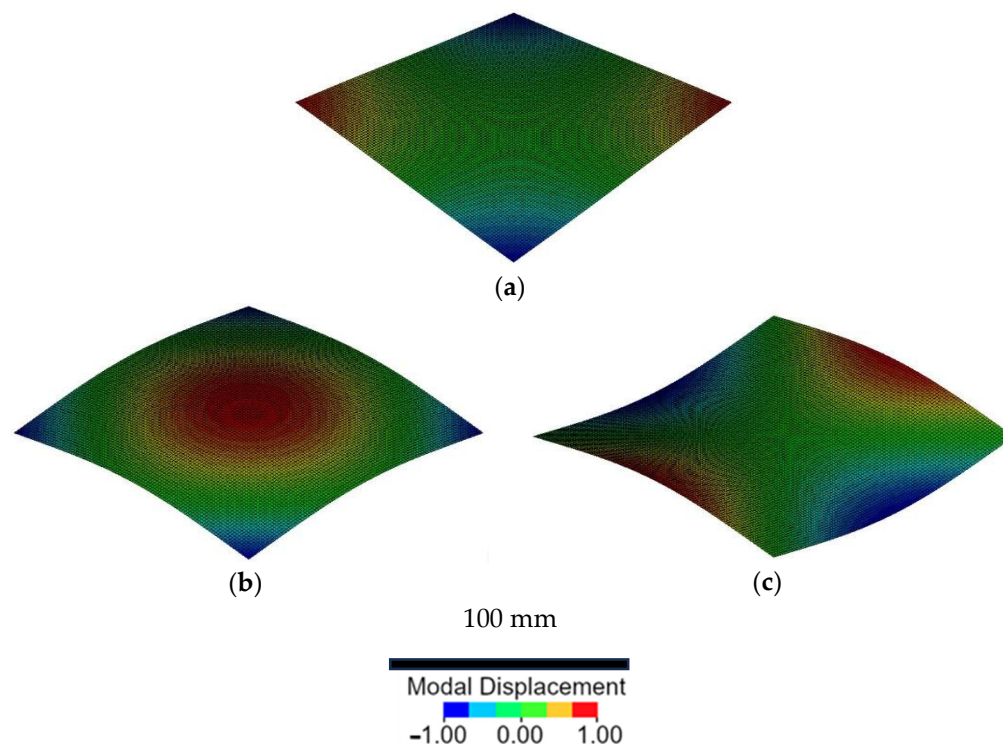
Figure 1. Mode shapes for the assessment of the elastic properties: (a) torsional mode, (b) O mode, (c) X mode.

In this study, the IET was employed to compare the material properties of the two composites. It was assumed that the elastic properties in the two principal directions were equivalent and that the plate was perfectly square with its in-plane material principal directions aligned to the plate edges. Under these assumptions, the equation $\frac{a}{b} = \left(\frac{E_{11}}{E_{22}}\right)^{\frac{1}{4}}$ was satisfied, where a and b are the plate dimensions, and E_{11} and E_{22} represent the in-plane Young's moduli [41]. Consequently, we decided to use the torsional, O (ring) and X modes to determine the elastic properties of composite plates. Figure 1 illustrates the considered

torsional (Figure 1a), O (Figure 1b) and X modes (Figure 1c). The red colours indicate the higher displacements of these vibrational modes.

Figure 7a,b show the normalised values of the acquired resonance frequencies for the repeated impacts. The normalised values were computed using the ratio $\frac{f_n}{f_0}$, where f_n is the frequency of the repeated impact and f_0 is the initial frequency of the undamaged specimen, to show whether the frequency decreased or increased while damage progressed. As reported in Section 2.3, the torsional mode, the O mode and the ring modes, namely f_{tor} , f_O and f_X , were computed and were reported for both the laminates under repeated impact at 5 and 7 J. The green curves represent the bio-based laminates in Figure 7a,b, while the black curves represent epoxy. The torsional mode frequency for both laminates prepared with conventional and bio-based resins presented an increasing value or values after the first impact that then decreased before the failure. The increase in the frequency of the f_{tor} mode was expected. As shown in Figure 1, this modal shape has nodal zones where the damage

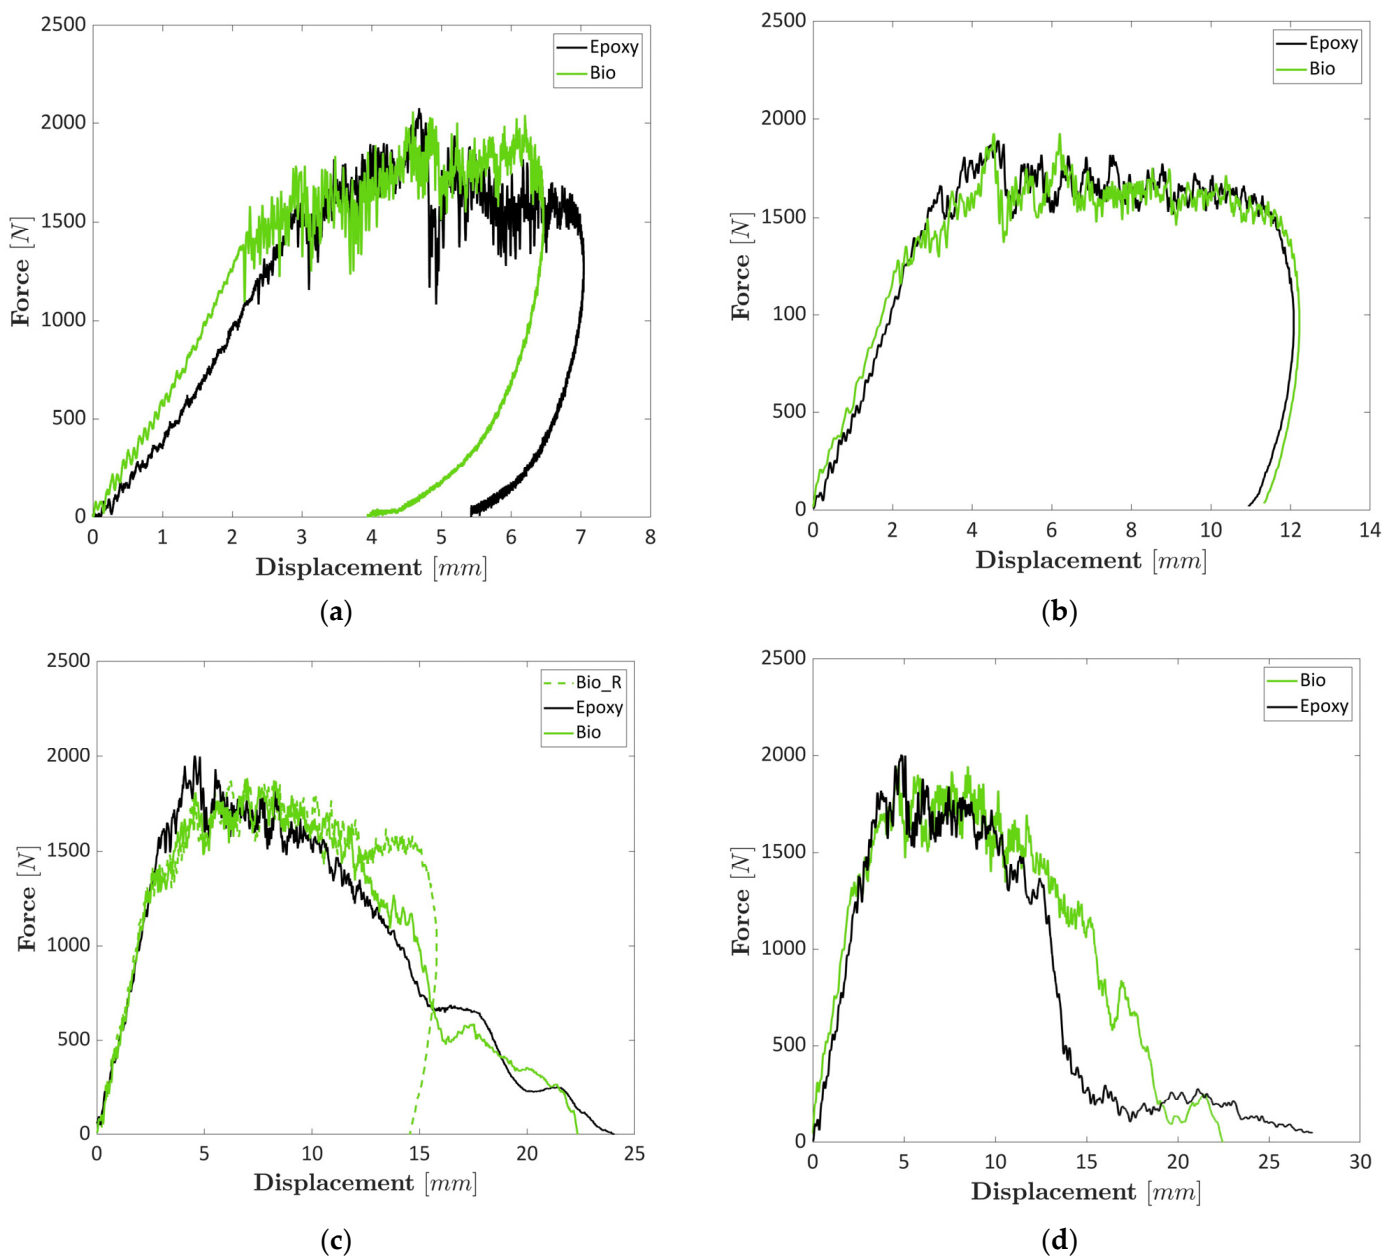
Figure 3. Impact tests conducted at 7 J (a), 15 J (b), 20 J (c) and 30 J (d).

Figure 3 shows representative force–displacement curves at different increasing impact energies of 8.6 J, 16.5 J, 23.5 J and 33.5 J. Representative curves are shown due to the limited scatter between the curves of the same set of samples as it is indicated by the error bars of the charts in Figure 4. The impact energy took into account the energy computed with the velocity when the impact started (namely 7, 15, 20 and 30 J) plus the energy added due to the displacement of the dart within the specimen during the tests. The force–displacement curves of laminates prepared with both epoxy and bio-epoxy resins presented a very similar behaviour in all four analysed cases with a slight difference at higher impact energy, 20 and 30 J, when the perforation of the composite laminates and the falling dart experienced a rebound due to the elastic energy of the specimen. The rebound was visible by analysing the force–displacement curves, which ended with a negative displacement. Impacts carried out at 7 and 15 J, Figure 3a and Figure 3b, respectively, could not perforate the specimens. However, at 15 J, the displacement was almost doubled compared to the impact at 7 J, while the maximum forces remained practically constant. At 20 J, Figure 3c, two curves over three are shown for the specimens prepared with the bio-based epoxy resin because two different behaviours were obtained. For this reason, a bio curve representative of the specimens that presented the rebound is also reported in Figure 3c. Indeed, the composite laminates prepared with bio-resin experienced a rebound in two out of three cases. This behaviour indicated that these specimens still present a residual elastic energy compared to the laminates prepared with the conventional epoxy resin. An explanation of this property can be related to the higher displacement and deformation that the bio-resin exhibits over the conventional resin, as shown in a preliminary work of the same authors [12], especially in flexural tests. The higher ductile behaviour of the resin explains why the composite prepared with bio-resin can bear a higher load before perforation. Figure 3d illustrates that 30 J was enough to perforate both types of laminates. However, the specimens prepared with bio-resin presented a final drop of the load at 20 mm, while the epoxy-based laminates presented a drop close to a 15 mm load drop. These different drops led to a higher value of the absorbed energy for specimens prepared with bio-resin.

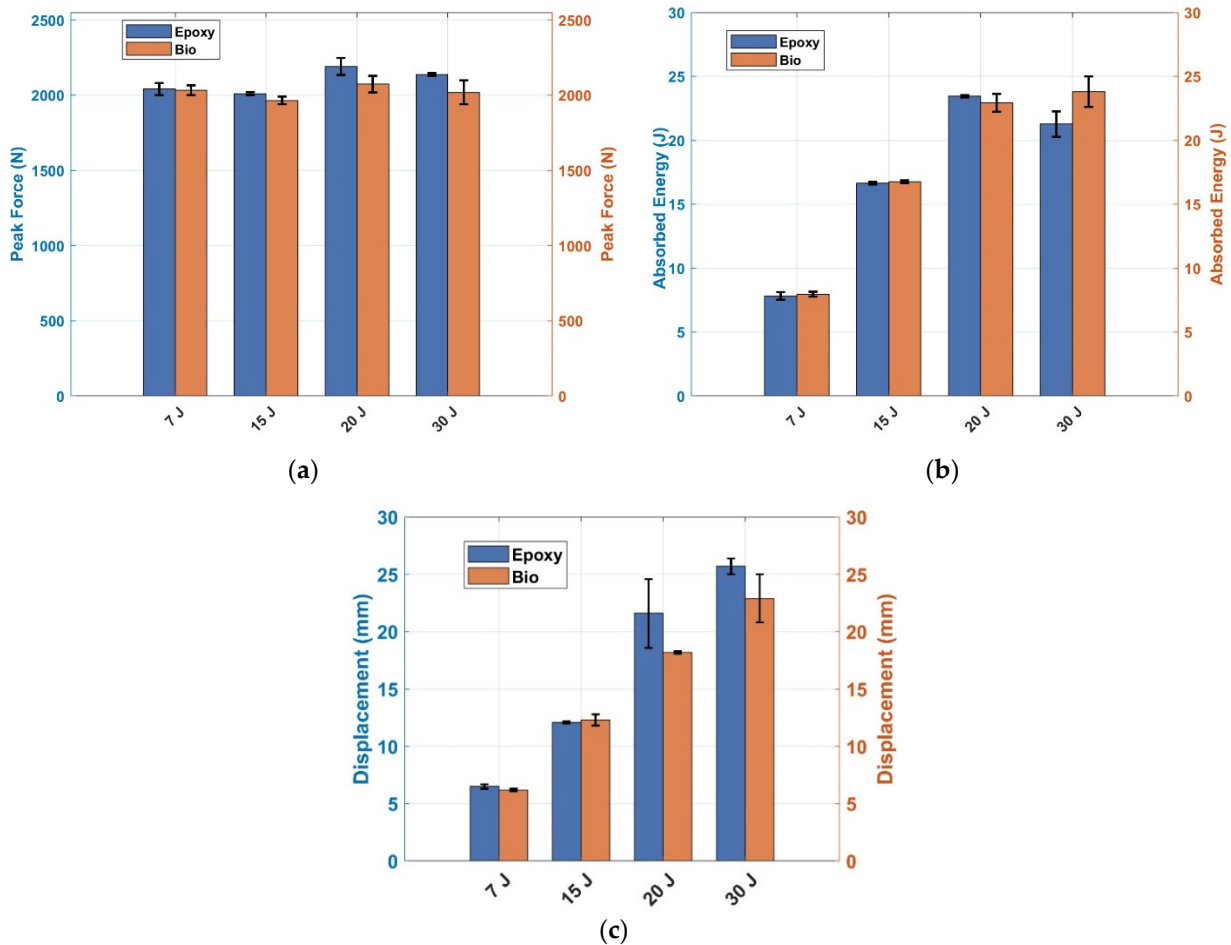
Figure 4. (a) Peak forces of bio and epoxy composites; (b) absorbed energy of bio and epoxy composites; (c) maximum displacements of the composite laminates prepared with bio and epoxy resins.

Figure 4a–c summarise the experimental activity shown in Figure 3. Figure 4a and Figure 4b show the values of the forces and the absorbed energy, respectively, for composite laminates prepared with bio-based resin and epoxy resin, respectively. The maximum force, around 2000 N, did not change significantly for any of the two types of specimens and the four analysed impact energies. This trend can be explained by considering that the fibre contents were similar. As shown in Figure 3, the damage was also triggered in laminates impacted at 7 J, as shown in the load–displacement curves. Indeed, load–displacement curves in Figure 3a do not show a perfectly elastic rebound since the displacement did not reach 0 mm after the impact. Thus, the values were similar, having the same number of layers for both conventional epoxy resin and bio-resin. Contrarily, comparing absorbed energies at different impact energy levels presented increasing values. Similar values at 7 and 15 J, where both specimens experienced a rebound, were obtained. Comparable values were also obtained at 20 J. However, the comparison is unfair in this case since two specimens out of 3 for the laminate prepared with bio-resin experienced a rebound.

In contrast, complete perforation was obtained in all cases for the specimen prepared with the conventional epoxy resin. Finally, the values of the absorbed energy at 30 J showed that the specimens prepared with bio-resin absorbed higher energy. Bio-based specimens bore a higher load before fracture at around 15 mm, while epoxy-based laminates exhibited a clear drop before failure, as shown in Figure 3d. The higher bearing capacity before failure can be related to the different matrices that have been used and the higher elongation that

Ultimate displacements are shown in Figure 4c. At 7 and 15 J, the ultimate displacements of both specimens prepared with the two resins were the same due to the rebound. At 20 J, the bio-based laminate presented lower displacement values due to the rebound of the specimens prepared with bio-resins. At 30 J, the displacement values of the specimens prepared with epoxy resin looked larger. However, the main significant drop occurred before 15 mm, and then the load remained constant between 100 and 200 N before going to 0 N. The specimens prepared with bio-resin presented a significant drop in the load at around 20 mm, which allowed them to absorb more energy during failure.

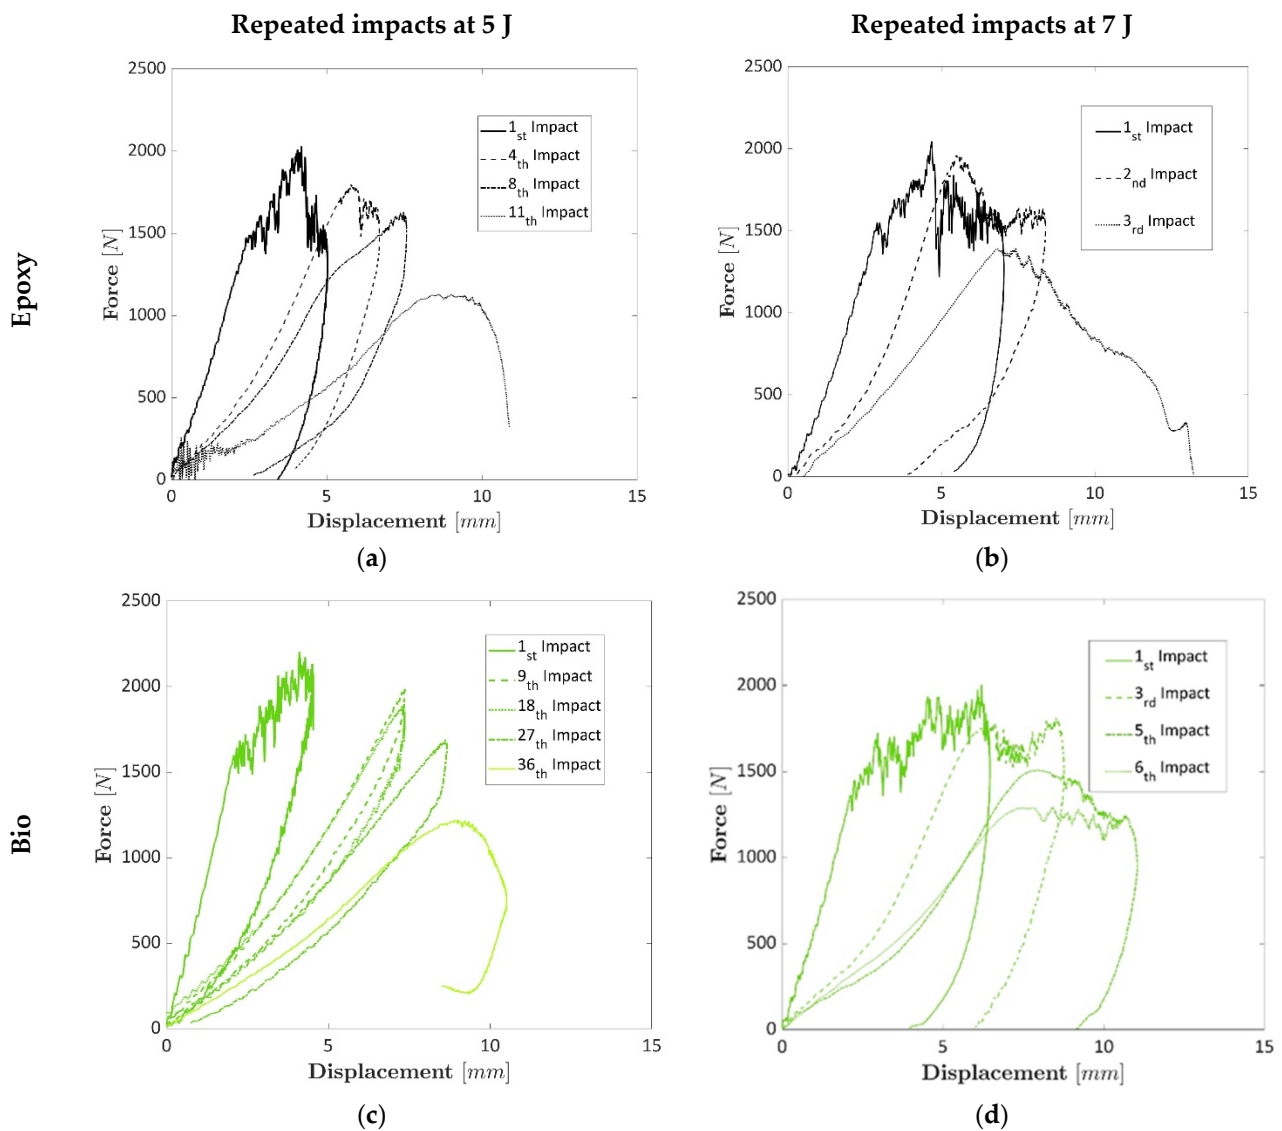
Figure 5. (a) Representative load–displacement curves for the laminates prepared with the epoxy resin at 5 J; (b) Representative load–displacement curves for the laminates prepared with the epoxy resin at 7 J; (c) Representative load–displacement curves for the laminates prepared with the bio-resin at 5 J; (d) Representative load–displacement curves for the laminates prepared with the bio-resin at 7 J.

Repeated tests were carried out to assess whether the specimens prepared with bio-resin presented higher resistance at repeated impacts due to the larger displacements they presented in the perforation tests. Figure 5a and Figure 5b show the repeated impact tests for the epoxy-based laminates at 5 J and 7 J, respectively. Figure 5c and Figure 5d display the repeated impact tests for the epoxy-based laminates at 5 J and 7 J, respectively. Different representative curves were chosen for each laminate due to the different numbers of obtained repetitions to highlight the damage progression among the different impacts. The damage progression can be shown by the decreased stiffness value (initial trend of the curves) and the increased displacement during repeated tests. The repeated impacts showed that at 5 J, the epoxy-based laminates bore 11 impacts, while the bio-based laminates reached 36 impacts. At 7 J, the conventional epoxy-based laminates bore three impacts, while the composite bio-based resin failed after six repeated impacts. The most significant differences between laminates prepared with epoxy and bio-resins can be found in the first drop of mechanical properties when the first peak was reached at both 5 and 7 J and the rebound of the dart that was identified with the values of the negative displacements in the load–displacement curves. The first curve of the epoxy laminates impacted at 5 J and 7 J showed a slight drop before 5 mm, Figure 5a,b, that was not present in the specimens prepared with bio-resin, Figure 5c,d. During the damage progression, the laminates prepared with bio-based resin exhibited higher force values sustained over more significant displacements, indicating superior residual elastic properties and lower damage levels than those made with epoxy resin under the same number of impacts. This

highlights the ability of bio-based resins to maintain a more consistent and elevated load capacity over repeated impacts. This trend is visible when comparing the first and the last curves of epoxy and bio-based epoxy at both 5 J and 7 J. Contrarily, the curves of the epoxy-based laminates present lower values of the forces after the maximum peak, which leads to a lower absorbed energy. Finally, the bio-based composite plates presented a higher rebound up to the failure, which means a higher residual energy. The meaning of this behaviour is attributed to the higher deformation that the epoxy bio-based resin can offer before failure, with a consequent higher number of impacts for the resin prepared with the bio-based resin.

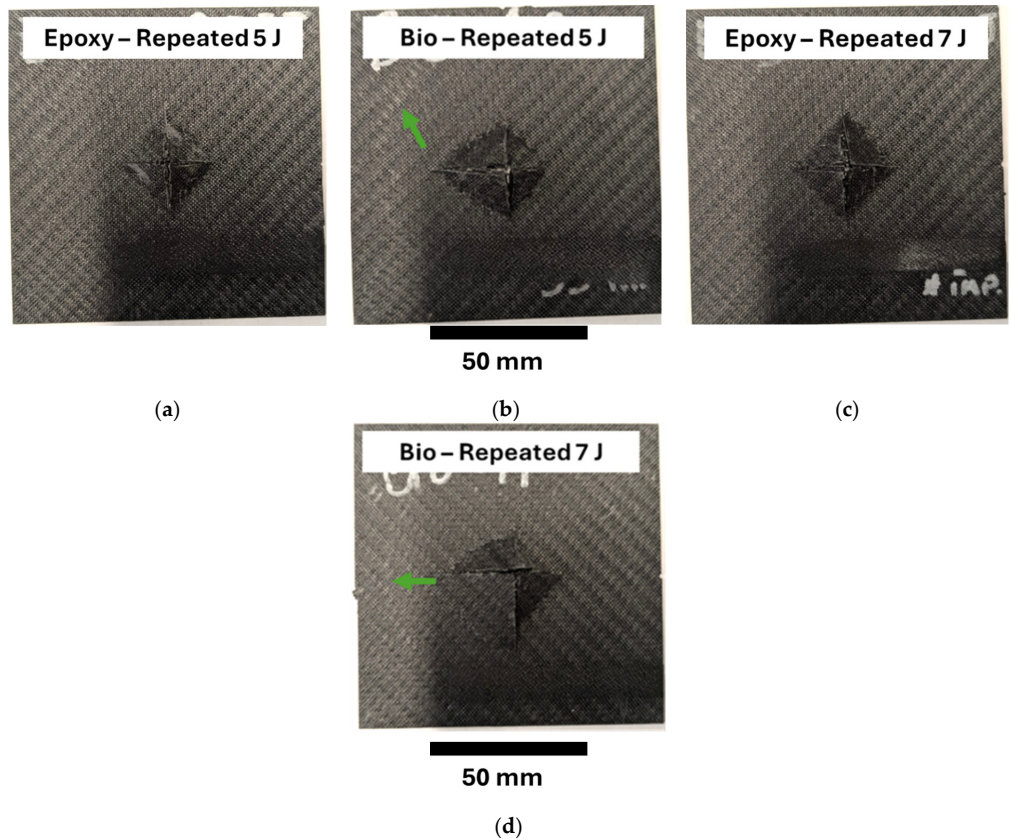
Figure 10. Fracture surfaces for the specimens subjected to repeated impact tests at 5 J and 7 J: (a) Epoxy 5 J, (b) Bio 5 J, (c) Epoxy 7 J, (d) Bio 7 J.

Figure 10 reports the specimens subjected to repeated impact tests at 5 J, Figure 10a and Figure 10b, and at 7 J, Figure 10c and Figure 10d, respectively, for plates prepared with epoxy and bio-resins. Figure 10 shows that the plates prepared with the epoxy resin and impacted at 5 J and 7 J presented similar fracture surfaces. The size of the damaged area and the shape were symmetric and quite close to the specimens impacted at 30 J, where complete perforation occurred. On the other hand, the plates prepared with the bio-based resin and impacted at 5 J and 7 J presented similar damage areas that were slightly longer on the left side, Figure 10b,c. This indentation was the result of the higher number of impacts that these specimens bore. The damaged area was slightly higher for bio-based due to the higher displacement that these specimens bore. Likely, the ductile behaviour of the plates prepared with bio-based resin triggers a different damage mechanism, and the interlaminar crack propagates before the final fragile failure. This behaviour involved a wider part of the plates in the damage progression. Indeed, the plates presented a tiny indentation close to the circular support, as shown by the green arrow. The frequencies computed throughout the IET also showed that this technique could detect greater damage. Indeed, the specimens impacted at 5 J presented a final value of 0.86 and 0.90 for the specimens prepared with bio and epoxy resins, respectively. The final values for specimens impacted at 7 J were 0.82 and 0.88, respectively, for the bio and epoxy resins. Thus, the plates with greater damage, the biospecimens, presented a higher drop in frequency.
