AE monitoring of crack evolution on UHPC deck layer of a long-span cable-stayed bridge

AE monitoring of crack evolution on UHPC deck layer of a long-span cable-stayed bridge / Jiang, Z., Zhu, Z., Lacidogna, G.. - In: DEVELOPMENTS IN THE BUILT ENVIRONMENT. - ISSN 2666-1659. - STAMPA. - 23:(2025), pp. 1-12. [10.1016/j.dibe.2025.100697]

# AE monitoring of crack evolution on UHPC deck layer of a long-span cable-stayed bridge

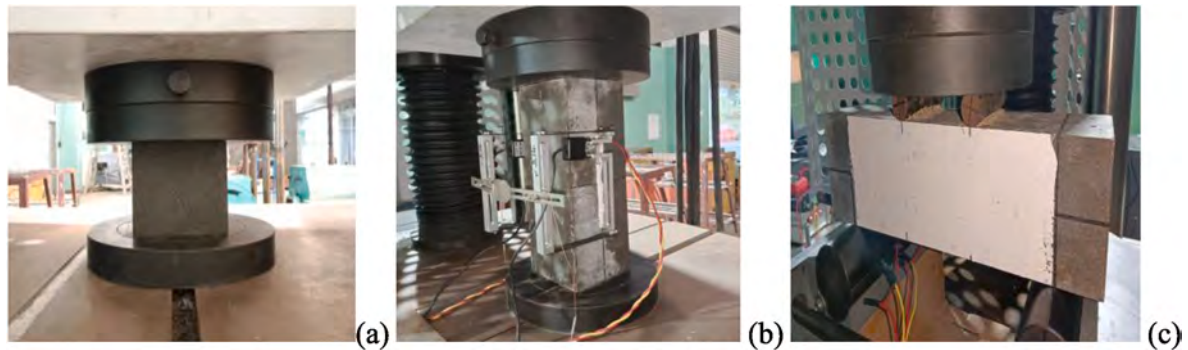
Fig. 6. Preliminary tests of UHPC: Compression (a), (b); Bending (c).
