Measurement campaign on the historical metallic construction tools and metallic elements of the Brunelleschi's Dome in Florence

Section: RESEARCH PAPER

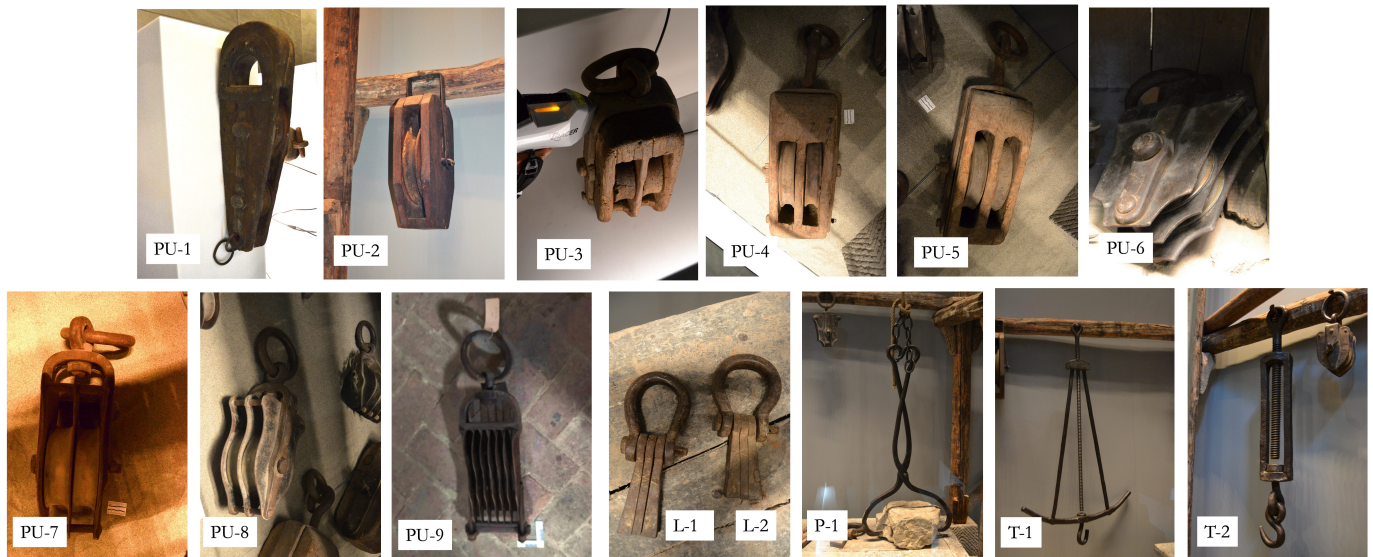
Figure 1. Historical tools employed for the construction of the Santa Maria del Fiore cathedral in Florence. From PU-1) to PU-9) pulleys, P-1) pincers, L-1) and L-2) three-legged lewis, T-1) and T-2) turnbuckles.

In a preliminary study of the Authors [21], [22], XRF analysis was carried out on various tools from the collection of the Opera di Santa Maria del Fiore that are currently on display at the Museo dell'Opera del Duomo in Florence. These items include tools and equipment that were used in the construction of the Santa Maria del Fiore cathedral. The objects examined consisted of two turnbuckles, eight pulleys, two three-legged lewis, and a pincer (Figure 1).

The pulleys can be classified based on their appearance in two main typologies: the first group presents a wooden body with a metallic frame needed to hold and anchor the tool (PU-1, PU-2, PU-3, PU-4, and PU-5), and the second group is made entirely in metal (PU-6, PU-7, PU-8, and PU-9).

The composition was investigated by XRF, highlighting that the metallic frame of the wooden pulleys consists of an iron alloy containing iron (Fe), manganese (Mn), copper (Cu), zinc (Zn), nickel (Ni), and traces of arsenic (As). The metallic pulleys present similar compositions, but the relative intensities of the characteristic peaks were different. Specifically, they were characterised by lower values of As and Mn. Some additional considerations have been extracted thanks to multivariate analysis. In particular, the

main body of the metallic pulley PU-6 was identified as an iron alloy with a similar composition to the wooden pulley frame, but with the additional presence of lead (Pb). Eventually, the material of the wheels of metallic pulleys PU-7 and PU-8 was identified as lead bronze, characterised by the presence of Cu, tin (Sn), and Pb.

The two turnbuckles, used for lifting heavy loads, were also studied and represented an interesting case study. They are relevant both from the technical and historical point of view. Indeed, these tools were innovative for the Renaissance period, since they allowed smooth and controlled lifting of heavy loads and reduced the risk of chipping stones during positioning. Their depiction in Renaissance drawings, such as in the "Taccuino senese" by Giuliano da Sangallo [23], underlay their historical relevance. Structurally, turnbuckles consist of a central screw, nut, hook, and two connecting rods. The study [22] paid particular attention to the threaded components, as their material composition provides insight into Renaissance production techniques and dating. The analysis performed on turnbuckle T-1 revealed that the nut is made of a bronze alloy containing Cu, Sn, Zn, and Pb, along with trace elements such as Fe, Ni, antimony, and As. The presence of Zn, Ni, and Fe in lead bronze was already reported in previous studies [24], [25]. The presence of antimony (Sb) is interesting since it aligns with previous studies on artefacts of the Renaissance period, including the *Porta del Paradiso* reliefs by Lorenzo Ghiberti, where elements like antimony and arsenic were present as impurities in the alloys [26]. This compositional evidence supports the dating of T-1 to the era of Brunelleschi. The other components of T-1 are made of an iron alloy containing Cu, Zn, As, and Pb.

By contrast, the turnbuckle T-2 is exclusively composed of an iron alloy with a comparable chemical composition to T-1 but with Mn, Zn, and As higher concentrations. A difference in material composition like the one found in the two turnbuckles suggests differences in manufacturing techniques and possible differences in the period of manufacture. It is worth noticing that while bronze was commonly used during the Renaissance for threaded components due to its good machinability with steel tools, iron-threaded components suggest a later manufacturing period.

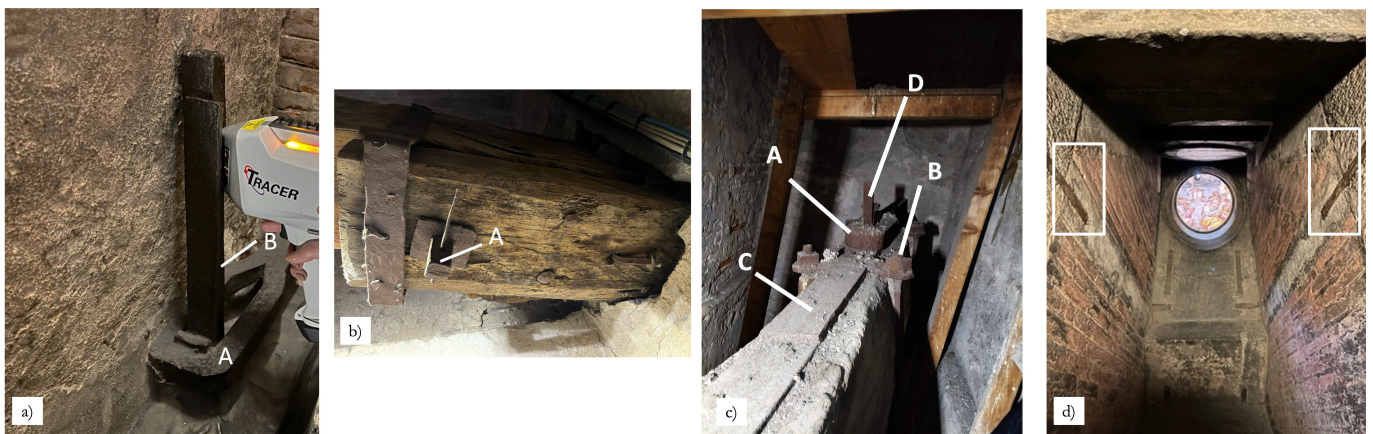
Figure 3. a) Metallic joint in compartment 8; b) Chestnut chain and metallic joint in compartment 12; c) Chestnut chain and metallic joint in compartment 16. The white letters indicate the areas of analysis; d) Compartment and the two metallic rods on the sides (white rectangles).

The metallic joints of the chestnut chain (Figure 3 a) located

in compartment 8 - web 3, are datable back to the repairs that occurred in 1637 at the behest of the architect Gherardo Silvani. This involved the consolidation of the existing chestnut chain through the insertion of additional joints [10], [11]. Indeed, three iron rods can be observed superimposed on the original hoop, equipped with an eyelet at the ends and connected to each other by means of a "hinge" joint, i.e. by overlapping the eyelets of two adjacent rods and inserting a vertical rod as a blocking element. The latter, crossing the chain at its entire height, also guarantees the vertical connection between the elements, fixing the new metal tie rods to the pre-existing wooden beams. The chestnut chain is covered by a sheet of copper, which makes it difficult to observe additional elements of connection. This type of joint is present in two occurrences within the structure [10], [11].

Another type of joint of the chestnut chain is characterised by the use of wood beams connected through a metal banding. This joint consists of wooden beams secured together using nails. The beams are supported by an iron pin, which ensures the joint's stability, while the iron banding reinforces the connection. It is the most widespread and remains largely authentic. The dating of this joint is placed in the early period of the Dome's construction, making it an important example of the construction techniques used in the 15th century. There are 18 instances of this joint type identified on the chain [10], [11]. In this study, the metallic joints

of the chestnut chain located in compartment 12 of web 4 have been analysed (Figure 3b).

The other type of joint analysed in this study appears quite complex and includes both vertical and horizontal connection elements. Two large U-shaped brackets ensure the vertical connection between the wooden elements (the chain and the underlying corbel). An interesting feature is that the brackets are closed at the upper end by threaded bolts. A metal tie rod with an eyelet terminal and an iron wedge reinforces the horizontal connection between adjacent beams. The system is completed by two metal plates nailed to the beam to ensure a stronger anchoring between the tie rod and the wooden beam, as well as among the various metal components [10], [11]. This typology is found in 4 locations in the Dome. In this paper, the one in compartment 16 of web 6 was analysed (Figure 3c).

Figure 3d reports a representative image of one of the compartments mentioned in this section. The surface of the metal rods was cleaned before analysis to remove the superficial layer of corrosion products, to highlight differences in the bulk composition of the components.
