# Development of a Large Database of Italian Bridge Bearings: Preliminary Analysis of Collected Data and Typical Defects

**Abstract:** This paper presents the development and analysis of a bridge bearing database consistent with the 2020 Italian Guidelines (LG2020), currently enforced by the Italian law for risk classification and management of existing bridges. The database was developed by putting together the contribution of 24 research teams from 18 Italian universities in the framework of a research project foreseen by the agreement between the High Council of Public Works (CSLP, part of the Italian Ministry of Transportation) and the research consortium ReLUIIS (Network of Italian Earthquake and Structural Engineering University Laboratories). This research project aimed to apply LG2020 to a set of about 600 bridges distributed across the Italian country, in order to find possible issues and propose modifications and integrations. The database includes almost 12,000 bearing defect forms related to a portfolio of 255 existing bridges located across the entire country. This paper reports a preliminary analysis of the dataset to provide an overview of the bearings installed in

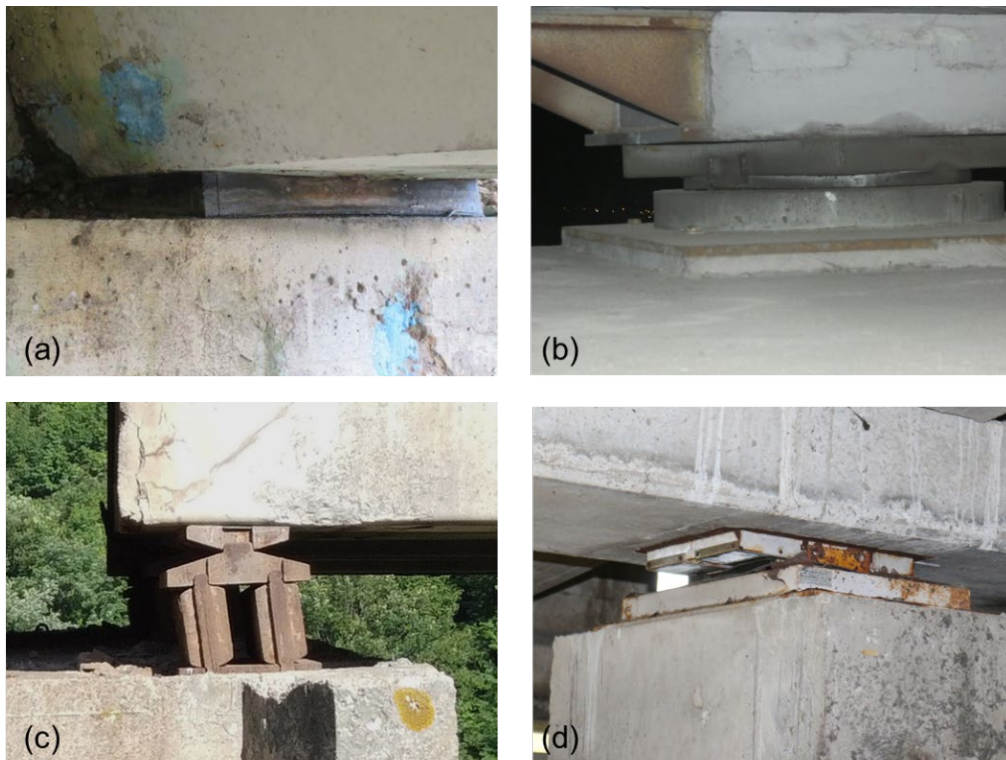
Figure 2. (a) Elastomeric, (b) pot, (c) steel, and (d) steel–Teflon bearings in inspected bridges.

Figure 2 shows some samples of bearings photographed during the inspections on the bridge subjects of this project. Figure 2a is related to a laminated elastomeric bearing

with light degradation signs on a vertical surface; Figure 2b represents a pot bearing with no visible degradation; and Figure 2c shows a heavily corroded steel roller installed in a half-joint belonging to a Gerber bridge. Lastly, Figure 2d depicts a recently installed bearing with planar multidirectional steel–Teflon surfaces.

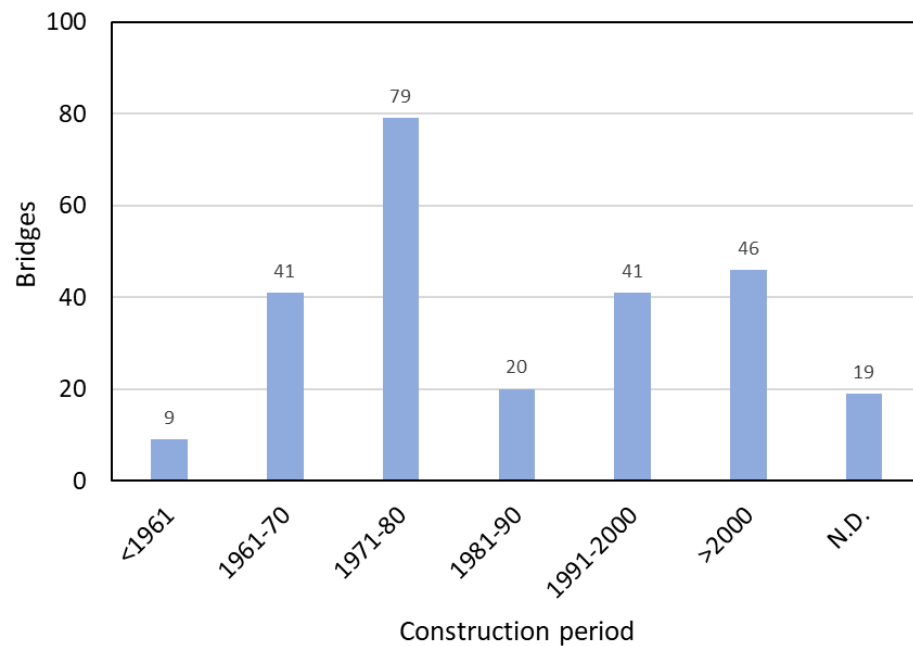
Figure 6. Distribution of bridges by construction period.

Regarding the construction periods, Figure 6 shows the distribution across the periods from pre-1961 to post-2000. Most bridges were constructed in the period 1971–80 (79 structures) while 1961–70, and from 1991 onwards, present almost the same number of bridges, around 40. The least covered periods are <1961 and 1981–90. There is also a share of bridges lacking this information (19 structures identified as N.D.). This means that for some bridges, due to the poor availability of design documents, even a basic piece of information like the construction period is missing. This aspect can impair the bridge knowledge necessary for detailed assessment activities and intervention planning necessary for effective bridge management. However, it is assumed that the age of the bearings is the same as that of the bridge they belong to, since some of the bridges may have undergone bearing replacement interventions, which are beyond our current knowledge.

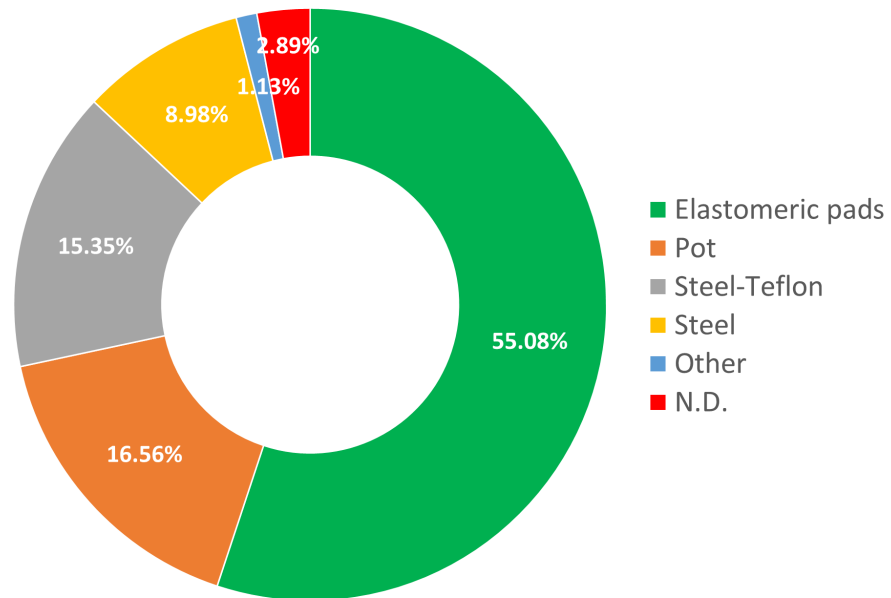
Figure 7. Typological distribution of bearings in database.

Figure 7 shows the percentage presence of each type of bearings within the available database. Out of the 11,984 bearings, 55.0% are elastomeric pads (plain or reinforced), 15.35% feature steel–Teflon surfaces, 16.56% are pot bearings (confined elastomeric disks), and 8.98% are entirely steel. In a few cases, seismic isolators or other types of bearing are installed (e.g., reinforced concrete pendulums). These latter are classified as “other” and represent 1.13% of the total. Moreover, 2.89% are bearings for which the typology is not identified (N.D. in Figure 7).

The frequent use of elastomeric bearings likely results from their ease of installation [11], which in most cases, did not require mechanical anchors for the connection to the substructure and superstructure, relying solely on friction. This also allowed the possibility to easily install the deck structure, permitting higher flexibility during the launching operations.

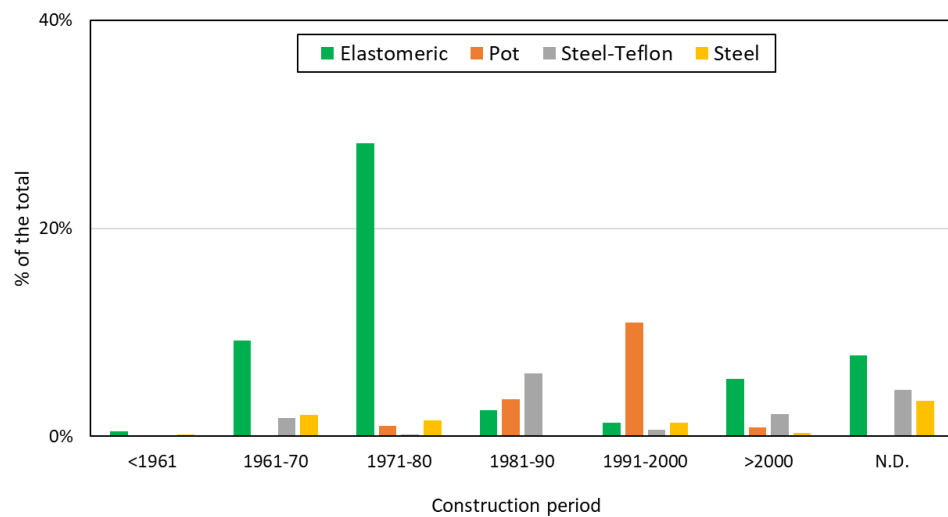
Figure 8. Percentages of bearing types by bridge construction period.

As shown in Figure 8, the ease of installation of elastomeric pads made them the preferred ones for bridges built before 1980, although they were used also after that period. The use of pot bearings started in the 1970s but had a wider diffusion after 1980. It is well-known that steel bearings were the first used in bridge applications, and based on this database analysis, were mostly used before 1980, even though they are also present in bridges built after 1990. However, they have a significant share with the unknown construction period that could be likely attributed to earlier periods (e.g., <1970). Steel-Teflon bearings, although present before 1970, were widely used after 1980.

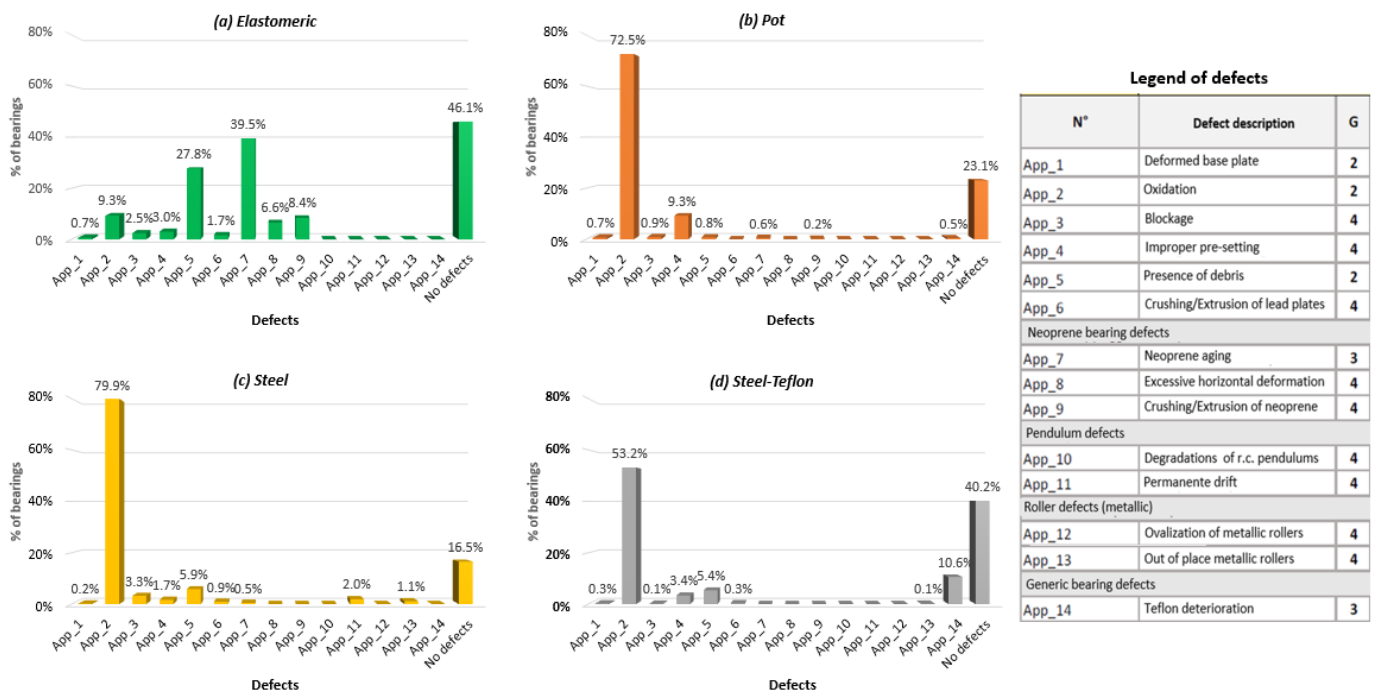
Figure 10. Defect incidence by bearing type.

For each bearing type in the database, distributions of various identified defects were determined based on the level 1 “Bearings” form (Figure 3). The reported percentages are related to the number of each bearing type in the database. For some bearings, the defect did not match any category on the form, so the “other” option was used by the inspector and specified in the notes. As mentioned before, the level 1 form does not feature a dedicated field for textual bearing type descriptions, so this information sometimes must be inferred from the defect type, which is not always possible. The defect distribution for each type of bearing is shown in Figure 10.

For elastomeric bearings (Figure 10a), the most frequent defect is App\_7 (neoprene aging, related to surface microcracking or delamination), followed by App\_5 (presence of debris), then App\_2 (oxidation), and App\_9 and App\_8 (neoprene crushing/extrusion and

For pot bearings (Figure 10b), App\_2 (oxidation) is by far the most prevalent, observed in over 72% of cases, with App\_4 (improper pre-setting) occurring around 9.3%, while other defects are either absent or negligible. For steel bearings (Figure 10c), some considerations made for elastomeric bearings apply. In fact, almost 80% feature oxidation, and about 6% are affected by App\_5 (presence of debris), which, among minor defects, appears most frequently. The presence of App\_7 is clearly attributable to form entry errors since steel bearings do not have neoprene parts.

Finally, for bearings with steel-Teflon surfaces [22] shown in Figure 10d, the most common defect is App\_2 (Oxidation), affecting more than 53% of devices, with a significant presence of App\_14 (Teflon degradation) with 10.7%, App\_5 (presence of debris) with 5.4%, and App\_4 (improper pre-setting) with 3.4%. Additionally, for these bearing types, the notes often report defects like "Loose bolts", with known issues of anchoring pins

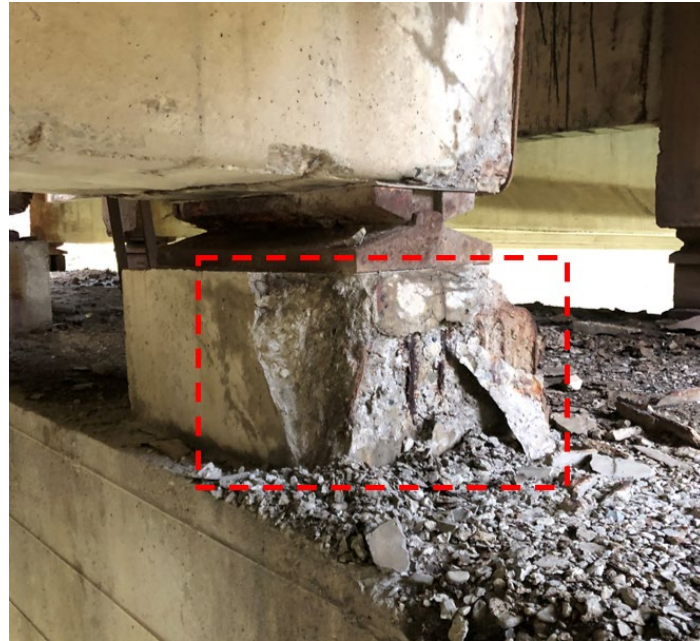
**Figure 11.** Example of damaged/degraded (spalling and reinforcement corrosion) reinforced concrete support (from Authors' inspection).

excessive horizontal deformation) are present. Inspectors occasionally report defects not covered in the bearings form, such as damaged/degraded bearing supports (Figure 11). Although this defect is not directly related to the bearing device, it can affect its correct operation and, therefore, should be considered among the defects of bearings, highlighting those that need restoration interventions. A similar issue can be detected for the members supporting or directly related to bearing devices in Gerber bridges (also referred to as cantilever bridges) (e.g., [21]) as, for example, the half-joints.
