Numerical Modeling of Dapped-End Beams Subjected to Corrosion and Retrofitting Interventions

Numerical Modeling of Dapped-End Beams Subjected to Corrosion and Retrofitting Interventions / Di Benedetto, M., Di Trapani, F., Sberna, A.P., Villar, S., Ferrara, M., Bertagnoli, G.. - 638:(2025), pp. 111-121. (Eurasian OpenSees Days 2024 Beijing (China) July 24–25, 2024) [10.1007/978-3-031-90690-9_10].

Marilisa Di Benedetto¹, Fabio Di Trapani¹, Antonio Pio Sberna¹, Sofia Villar¹,
Mario Ferrara¹, Gabriele Bertagnoli¹.

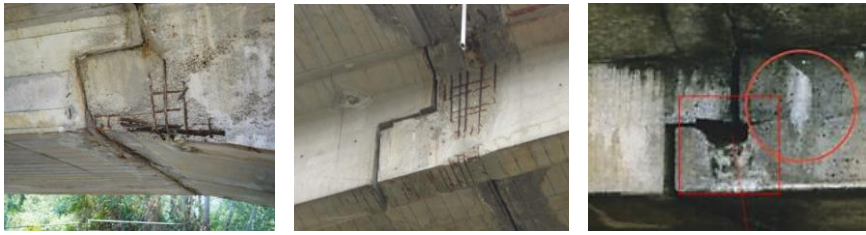
Fig. 1. Degradation of dapped-end beam bridges caused by steel reinforcement corrosion.

Dapped-end beams, also known as half-joint beams, are a notable example of structures often subjected to degradation especially because of corrosion of reinforcement (Fig.1). These structural elements, widely used from the 1960s to the 1980s for their design simplicity and settlement insensitivity, have shown early degradation and brittle failures [2, 3]. Several studies have evaluated the performance of dapped-end beams under both undamaged and damaged conditions, employing Strut-and-Tie models (STMs) [4]. Recent research has focused on experimental and numerical investigation of the impacts of reinforcement corrosion and retrofitting solutions for structural deficiencies [5-10].

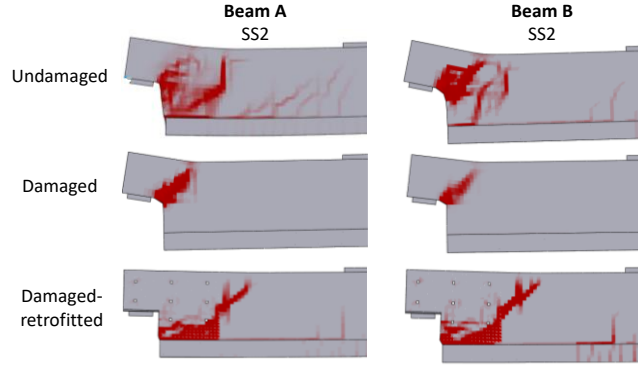
Fig. 9. Numerical crack patterns of the dapped-end beams (beam A and beam B) in three different configurations in static scheme 2 (SS2).

Failure in the retrofitted saddle occurs due to a block tearing mechanism, while the unreinforced damaged beam fails through localized cracks near the saddle notch without propagating through the entire web, as shown in Fig. 9.
