# Safety evaluation of an existing PRC bridge beam: preliminary outcomes of in-situ test

Diego Gino<sup>1</sup>[0000-0002-8689-0790], Luca Giordano<sup>1</sup> and Paolo Castaldo<sup>1</sup>[0000-0002-7956-9392]

<sup>1</sup> Politecnico di Torino, Turin, Corso Duca degli Abruzzi 24, 10129, Italy

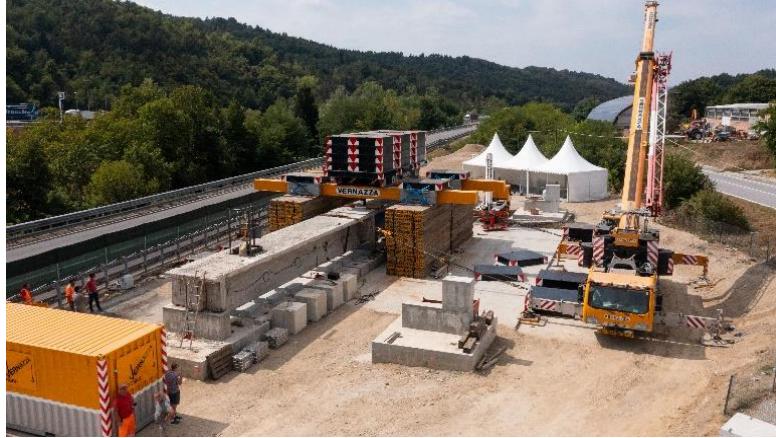
**Fig. 4.** Ultimate test layout arrangement featuring the 3000 kN counteracting structure.

The image in Figure 4 depicts the configuration of the test setup and the counteracting structure created using Azobè wood walls, steel beams, and iron ballasts.

counterweight on the counteracting steel structure (Figure 4), including iron ballasts and the self-weight of the structure, was set at 3000 kN (300 tons). This setup ensured that each of the two load points could apply a maximum force of 1500 kN (150 tons) to the beam while maintaining an adequate safety margin. The testing procedure involved applying incremental displacements simultaneously to each jack, as illustrated in Figure 5. The displacements of the jack were gradually increased at a slow rate between each step, and at each reached displacement level, the corresponding reaction force was measured.

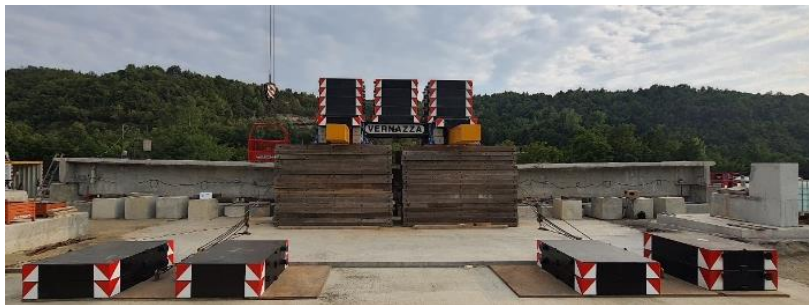
Fig. 7. View o of the PRC beam with around 50cm of deflection in midspan.

The test was halted when the beam showed a midspan deflection of approximately 46 cm (Figure 7). The neutral axis consistently exhibited a depth beyond the upper slab thickness for each investigated section along the beam axis, causing the slab to remain consistently compressed with deformation values below 0.1%. In the central zone with a constant moment (i.e., the portion of the beam between the two jacks), cracks appear to be nearly vertical due to the absence of interference between bending and shear stress.
