SMAR 2024 – 7th International Conference on Smart Monitoring, Assessment and Rehabilitation of Civil Structures

Full-scale load test of a PRC bridge beam after 60 years of service life

This study presents preliminary findings from a full-scale experimental investigation conducted on a PRC beam spanning 34.60 meters. The beam, post-tensioned over 60 years ago, was originally part of the Mollere viaduct along the Torino-Savona highway in Italy (Darò et al. (2023)) but was intentionally removed during dismantling work. It was subsequently relocated and supported by two separate RC footing foundations within an appropriately prepared testing area. The load test involved applying prescribed displacements at two central supports located 5.02 meters apart across the midspan, using hydraulic jacks with a maximum capacity of 2000 kN (200 tons) each. The PRC beam was tested up to a maximum deflection displacement of approximately 50 cm without experiencing catastrophic failure but exhibiting a progressive bending failure mode with significant ductility. This paper further discusses the test setup configuration and preliminary outcomes.

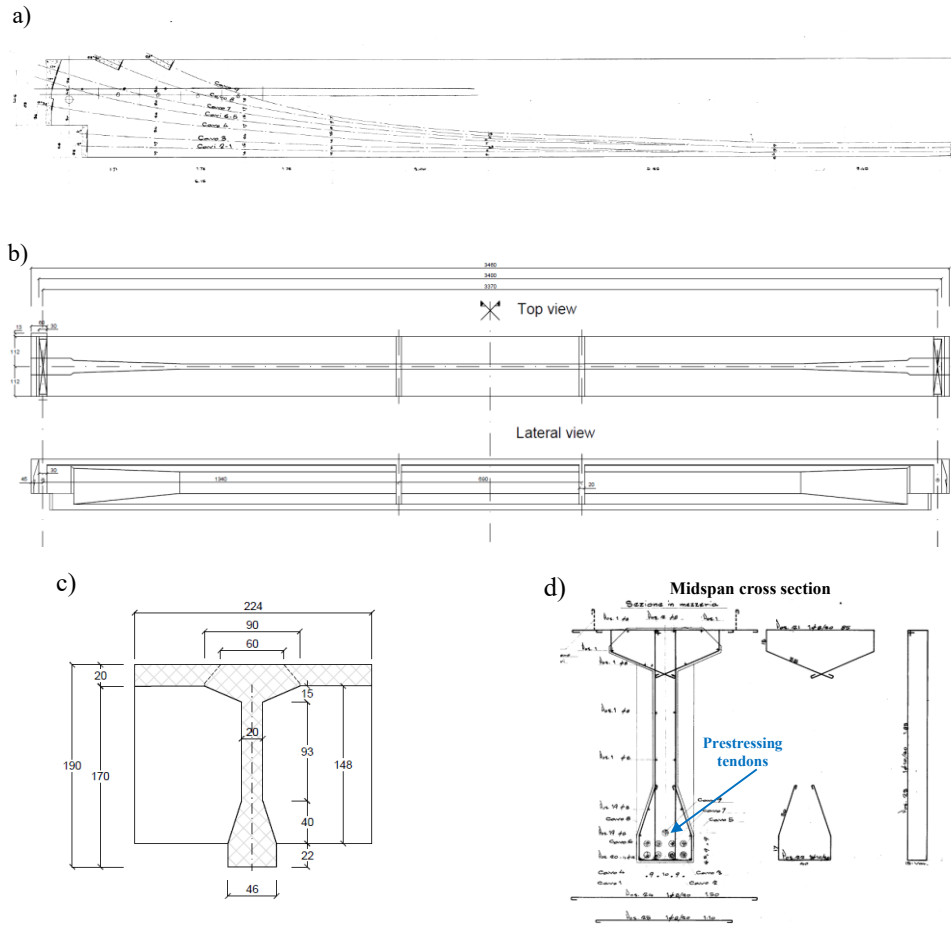
Fig. 1. Arrangement of the prestressing tendons longitudinally in (a). The longitudinal configuration of the beam is illustrated in (b). At the midspan, a cross-sectional perspective of the precast concrete beam and the top slab is depicted in (c), shows the reinforcement layout and placement of the prestressing tendons in (d). All measurements are presented in centimeters.

This section presents a thorough examination of the PRC beam, encompassing its geometric features, material attributes derived from initial design records, and its present state, inclusive of damage identification. Positioned as the pivotal element within a girder bridge deck constituted by six primary beams, the beam measures an overall height of 190 cm and displays a symmetrical cross-sectional configuration, as illustrated in Figure 1(c) based on available documentation and on-site surveys.

The cross-sectional setup entails an in-situ cast concrete slab with a thickness of 20 cm and a prefabricated main PRC beam in precast concrete. Despite the longitudinal separation from the original deck, remnants of the in-situ cast concrete crossbeams endure at the supports and midspan. Complemented by bonded prestressing main reinforcement facilitated through post-tensioning with injected mortar, the beam features nine tendons, each comprising 18 wires with a 7 mm diameter, following a parabolic trajectory, as depicted in Figures 1(a)-(d). The arrangement of parabolic tendons is delineated in Figure 1(d), while Figure 1(a) illustrates the longitudinal profile of the PRC beam. Figure 2 portrays the assessment of the structural member's degradation level through preliminary inspections, revealing a corrosive process in the web stirrups and reinforcements near the drainage device holes in the deck. Additionally, longitudinal cracks along the alignment of the post-tensioning tendons near the anchorage heads, ascribed to the "bursting" phenomenon, were noted, potentially present even during post-tensioning. Remarkably, despite 60 years of service, no significant degradation was discerned. Information pertaining to the condition of the prestressing tendons, including the quality of the original mortar injection within the sheaths, remained elusive prior to testing.

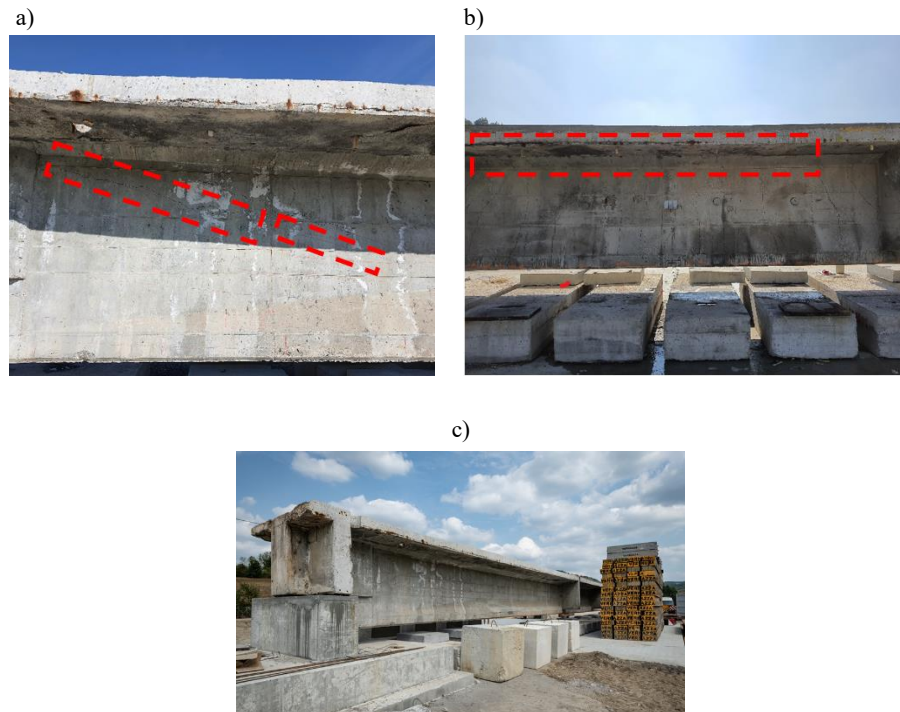
Fig. 2. Cracking along the longitudinal direction near the path of post-tensioning tendons close to the anchorages. (a). Longitudinal cracking of the slab (b). General view of the beam (c).

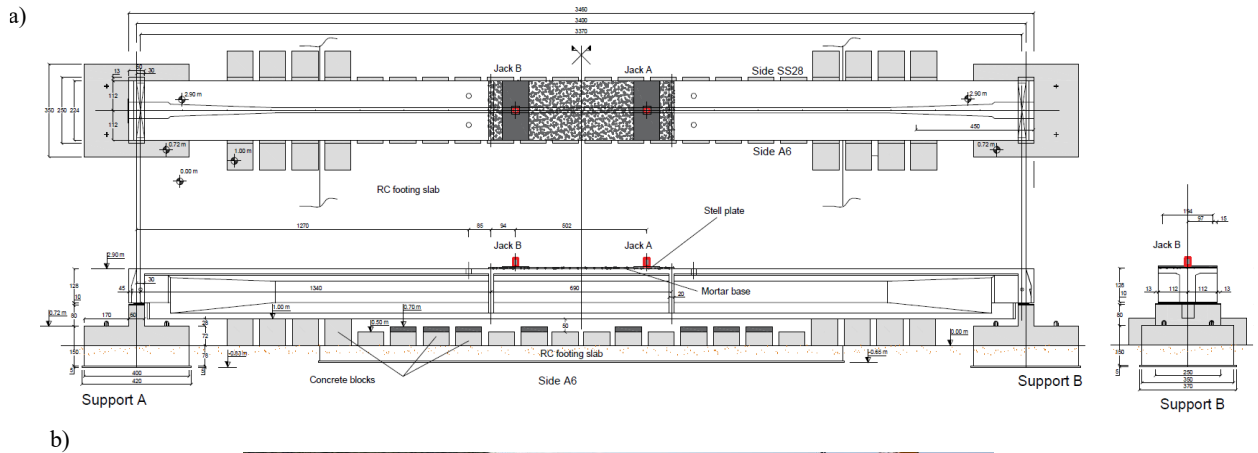
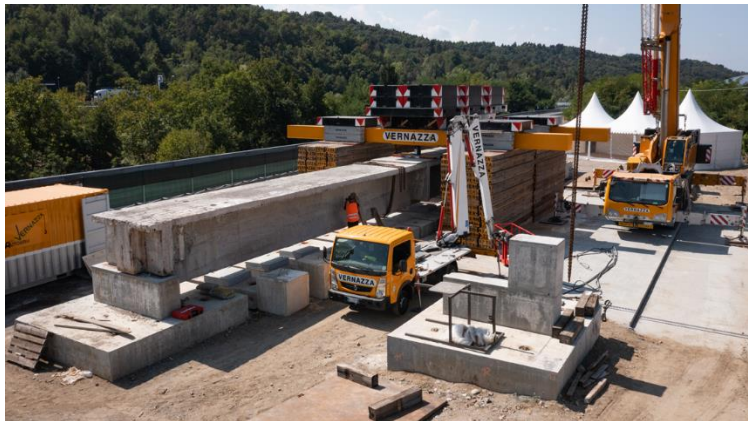
Fig.3. The testing layout is depicted in (a), with measurements in centimeters. (b) provides a general view of the testing area.

The positioning of the PRC beam within the test area adheres to the arrangement depicted in Figure 3 (a)-(b). Supported by two specifically casted in situ RC footings labeled as support A and B, the beam is situated accordingly. Underneath the beam, an RC slab footing measuring 20x22x0.5m has been erected to offer a clean and stable surface for accommodating the loading devices, totaling 3000 kN in weight, as illustrated in Figure 3 (b). Strategically placed concrete blocks beneath the span ensure a clearance of 50 cm, corresponding to the maximum midspan displacements achievable during the test, as shown in Figure 3 (a). Positioned 5.02m apart across the midspan, two jacks (A and B) are situated on the top slab, positioned as close as feasible to the original transverse beams. Each jack has a capacity of 2000 kN (equivalent to 200 tons). Figure 3 (b) offers a visual depiction of the test setup, showing the counteracting structure constructed using Azobè wood walls, steel beams, and iron ballasts. The mobilization of heavy materials within the testing area was facilitated by a mobile crane.

To achieve the estimated resisting moment, the total counterweight on the counteracting steel structure (depicted in Figure 3(b)), comprising the iron ballasts and the structure's self-weight, amounted to 3000 kN (300 tons). This configuration ensured that each of the two load points could apply a maximum force of 1500 kN (150 tons) to the beam, maintaining a sufficient margin for conducting the test. The jack displacements were incrementally increased at a slow pace between each step, with the reacting force measured and recorded upon reaching the desired displacement level.

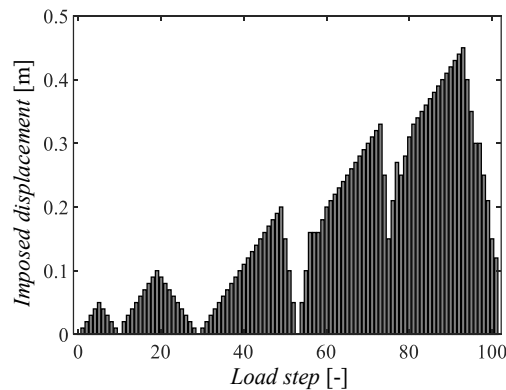
Fig.4. The imposed displacement at jacks A and B during the execution of the test is illustrated.

The load test entailed applying controlled displacements at two jacks, A and B, as depicted in Figure 4. Using geometric and mechanical data acquired from a historical survey and visual inspection of the RC beam spanning 34.60 meters, a resisting bending moment of 17750 kNm was computed following EN 1992-1-1 guidelines. It's essential to emphasize that this resisting moment value was determined utilizing mean values of material mechanical properties derived from known characteristic values (from design reports), per EN 1992-1-1.

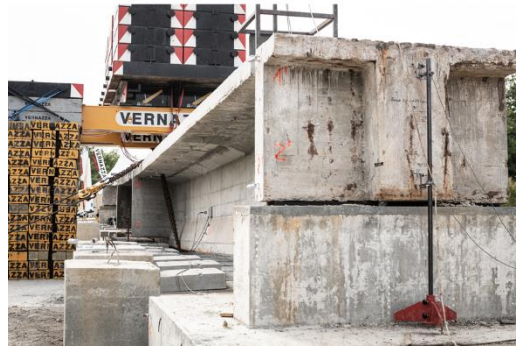
a)

The test concluded upon the beam exhibiting a mid-span deflection of approximately 46 cm, corresponding to a total load transmitted by the jacks of around 1800 kN. Across the beam axis, the neutral axis consistently extended beyond the upper slab thickness in every investigated section, leading to continuous compression of the slab. The observed crack pattern (Figure 6(b)) aligns with that of a structure fixed at both ends with simple supports and loaded by two concentrated forces straddling the midpoint. In the central zone with a constant moment (between the two jacks), cracks appeared nearly vertical due to minimal interference between bending and shear stress. However, as one moves toward the supports where shear stress intensifies, cracks tend to incline, with a minimum angle of around 30 degrees, influenced partially by the presence of prestressing force. The maximum midspan deflection measured approximately higher than 45 cm, as evident in Figure 6(a). Upon reaching this displacement level, the test was concluded.

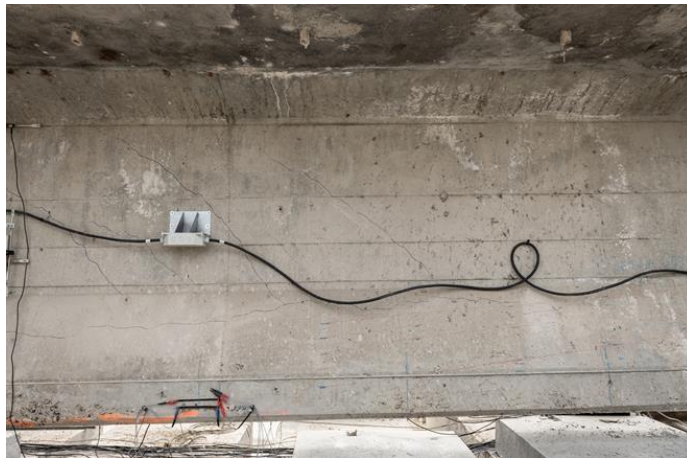
b)

Fig. 6. (b) provides a view of the deflection of the PRC beam under the maximum load. (c) shows the crack pattern of shear cracks close to the support.
