Full-scale load test of a PRC bridge beam after 60 years of service life

SMAR 2024 – 7th International Conference on Smart Monitoring, Assessment and Rehabilitation of Civil Structures

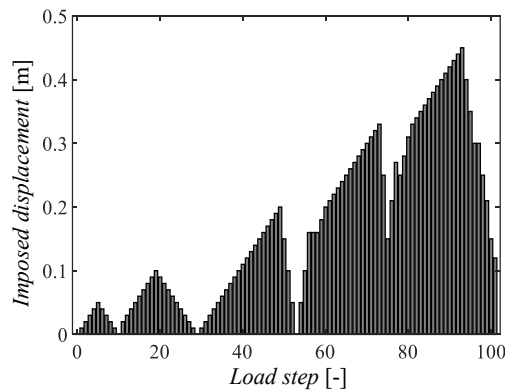
Fig.4. The imposed displacement at jacks A and B during the execution of the test is illustrated.

The load test entailed applying controlled displacements at two jacks, A and B, as depicted in Figure 4. Using geometric and mechanical data acquired from a historical survey and visual inspection of the RC beam spanning 34.60 meters, a resisting bending moment of 17750 kNm was computed following EN 1992-1-1 guidelines. It's essential to emphasize that this resisting moment value was determined utilizing mean values of material mechanical properties derived from known characteristic values (from design reports), per EN 1992-1-1.
