Full-scale load test of a PRC bridge beam after 60 years of service life

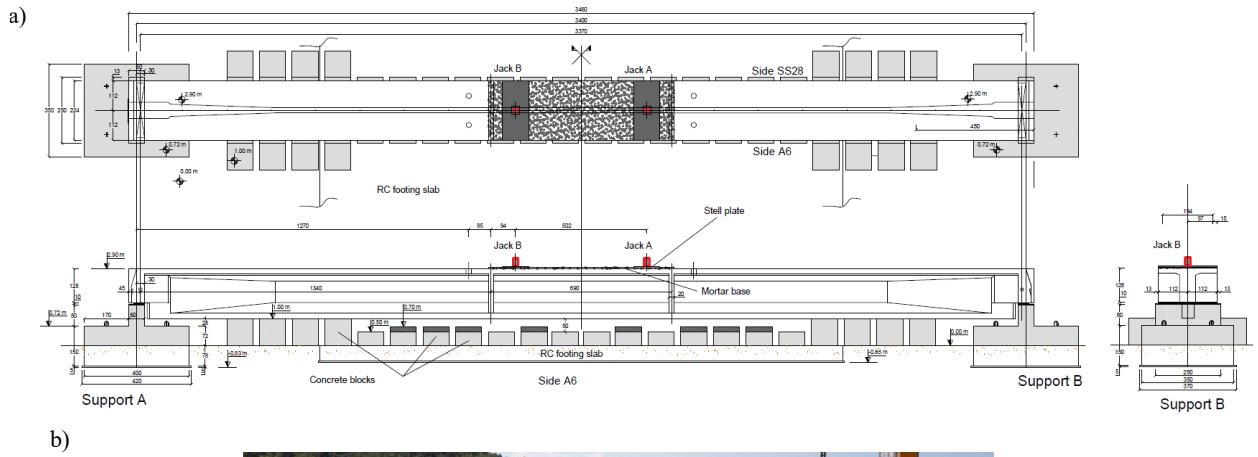
Fig.3. The testing layout is depicted in (a), with measurements in centimeters. (b) provides a general view of the testing area.

The positioning of the PRC beam within the test area adheres to the arrangement depicted in Figure 3 (a)-(b). Supported by two specifically casted in situ RC footings labeled as support A and B, the beam is situated accordingly. Underneath the beam, an RC slab footing measuring 20x22x0.5m has been erected to offer a clean and stable surface for accommodating the loading devices, totaling 3000 kN in weight, as illustrated in Figure 3 (b). Strategically placed concrete blocks beneath the span ensure a clearance of 50 cm, corresponding to the maximum midspan displacements achievable during the test, as shown in Figure 3 (a). Positioned 5.02m apart across the midspan, two jacks (A and B) are situated on the top slab, positioned as close as feasible to the original transverse beams. Each jack has a capacity of 2000 kN (equivalent to 200 tons). Figure 3 (b) offers a visual depiction of the test setup, showing the counteracting structure constructed using Azobè wood walls, steel beams, and iron ballasts. The mobilization of heavy materials within the testing area was facilitated by a mobile crane.

To achieve the estimated resisting moment, the total counterweight on the counteracting steel structure (depicted in Figure 3(b)), comprising the iron ballasts and the structure's self-weight, amounted to 3000 kN (300 tons). This configuration ensured that each of the two load points could apply a maximum force of 1500 kN (150 tons) to the beam, maintaining a sufficient margin for conducting the test. The jack displacements were incrementally increased at a slow pace between each step, with the reacting force measured and recorded upon reaching the desired displacement level.
