Structural adaptations: The role of existing structures in adaptive reuse projects

Structures and Architecture | Volume 3

*Structural adaptations: The role of existing structures in
adaptive reuse projects*

Case study: Adaptive reuse of abandoned industrial buildings in Oklahoma

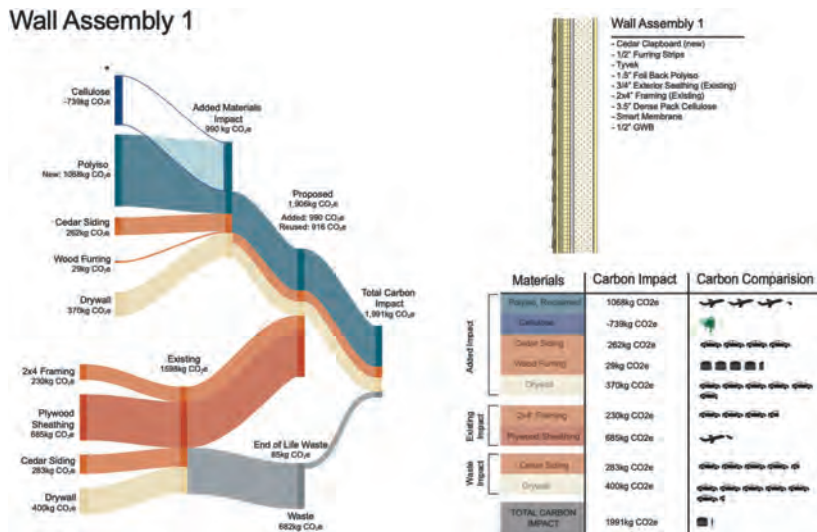
Figure 7. Wall Assembly 1 – Sankey Diagram, Wall Section and Carbon Comparison.

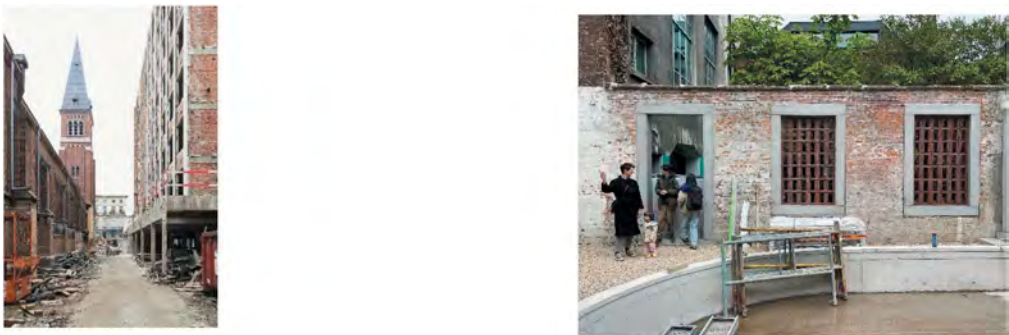
Figure 10. Left: Freeing the church of the added storage volumes gives some air to the public garden-to-be and allows for a strip of fertile soil; Right: Reinforced concrete beams are disguised as garden elements such as a pond, stairs and a bench, creating the possibility for heavier loads (greenery). (©ono architectuur).
