Structural adaptations: The role of existing structures in adaptive reuse projects

Structures and Architecture | Volume 3

*Structural adaptations: The role of existing structures in  
adaptive reuse projects*

# Case study: Adaptive reuse of abandoned industrial buildings in Oklahoma

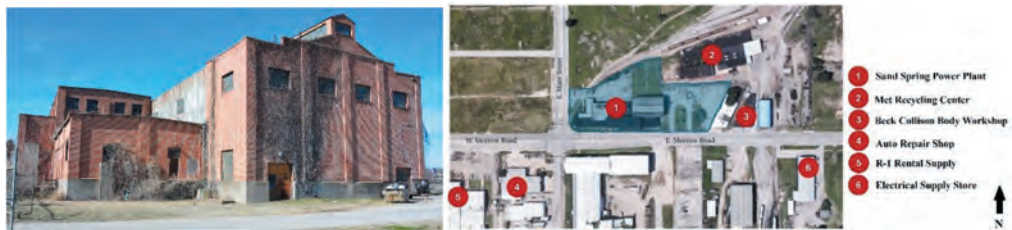
Figure 1. Sand Springs power plant (Photo by authors) Figure 2. Site context, graphical representation, Google Earth.

The Sand Spring Powerhouse is a massive structure encompassing 2,950.5 square meters (31,759 square feet) on a 7527.2 square meters (1.86 acre) lot (Figs 1-2). The building is mainly red brick, with some sections featuring metal walls. Due to several additions, it has an irregular form, roughly 15.2 meters by 36.5 meters (50 feet by 120 feet). The building extends from west to east, ending with two three-story sections. The foundation is made of concrete or brick and the floors are concrete. There is a small basement on the south side. Over the years, some windows have been bricked up (Iconions 2017). The three-story section creates a dynamic volume with a gable roof on top. Excluding the load-bearing walls in the southwest part of the building, it has composite brick walls and steel columns with steel trusses that support the roof.

This study was conducted on two scales: regional and site. The regional study applied Sand Spring's GIS (Graphics Information System) data files to examine and analyze demographic, social, economic, and infrastructural information. This information was then graphically represented using the ArcGIS software. The site and its immediate context were studied through direct observation and mapping techniques (Fig. 2).

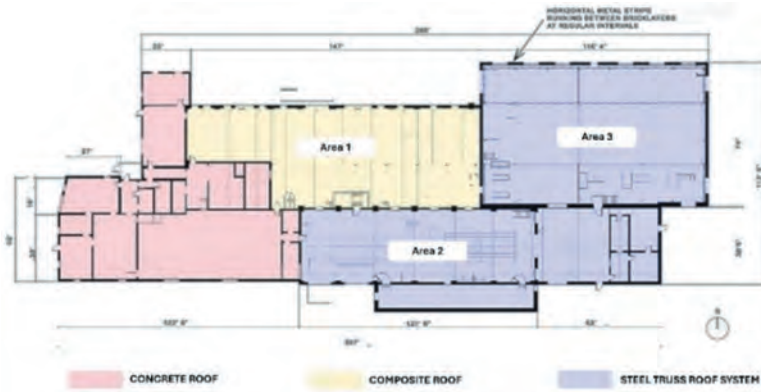
Figure 8. Sand Spring power plant- existing plan, graphical representation (Plan view by owner).

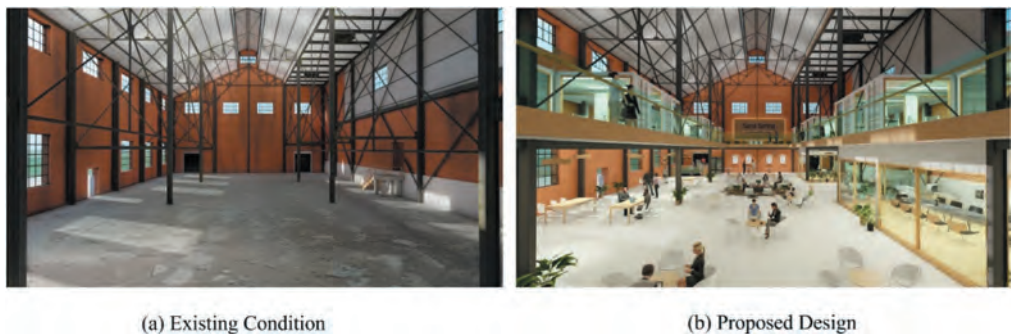
Figure 11. Rendered interior perspective of Area 3, a) before and b) after proposed architectural design (By authors).

As shown in Figure 11b, old containers are used to create a mezzanine level in the northeast block of the building. This area provides a certain degree of privacy for the office spaces while creating opportunities for social interaction at the ground level. Due to the addition of the mezzanine level, it is recommended that the structural frame system be re-evaluated to ensure the structure's strength.

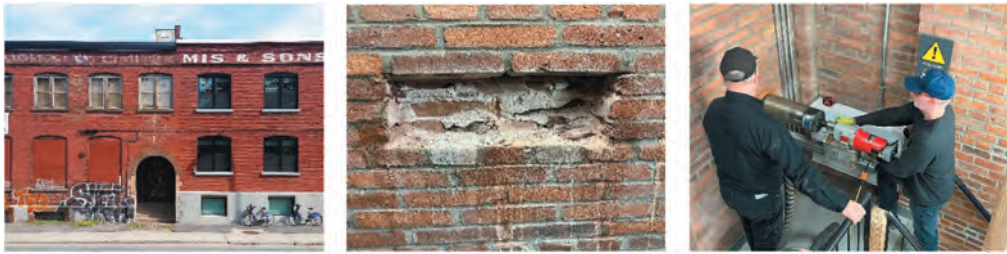
Figures 1, 2, 3. An existing building at 3558 Saint Patrick Street, Montreal, was selected as a case-study and used to collect detailed information on material and construction systems.

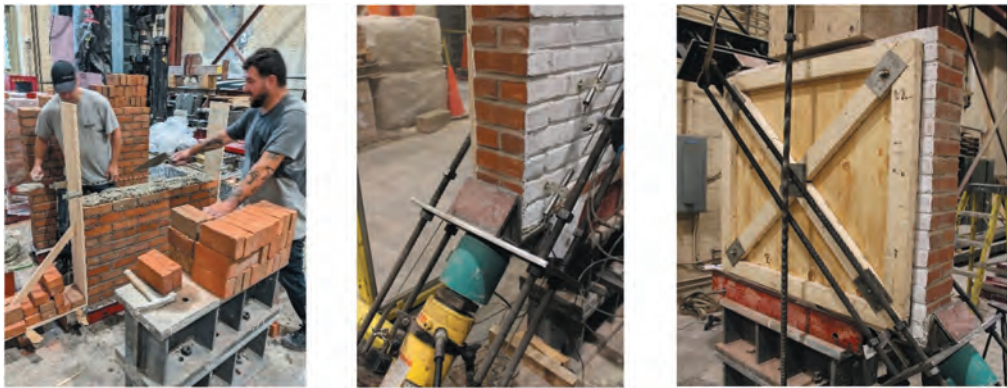
Figures 4, 5, 6. Preliminary test configurations at McGill University's Structural Laboratory.

Structural tests were initiated at McGill University with the construction of six identical URM walls measuring 1.2 x 1.2 x 0.2 m. Extending from data gained from samples of the Saint Patrick Street building, each wall was erected by two professional masons and cured for a minimum of 28 days while being controlled for humidity and temperature. To approximate the physical properties of the existing bricks, the team selected Glen-Gery solid handmade clay bricks for construction of the test walls, however matching the properties of the original lime mortar proved more challenging, since any newly mixed mortar would lack the 100 years of environmental exposure that characterized the test sample. To overcome this problem the team sought to develop an approximation of the existing sample using a cementitious mortar (Type-O), which was weakened by the introduction of additional sand at a mix of 15%.

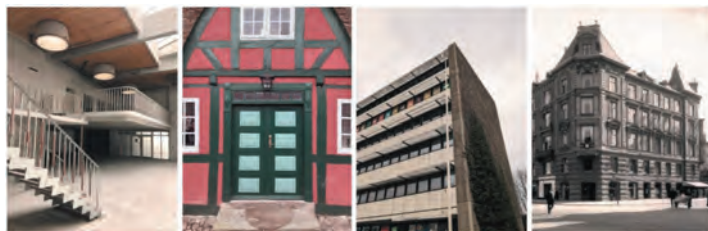
Figure 2. Case A-B-C-D, Credits: A+C Henning Larsen, B Agency for Culture and Palaces, D Peter Elfelt.

A) *A functionalistic office building* from 1957, built in classic modernistic prefabricated concrete elements and situated in the heart of Copenhagen. It holds a formal SAVE value of 5, characterized as

a middle preservation value. The actual assessment is from 1995 and with very limited information. In 2021 the roughly 12.000 m<sup>2</sup> building was reused through a deep renovation to create a modern, energy-optimized mixed-use building adapted to contemporary standards. The original concrete facade was replaced with a new sandstone facade and the interior of the building was in the rebuilding process stripped down to the raw structure. The result for the final in the LCA assessment was **6,5** kg CO<sub>2</sub>e/m<sup>2</sup>/year.

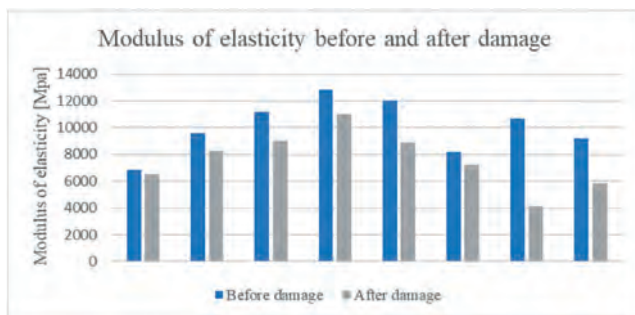
Figure 1. Modulus of elasticity before and after damage.

Ten beams were damaged by compressing the wood fibres in the middle of the beam. Different compression forces were used, relating to different types of sorting grabs. The modulus of elasticity of each beam was tested before and after the damage was applied. As shown on Figure 1, every beam has a reduction of modulus of elasticity. The average reduction amounted to 20%, with reductions over 60% for higher compression forces. These results are without a correction for the reduced cross section. Since it is not possible to determine the compression force of the sorting grab used for disassembly, a rejection of the beams that visually show compression is suggested.

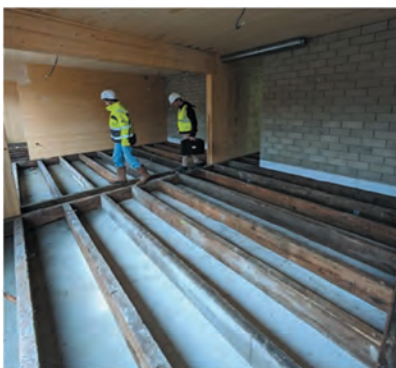
Figure 2. Reuse in raised flooring.

In a construction project in Brussels, the contractor wanted to use reclaimed timber to build a raised floor. When timber beams are reused on a concrete slab to support a raised floor (see Figure 2), they are not subjected to bending forces. Consequently, it is unnecessary to evaluate their bending strength or modulus of elasticity. Additionally, since the compression strength of timber exceeds the design value of floor loads (with floorboards directly laid onto the beams), compression tests are also deemed unnecessary.

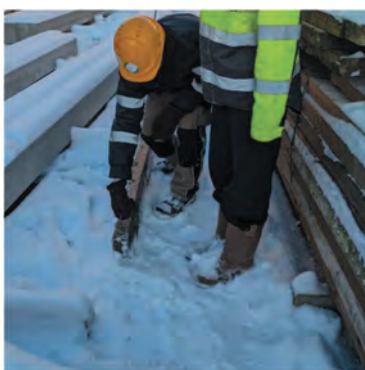
Figure 3. Screwdriver test.

However, the quality of the timber remains a critical factor. Beams must be free of rot and insect damage to ensure their suitability for reuse. A visual inspection was conducted to identify appropriate beams, with a screwdriver test (Figure 3) employed as part of the assessment. In this test, fractures in healthy timber were observed to follow the direction of the fibers, while decayed timber exhibited breaks into small fragments or splits across the fibers. (Rotor vzw, 2021)

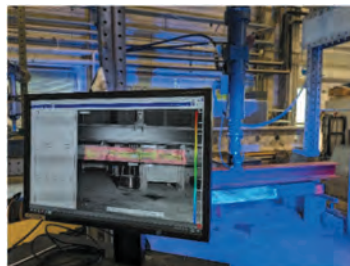
Figure 6. Bending test solid timber beam.

effective bending strength without any statistical uncertainty, as well as an effective measure of the E-Modulus (using a DIC measurement system). The tests showed that all the beams meet the stability requirements and can therefore be used for the application in question.

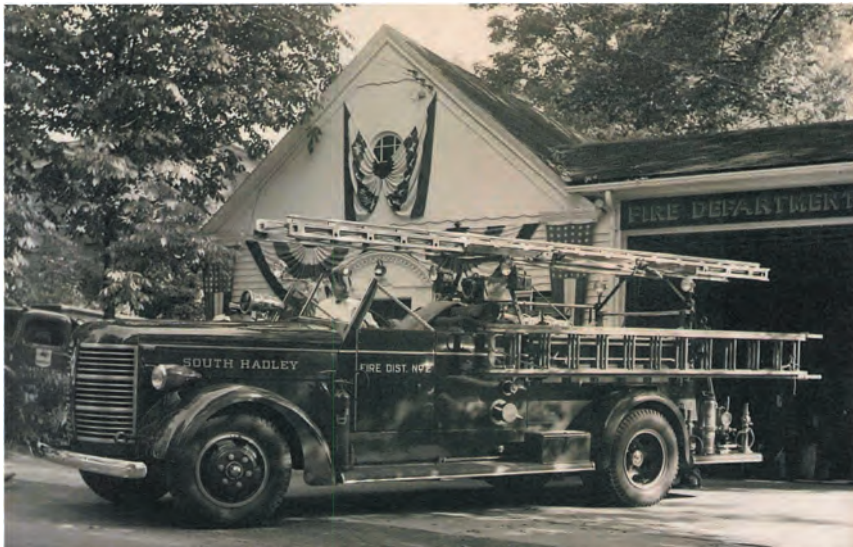
Figure 1. Historic Photo of the Phoenix as an active Fire Station.

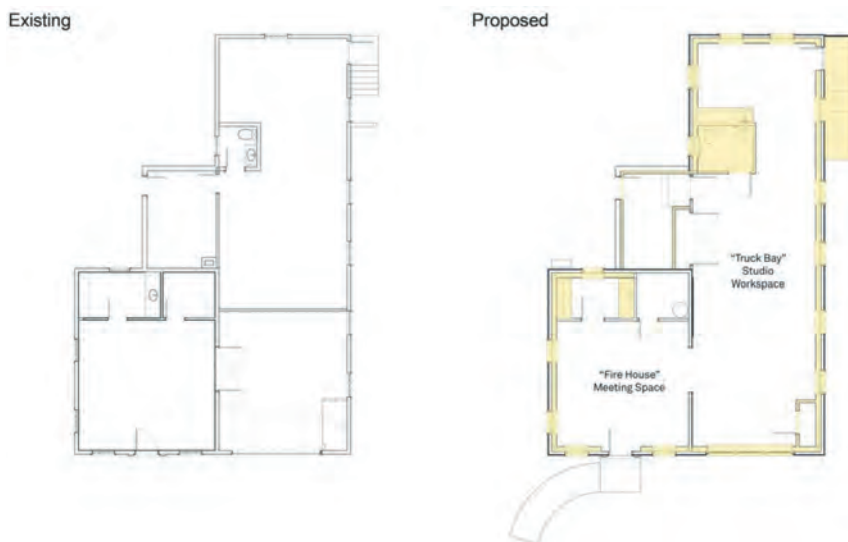
Figure 2. Plans of the Phoenix as existing and proposed showing added in yellow - 2x4 stud wall, insulation, new windows, kitchenette and accessible restroom.

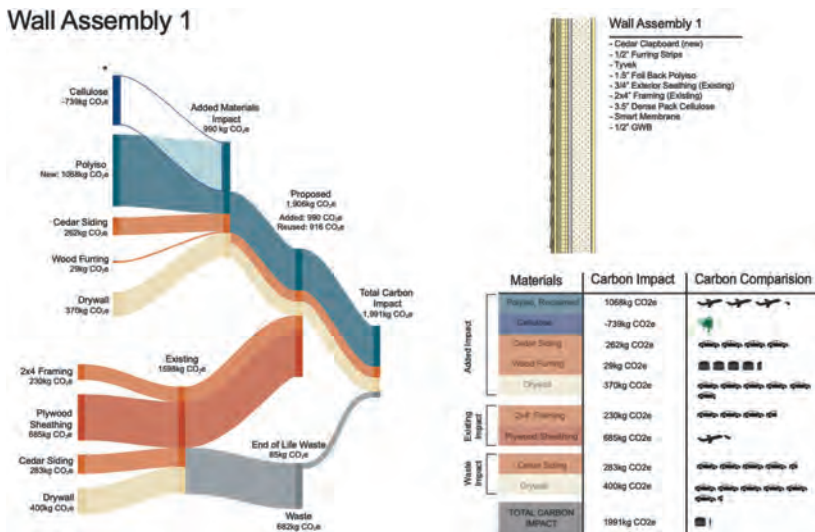
Figure 7. Wall Assembly 1 – Sankey Diagram, Wall Section and Carbon Comparison.

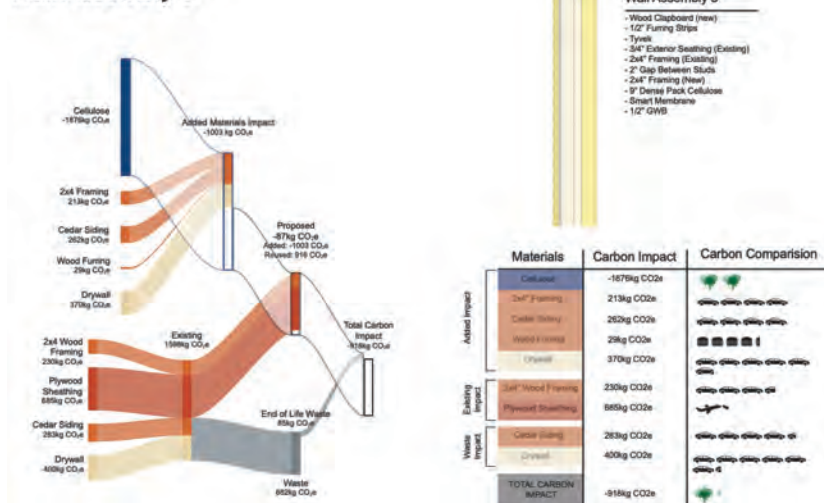
Figure 9. Wall Assembly 3 – Sankey Diagram, Wall Section and Carbon Comparison.

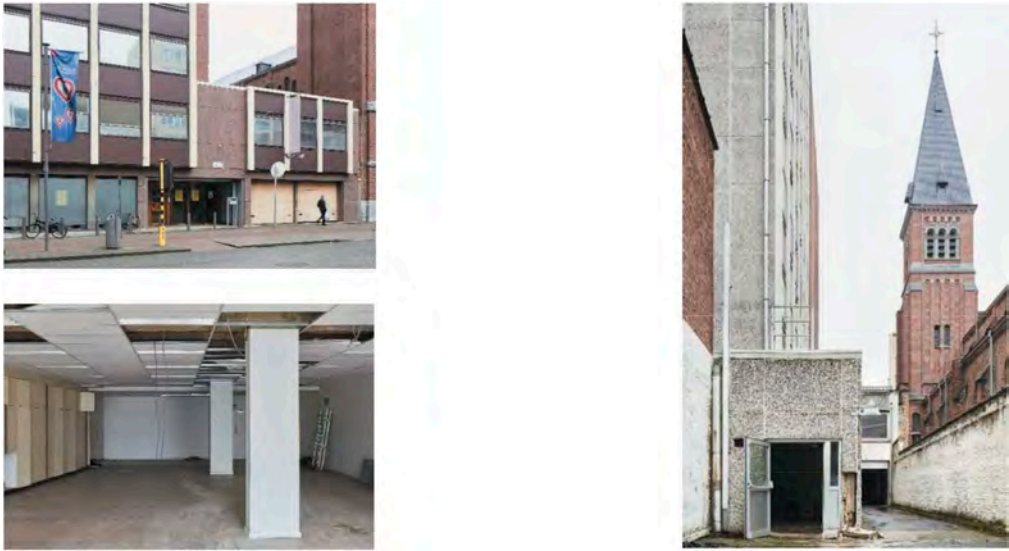
Figure 1. Top left: At M127, a '60s office building behaved hermetically towards its surroundings; Bottom left: The concrete structure was hidden behind wafer-thin coverings. Daylight hardly entered in the deep ground floor level; Right: The outdoor space was fully asphalted and intended for access with vehicles. The only strip without parking underneath was filled with storage volumes from the adjacent church. (©ono architectuur).

The building previously behaved hermetically towards the surroundings and its facades were uninsulated. It lacked porosity towards the city and its own private outdoor spaces. Every open area and roof on the building plot was asphalted or paved. Solid ground was

absent. Furthermore, the building was missing spatial hierarchy. Low stacked floors without variation lead to monotonous usage of the building and dark spaces on the wide lower floors. The lack of spatial variation prevents multifunctional use and decreases encounter and publicness. On top of that, the vertical stair cores were closed off from the rest of the building, dark and little used unlike the elevators.

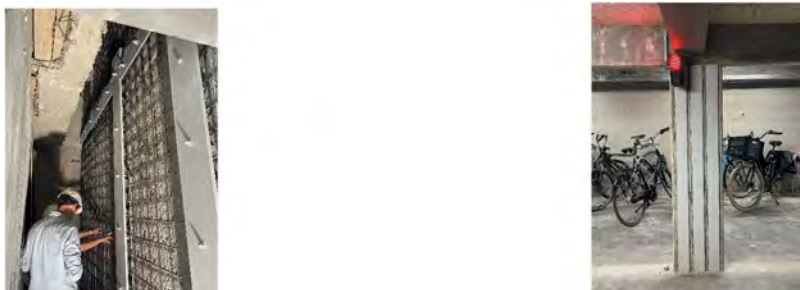
Figure 5. Left: The concrete core is reinforced by adding steel strips and profiles; Right: On lower floors, the needed glued-on steel strips seem almost-intentional decorative stripes. (©ono architectuur).

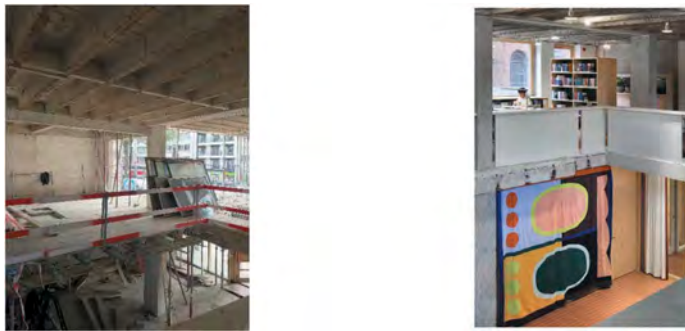
Figure 7. Left: Low stacked floors are cut away at precise locations at ground floor; Right: New cuts through the building are left in their raw state. (©ono architectuur, Filip Dujardin).

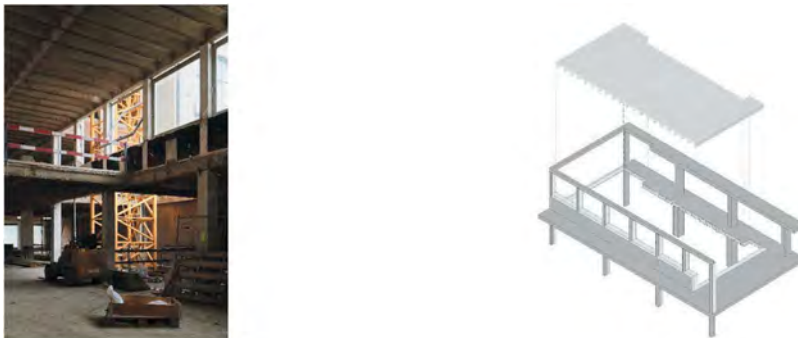
Figure 8. The adapted structure can house uses that were not possible before. (©ono architectuur).

Also in the back of the building a new cut-out alters the space. Meeting rooms connect to the company's library. The new void adds hierarchy to the space, elevating its presence in the building. The central space is surrounded by glazed meeting rooms that connect to the new garden. The previously introvert space opens up to the surroundings and allows for multifunctional and shared use. By taking away part of the building we get more building in return. The structure can house uses that were not possible before.

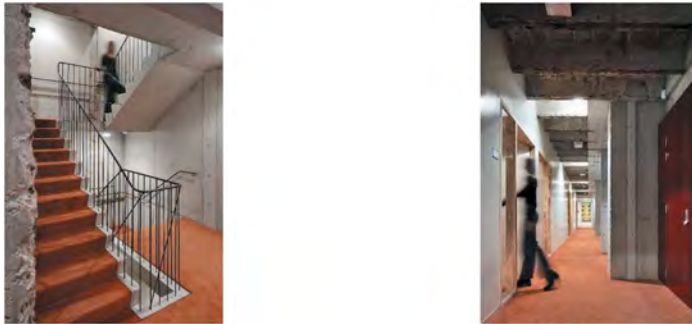
Figure 9. An adaptation of the lower levels of the staircase (left) leads to additional steel strips, embracing the central core (right) with elevator and stairs. (©Filip Dujardin).

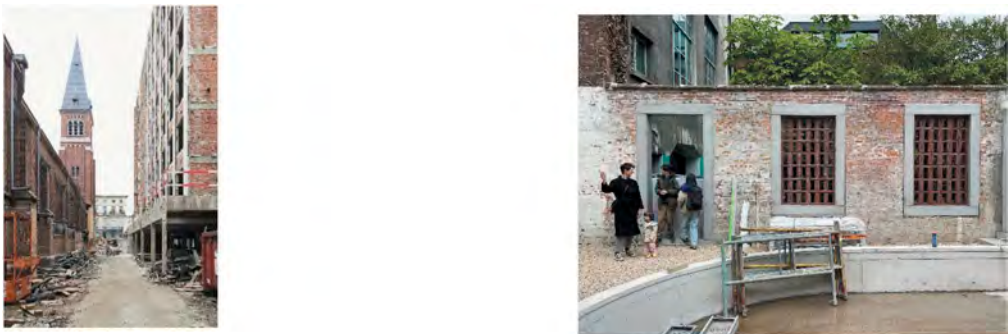
Figure 10. Left: Freeing the church of the added storage volumes gives some air to the public garden-to-be and allows for a strip of fertile soil; Right: Reinforced concrete beams are disguised as garden elements such as a pond, stairs and a bench, creating the possibility for heavier loads (greenery). (©ono architectuur).

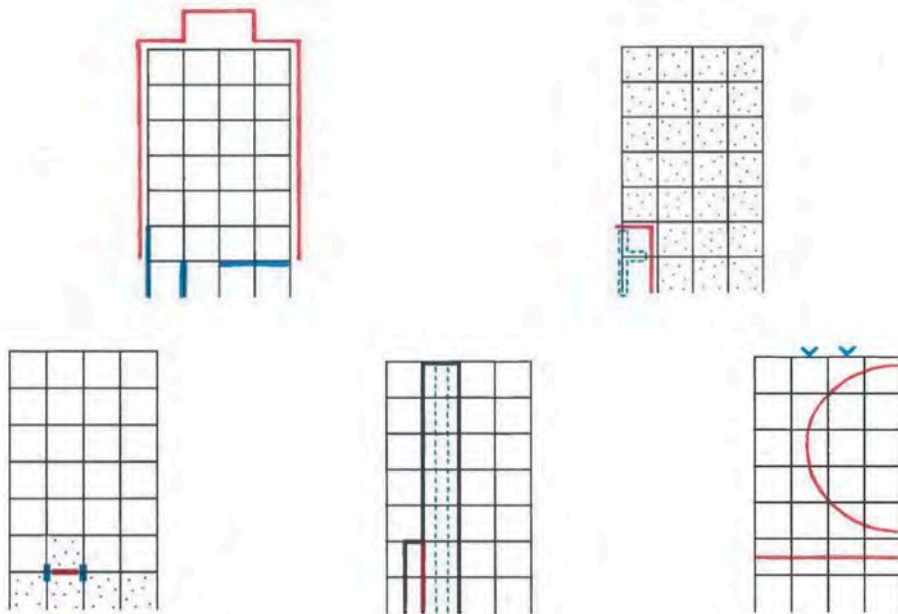
Figures 11-12-13-14-15. From left to right. 11: Adding extra loads to an existing construction generally leads to the need for reinforcements at other locations throughout the building; 12: Changing the perimeter between in- and outside ask for detailed study of reinforcement covers and thermal behaviour of building details. This could be an invitation for specific design solutions; 13: Creating voids can improve public realm and allow more diverse programs. By removing floor slabs selectively, structural modifications can be reduced; 14: Modifying rigid (circulation) cores locally may require reparative interventions over the entire height; 15: Adding reinforcing structures can make the existing structure more load bearing and enable qualities that were previously absent. (©ono architectuur)

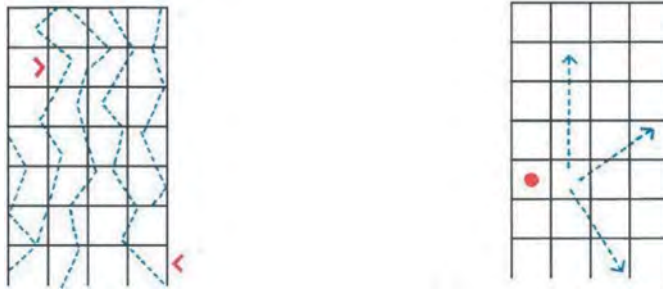
Figures 16-17. From left to right. 16: Metaphor of a delicate equilibrium; 17: Metaphor of a balloon. (©onoarchitectuur).

We synthesize by adding two overarching metaphors, illustrated with similar abstract schemes and expressed more physically with photographs of art works by Fischli & Weiss. The first metaphor states that these constructions could be seen as delicate equilibriums. This creates the awareness that any intervention (red, action) can be very impactful (blue, reaction) for integral stability. The second metaphor states that these structures could be regarded as a balloon. When you push it at a certain place (red, action), it is visible at another location (blue, reaction). But one should not push too hard.
