Material Degradation and NaTech Risk: A Case Study to Discuss Bidirectional Vulnerability in Industrial Systems

Material Degradation and NaTech Risk: A Case Study to Discuss Bidirectional Vulnerability in Industrial Systems / Vitale, M., Demichela, M., Barresi, A.A.. - In: APPLIED SCIENCES. - ISSN 2076-3417. - ELETTRONICO. - 15:21(2025). [10.3390/app152111361]

# Material Degradation and NaTech Risk: A Case Study to Discuss Bidirectional Vulnerability in Industrial Systems

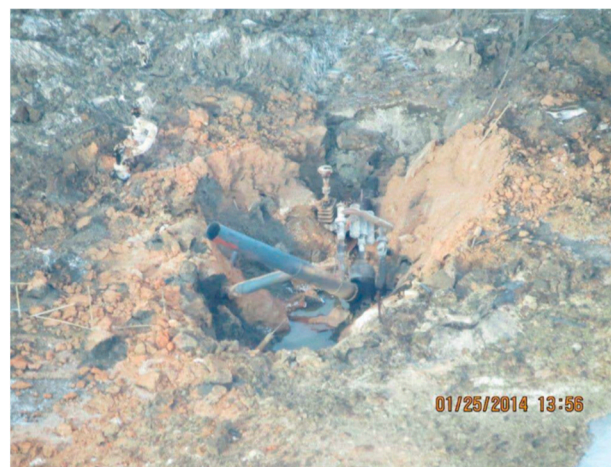
**Figure 1.** Uplift of the valve and pipeline section following rupture and explosion. Photo credit: courtesy of Transportation Safety Board of Canada [26].

The natural gas continued to burn for about 12 h. In response to the event, five homes in the immediate vicinity were evacuated, and the provincial road remained closed until the fire was completely extinguished. Fortunately, no injuries were reported. Before the event, the system was operating normally, with an operating pressure at the event site of approximately 6330 kPa. The maximum operating pressure for this section of the system

was 7030 kPa. The event happened in an agricultural land; the area was sparsely populated. Due to lack of customer demand, gas flow in the pipeline was interrupted starting 5 January 2014. However, static pressurized gas was still present in the line between the two closed valves. The line had undergone hydrostatic testing when the pipeline was originally placed in service in 1960. No other pressure tests had been performed since then. Records of welding and non-destructive testing dating back to the commissioning had not been retained. Internal inspections of the line were performed as follows: in 2001, the pipeline was inspected using a gage instrument and a high-resolution magnetic flux dispersion (MFL) instrument. In 2009 the pipeline was inspected again using a high resolution MFL instrument. The following integrity-related activities were conducted in proximity of the incident: in 1997, a single excavation was performed 9 m downstream of the line to inspect for external corrosion. Subsequently, in 1998, 1999, and 2009, a series of investigative excavations took place in adjacent sections of the valves to confirm the presence of external corrosion and stress corrosion cracking (SCC). The nearest excavation site was situated approximately 3 km downstream from the line. As a result of the 1999 excavations, a 38 m segment of the pipeline located on the line was cut and replaced due to the identification of SCC. The line rupture occurred around 1 m north of the first valve, resulting from a brittle fracture originating in a pre-existing crack. This crack is presumed to have developed during the pipeline construction phase due to an inadequate welding procedure and poor welding quality, leading to hydrogen cracking. In this context, the hydrogen is not related to the transported substance, which was methane, but was introduced locally during welding operations, where it remained trapped in the metal structure, generating HE cracks. Amazingly, the weld defect remained stable for over 50 years before failing. As a result of the failure, the first valve and an 11 m-long section of pipe to the South rose, causing a sharp bend at a circumferential weld at the top of the pipe, thus causing a secondary failure. The release of natural gas from the pipeline triggered an explosion, and the resulting fire lasted about 12 h.

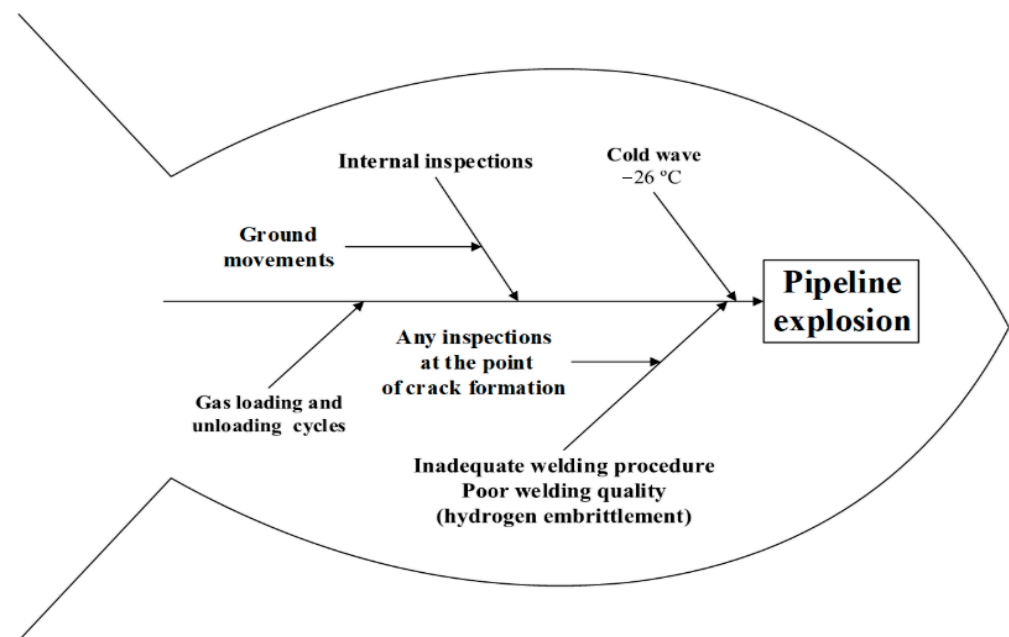
The Otterburne accident highlights the importance of considering materials degradation during a potential NaTech event, as the combination of both led to the pipe explosion. The cause-and-effect diagram depicted in Figure 2 provides a clear illustration of the causes of the accident. The Ishikawa diagram for the Otterburne pipeline accident classifies the causes into four main categories, each represented by a branch highlighting specific contributing factors:

- **Maintenance and inspection:** Maintenance activities carried out prior to the accident caused soil displacement, altering stability and contributing to mechanical stress on the structure.
- **Environmental conditions:** An exceptional cold snap caused frost to penetrate the ground, amplifying the material fragility and promoting crack propagation.
- **Operational factors:** Gas loading and unloading cycles generated pressure fluctuations that increased mechanical stress on the pipeline.
- **Construction and quality:** During the construction phase, poor quality procedures were employed, including inadequate welding practices and deficient post-installation inspections, which promoted hydrogen embrittlement and the presence of latent defects.

**Figure 2.** Fishbone diagram illustrating the root causes and contributing factors of the Otterburne pipeline accident.

Hydrogen embrittlement (HE), although it had occurred 50 years earlier, had not caused significant damage during the years. However, it was the natural event that triggered the breakup. In this situation, it emerges that although the inspections were conducted, their effectiveness was limited and they were incomplete, as the fracture dates to the construction period of the pipe, which was not adequately monitored after the installation. Furthermore, the lack of protection systems against extreme natural events

The incidental event examined in this study also involves an extreme natural event, as shown in Figure 2, the anomalous cold waves. Ricci et al. [20] highlighted that industrial sites are more susceptible to cold climate impacts than to heat waves. Low temperatures are the third leading cause of NaTech accidents in Europe, following lightning and floods. It is important to note that the perceived risk related to such accidents is significantly underestimated by the European population. In the industrial context, the Chemical & Petrochemical sector is particularly vulnerable to accidental events caused by cold waves (38% of events), mainly due to the widespread use of dangerous substances. Pipes represent the component of the system most affected by cold waves, contributing to 39% of recorded events. Furthermore, the transportation sector, especially through pipelines, is identified as the second most affected category (18% of events). This frequency is attributed to the significant impact of cold waves in causing accidents during the transportation of hazardous substances, confirming the high vulnerability of transportation systems and infrastructure to the effects of these adverse weather conditions. Extreme weather conditions linked to cold waves add further risk factors, such as ice formation on transport infrastructure. The study highlights several major direct causes of NaTech events occurring during cold spells in the process industry, included in the analysed dataset. These include equipment failures caused by low temperatures exceeding the brittle transition temperature of some materials, contributing to 16% of recorded events. Through the phenomenon known as cold fatigue, materials can be impacted over time. This process of degradation occurs when materials are subjected to repeated cycles of mechanical loading under low-temperature conditions, particularly during cold waves. As in the Otterburne pipeline accident, during a cold wave, materials can become more brittle, making them susceptible to fracture even under relatively modest mechanical stresses.

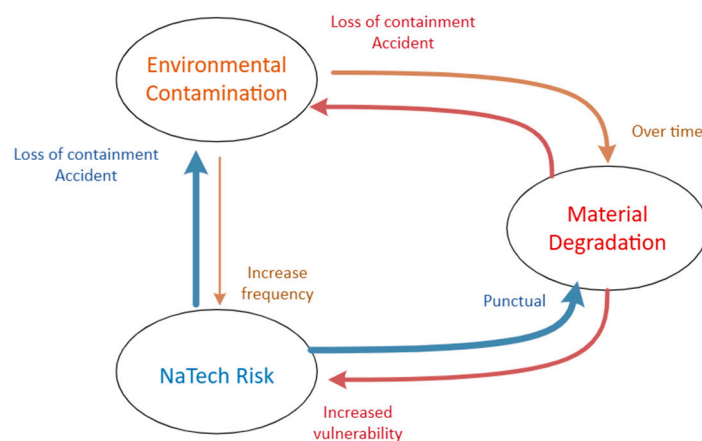
This is depicted in Figure 3, which shows the scheme devised in the study conducted by Pilone et al. [28], integrating the notion of material degradation and its influence on NaTech risk.

Figure 3 represents the conceptual model of bidirectional vulnerability, enriched with graphical elements that enhance its analytical capacity. The three main domains are colour-coded: orange highlights the effects of environmental contamination, blue highlights those associated with NaTech risk, and red highlights those resulting from material degradation. The directional arrows represent the causal relationships between model domains and vary in thickness to indicate the intensity of their influence. Specifically, thicker arrows correspond to high-intensity interactions, i.e., phenomena that generate immediate and significant effects on the system, such as the accidental release of hazardous substances or the NaTech escalation. Conversely, thinner arrows represent low-intensity influences, typically associated with slow, cumulative, or indirect processes, such as progressive corrosion or the alteration of the mechanical properties of materials over time. This visual coding allows for the distinction between acute and chronic impact mechanisms. and supports the integration of degradation indicators into NaTech vulnerability models, providing a foundation for future quantitative developments.

**Figure 3.** Conceptual model of the bidirectional relationship between material degradation and NaTech risk. The colours distinguish the risk domains; the thickness of the arrows represents the intensity of the causal influence, from indirect effects to acute impacts.

Moreover, the diagram emphasises the cyclical and interconnected nature of the three domains. Each element can act as both cause and effect, generating a systemic vulnerability loop. Environmental contamination can increase the frequency and intensity of extreme natural events, which accelerate material degradation processes. Degradation, in turn, can compromise the structural resistance of infrastructure and contribute to the release of hazardous substances, further fuelling environmental contamination and closing the cycle.

Therefore, from Figure 3 emerges that natural events can influence material degradation in short timescales, material degradation can influence natural events, but the impact on frequency occurs much more slowly and gradually. Therefore, during the risk analysis, it is essential to consider the state of infrastructure on the consequences of natural events. Consequently, it is crucial to incorporate this factor into the NaTech risk assessment.

The conceptual model presented in Figure 3 describes bidirectional vulnerability as the dynamic interaction between material degradation and NaTech risk. Applying this framework to the Otterburne case, it is possible to observe how a latent defect made the infrastructure vulnerable for decades. The extreme natural event acted as an external trigger, accelerating the failure process.

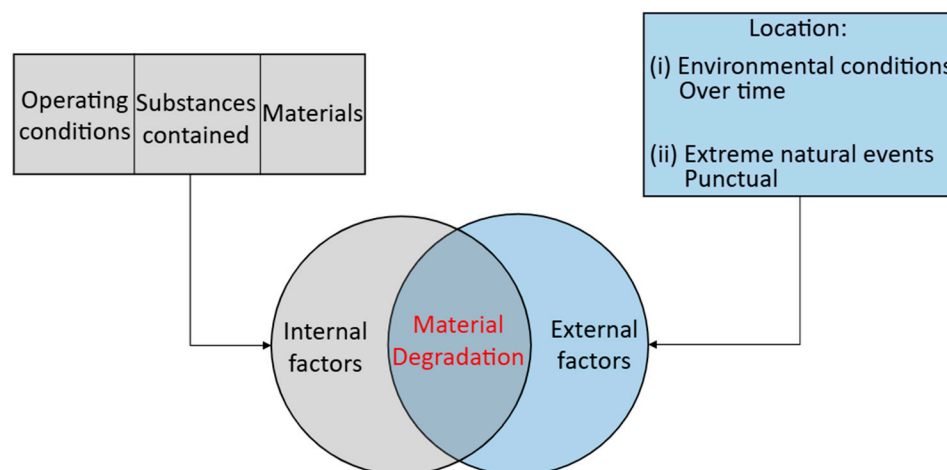
**Figure 4.** Internal and external factors contributing to material degradation in industrial infrastructures.

Thus, internal factors are intrinsic to the process and materials of the plant itself, while external factors are linked to the geographical location and surrounding environmental conditions, including natural events. A thorough understanding of both is essential for a complete and accurate assessment of the risk of material degradation and for the design of preventive maintenance programs. This approach improves the resilience of industrial structures to NaTech events, effectively reducing the risk of failures and significantly contributing to general operational safety.
