Material Degradation and NaTech Risk: A Case Study to Discuss Bidirectional Vulnerability in Industrial Systems

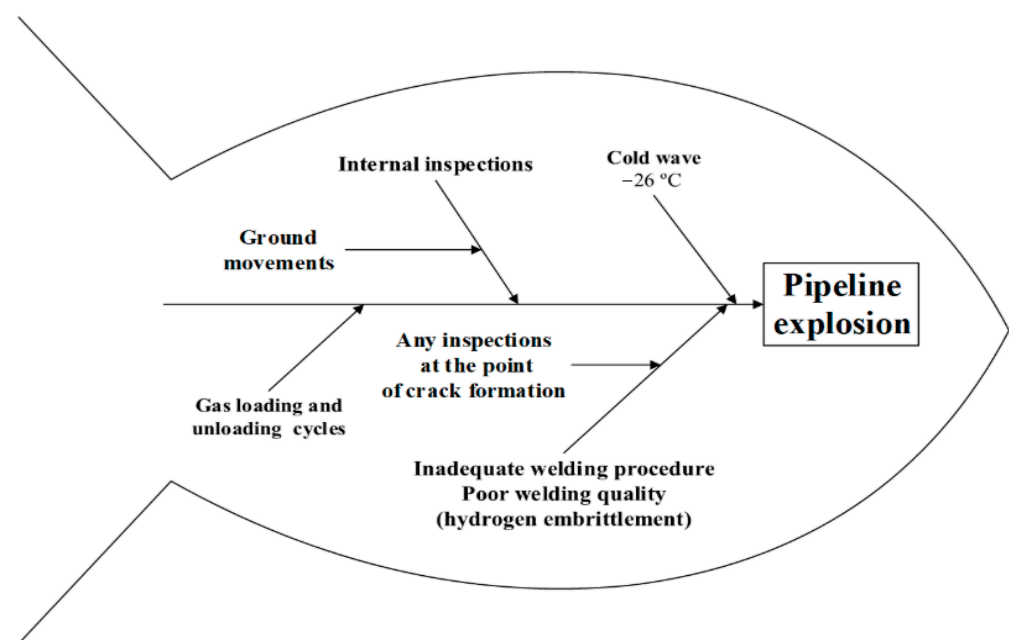
Figure 2. Fishbone diagram illustrating the root causes and contributing factors of the Otterburne pipeline accident.

The Otterburne accident highlights the importance of considering materials degradation during a potential NaTech event, as the combination of both led to the pipe explosion. The cause-and-effect diagram depicted in Figure 2 provides a clear illustration of the causes of the accident. The Ishikawa diagram for the Otterburne pipeline accident classifies the causes into four main categories, each represented by a branch highlighting specific contributing factors:

- **Maintenance and inspection:** Maintenance activities carried out prior to the accident caused soil displacement, altering stability and contributing to mechanical stress on the structure.
- **Environmental conditions:** An exceptional cold snap caused frost to penetrate the ground, amplifying the material fragility and promoting crack propagation.
- **Operational factors:** Gas loading and unloading cycles generated pressure fluctuations that increased mechanical stress on the pipeline.
- **Construction and quality:** During the construction phase, poor quality procedures were employed, including inadequate welding practices and deficient post-installation inspections, which promoted hydrogen embrittlement and the presence of latent defects.

The incidental event examined in this study also involves an extreme natural event, as shown in Figure 2, the anomalous cold waves. Ricci et al. [20] highlighted that industrial sites are more susceptible to cold climate impacts than to heat waves. Low temperatures are the third leading cause of NaTech accidents in Europe, following lightning and floods. It is important to note that the perceived risk related to such accidents is significantly underestimated by the European population. In the industrial context, the Chemical & Petrochemical sector is particularly vulnerable to accidental events caused by cold waves (38% of events), mainly due to the widespread use of dangerous substances. Pipes represent the component of the system most affected by cold waves, contributing to 39% of recorded events. Furthermore, the transportation sector, especially through pipelines, is identified as the second most affected category (18% of events). This frequency is attributed to the significant impact of cold waves in causing accidents during the transportation of hazardous substances, confirming the high vulnerability of transportation systems and infrastructure to the effects of these adverse weather conditions. Extreme weather conditions linked to cold waves add further risk factors, such as ice formation on transport infrastructure. The study highlights several major direct causes of NaTech events occurring during cold spells in the process industry, included in the analysed dataset. These include equipment failures caused by low temperatures exceeding the brittle transition temperature of some materials, contributing to 16% of recorded events. Through the phenomenon known as cold fatigue, materials can be impacted over time. This process of degradation occurs when materials are subjected to repeated cycles of mechanical loading under low-temperature conditions, particularly during cold waves. As in the Otterburne pipeline accident, during a cold wave, materials can become more brittle, making them susceptible to fracture even under relatively modest mechanical stresses.

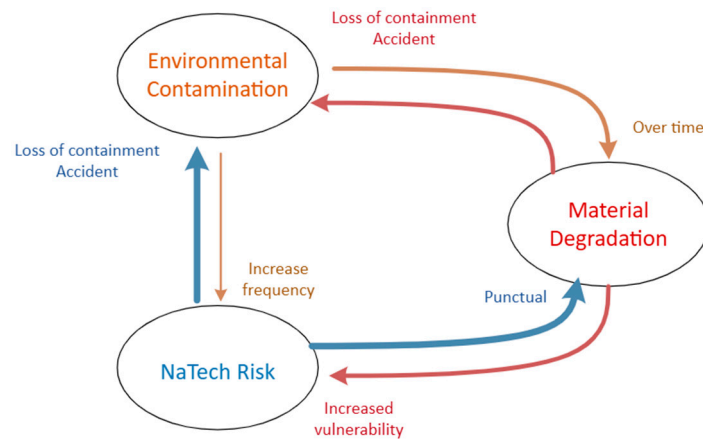
Figure 3 represents the conceptual model of bidirectional vulnerability, enriched with graphical elements that enhance its analytical capacity. The three main domains are colour-coded: orange highlights the effects of environmental contamination, blue highlights those associated with NaTech risk, and red highlights those resulting from material degradation. The directional arrows represent the causal relationships between model domains and vary in thickness to indicate the intensity of their influence. Specifically, thicker arrows correspond to high-intensity interactions, i.e., phenomena that generate immediate and significant effects on the system, such as the accidental release of hazardous substances or the NaTech escalation. Conversely, thinner arrows represent low-intensity influences, typically associated with slow, cumulative, or indirect processes, such as progressive corrosion or the alteration of the mechanical properties of materials over time. This visual coding allows for the distinction between acute and chronic impact mechanisms. and supports the integration of degradation indicators into NaTech vulnerability models, providing a foundation for future quantitative developments.

Figure 3. Conceptual model of the bidirectional relationship between material degradation and NaTech risk. The colours distinguish the risk domains; the thickness of the arrows represents the intensity of the causal influence, from indirect effects to acute impacts.

This is depicted in Figure 3, which shows the scheme devised in the study conducted by Pilone et al. [28], integrating the notion of material degradation and its influence on NaTech risk.

Moreover, the diagram emphasises the cyclical and interconnected nature of the three domains. Each element can act as both cause and effect, generating a systemic vulnerability loop. Environmental contamination can increase the frequency and intensity of extreme natural events, which accelerate material degradation processes. Degradation, in turn, can compromise the structural resistance of infrastructure and contribute to the release of hazardous substances, further fuelling environmental contamination and closing the cycle.

Therefore, from Figure 3 emerges that natural events can influence material degradation in short timescales, material degradation can influence natural events, but the impact on frequency occurs much more slowly and gradually. Therefore, during the risk analysis, it is essential to consider the state of infrastructure on the consequences of natural events. Consequently, it is crucial to incorporate this factor into the NaTech risk assessment.

The conceptual model presented in Figure 3 describes bidirectional vulnerability as the dynamic interaction between material degradation and NaTech risk. Applying this framework to the Otterburne case, it is possible to observe how a latent defect made the infrastructure vulnerable for decades. The extreme natural event acted as an external trigger, accelerating the failure process.
