The Sanctuary of Vicoforte

# Chapter 8

## The Sanctuary of Vicoforte

Rosario Ceravolo, Mario Alberto Chiorino, Stefania Coccimiglio,  
and Gaetano Miraglia

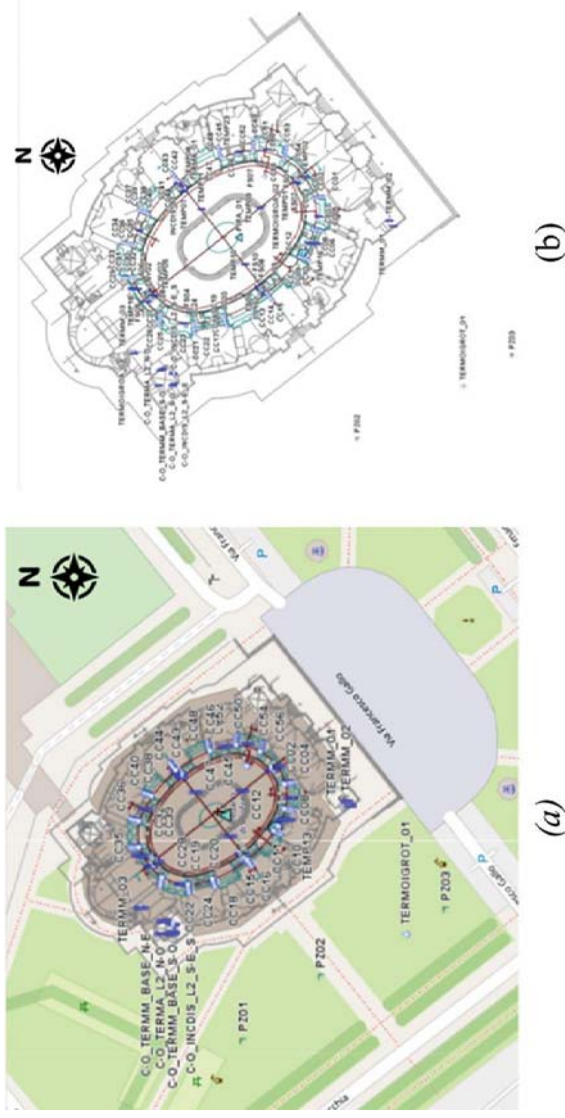
**Fig. 8.2** Layout of the low-rate system of the Sanctuary and the mixed monitoring system of the West bell tower

In the early 1980s, a hooping system was installed to prevent the widening of cracks, primarily concentrated in the dome-drum system. The system consists of four high-strength steel bars arranged in each of the 14 tangential directions. Steel frames connect the ends of the bars in two adjacent stretches. The tie bars, slightly prestressed to 50 kN using jacks, were retensioned in 1997 to compensate for physiological load losses (Chiorino et al., 2008). Geological and geophysical investigations, conducted between 1976 and 2008, confirmed that the subsoil of the Sanctuary is composed of different materials (Scandella et al., 2011). A marl layer slopes downwards from the northeast to the southwest, while a clay layer exists beneath the rest of the building, causing serious cracking patterns. Monitoring of the Vicoforte Sanctuary began in 1983 with the installation of instruments to investigate crack pattern evolution. Since then, the static monitoring system has undergone several updates, culminating in 2004 with an automated data acquisition system; this system was comprised of 133 instruments specifically placed on the dome-drum structure (Ceravolo et al., 2017). The system continuously operated from 2004 to 2015, after which it was restored and reactivated in November 2023. Today, the static monitoring of the Vicoforte Sanctuary consists of 56 load cells, 2 laser distance meters, 2 distance meters, 12 crack meters, 28 thermometers, 1 barometer, 1 pyranometer, 3 thermo-hygrometers, and 3 piezometers (Fig. 8.2). In 2015, a dynamic monitoring system was added, consisting of 12 accelerometers (Ceravolo et al., 2016) (Fig. 8.3) distributed at different heights to monitor the overall structural behaviour, which also underwent adjustments and updates in 2023. The dynamic acquisition system at the Sanctuary of Vicoforte records data based on two criteria: time and threshold. The time criterion involves recording for 20 min every hour to limit data storage, while the threshold criterion records data when ground horizontal acceleration exceeds 0.042 g, in line with Italian seismic hazard

Finally, in 2023, a mixed monitoring system was installed in the West bell tower, including 2 MEMS triaxial accelerometers, 2 inclinometers combined with biaxial laser distance meters, 6 thermometers, and 4 strain gauges.

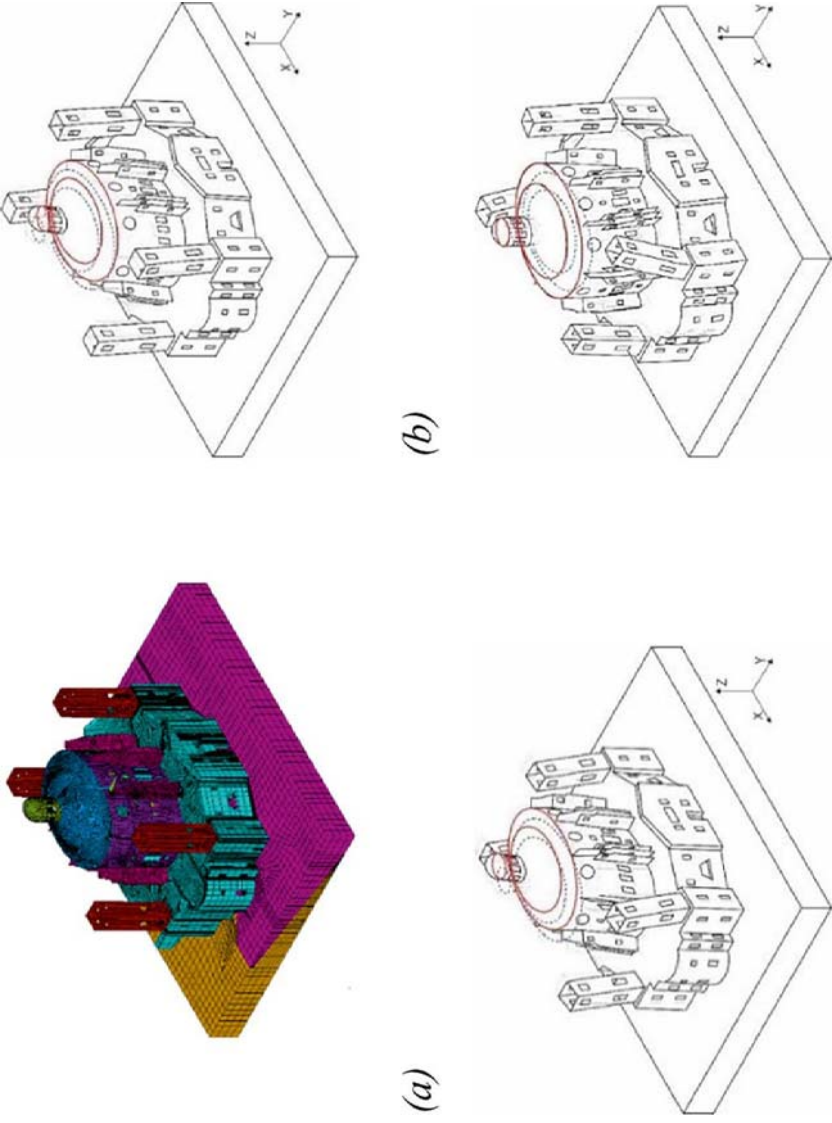
**Fig. 8.5** (a) FEM of the Sanctuary of Vicoforte, (b) first modal shape (longitudinal along Y direction), (c) second modal shape (longitudinal along X direction), and (d) third modal shape (torsional)

Then, the data acquired from the monitoring system can be used for the updating of the Finite Element Model (FEM) of the Sanctuary. The first model updating of the Sanctuary was based on the results of a dynamic test campaign conducted in 2008 (Chiorino et al., 2011). Successively, in order to consider the structural, typological and historical peculiarities of each component of the structure, a more accurate FEM model was built that consisted of 9 homogeneous macro-elements: 7 for the building (lantern, dome, drum, basement, but-tresses, belltowers and iron ties) and 2 for the soil (marl and clay). Then a thermo-elastic updating was performed using multiphysics data, including the thermal analysis to obtain the temperature distribution of the drum-dome system as related to the forces acting in the tie-bars (Ceravolo et al., 2020). This distribution was determined by applying local temperature measurements to the thermal FE model.

The update of the FEM model (Fig. 8.5) through experimental data allows the model to be as close as possible to reality, enabling it to accurately reflect the actual behaviour of the structure while always considering the uncertainties inherent in its nature. The more types of data are used to enrich the model and study the behaviour of the structure (Figs. 8.4 and 8.6), the greater the fidelity of the model to its real-world counterpart. Thus, it was decided to equip the Sanctuary of Vicoforte with instruments capable of characterizing its behaviour from multiple perspectives. In addition, when dealing with SHM, it is essential to consider the influence that the environment and the soil can have on the structure response. For this reasons, the Sanctuary of Vicoforte presents a complex monitoring system (Table 8.1) that
