# Large-scale tests of 50-year-old prestressed concrete bridge girders

## Abstract

## 2 | DISMANTLED VIADUCT AND EXPERIMENTAL CAMPAIGN

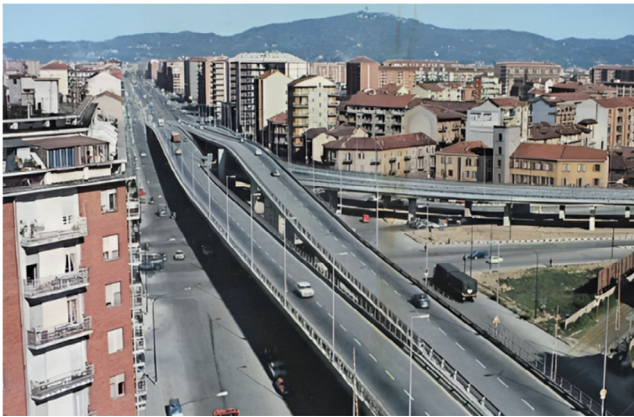
FIGURE 1 A view of the multilevel Corso Grosseto viaduct.

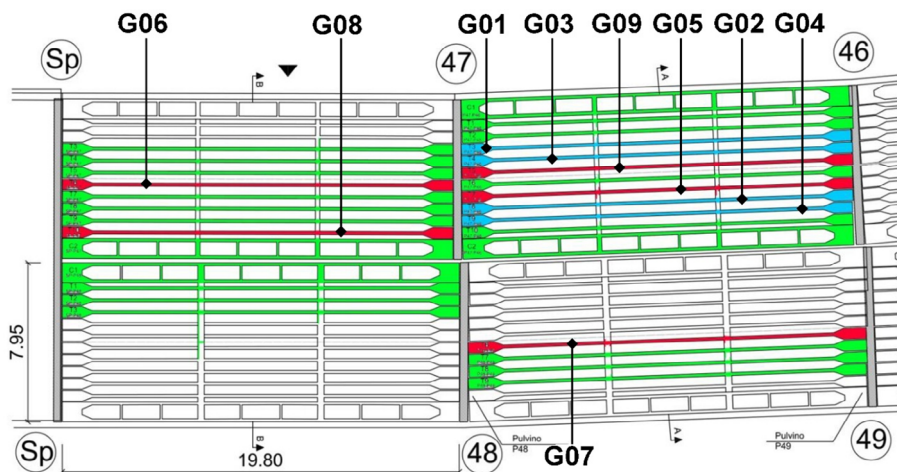
FIGURE 3 Top plan view of two adjacent spans of the in-service bridge deck with indication of the investigated deck girders. In red, the girders examined in this work. The numbering of the girders and their deck position is reported in Table 1.

In Table 1, the deck code for each girder is listed to identify the original location on the deck (Figure 3). Girders G05 and G06 were classified as undamaged and were used as a reference to compare the load-carrying capacity of the other damaged girders. Girder G07 had two outermost strands cut during dismantling on either side of the lower flange at distances 3.7 m, 9.6 m (Figure 4a), and 15.4 m from the end section; the same girder has damage due to drilling operations at the same locations of the strands that, at midspan reduces the width of the cast in situ slab of 15 cm. For G08, two strands were cut just on one side at distances of 3.8 and 15.5 m, respectively (Figure 4b). Accordingly, both girders were classified as damaged by dismantling operations. Lastly, to explore the changes in flexural behavior

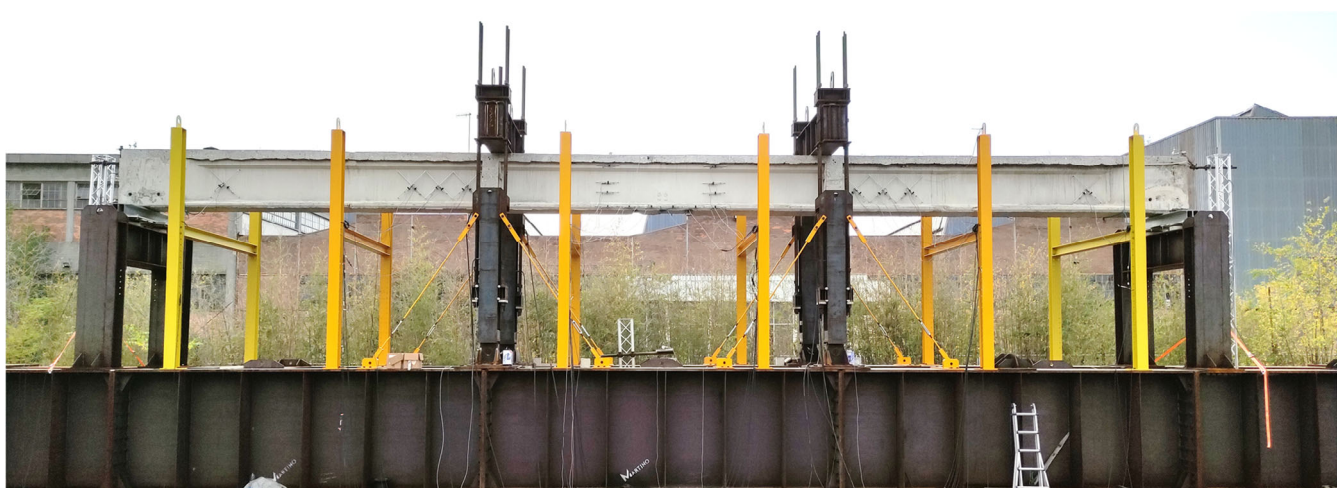
FIGURE 5 Steel reaction frame with a deck beam in a four-point bending test configuration.
