XX ANIDIS Conference

# Shake table testing of a pre and post-retrofitted unreinforced masonry structure: Preliminary experimental and numerical results

The paper presents the results of an experimental campaign on a 3/4-scaled unreinforced masonry structure subjected to bidirectional shaking table tests carried out at the L.E.D.A. Laboratory of the Kore University of Enna. The study investigates the impact of progressive retrofitting and repair strategies for the as-built structure, which was designed to represent a heritage residential building of central Italy. Three sequential shaking table tests were carried out. In the first test, the as-built configuration was tested up to the early damage achievement. In the second test, prior stiffening and strengthening of the floor slabs was performed, also including improved connections of the floor slabs with the perimeter walls. For the third test, the structure was repaired by the application of internal and external FRM layers to the masonry walls. A detailed 3D finite element model of the three configurations of the specimen was developed with the STKO software platform for OpenSees to reproduce the experimental tests and compleme

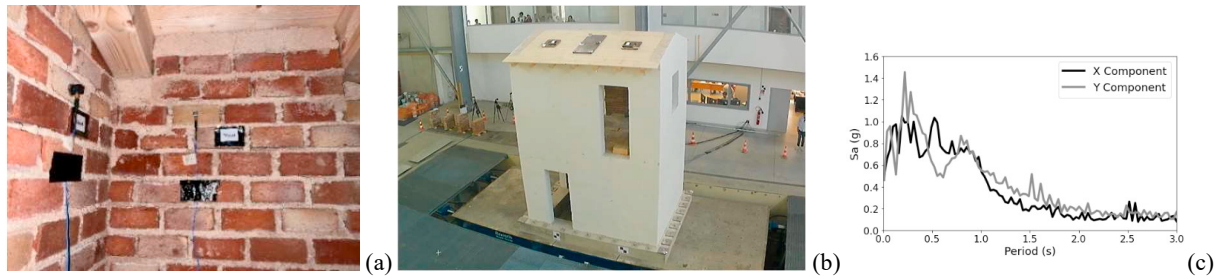
Fig. 5. (a) View of the sensors installed in the inner sides of the walls; (b) Overall view of the specimen in the shake table; (c) Response spectra of the reference input earthquakes.

The specimen was arranged over the L.E.D.A. Laboratory six-degree of freedom shake table having 4.0 x 10.0 m dimensions in plan. The accelerations of the shaking table were measured using sixteen single-axis MEMS accelerometers, positioned on the shaking table at the spherical joint on top of each of the horizontal and vertical hydraulic actuators (4 in the X direction, 4 in the Y direction, and 8 in the Z direction). 24 accelerometers were installed in the specimen in the positions indicated in Fig. 4. It is worth noting that the sensors were installed on the internal sides of the walls of the building and oriented so that their axes were aligned with those of the global reference system (Fig. 5a). Due to the absence of floor tie beams, it was assumed that, at least in the initial test configuration, each wall could undergo displacements independently of the others. Therefore, on each of the four elevations and for each story level, two biaxial accelerometers (measuring only the horizontal components) were placed at the endpoints of the elevation. In addition, a single-axis accelerometer was positioned at the mid-span of the wall to measure the out-of-plane acceleration component. An overall view of the specimen in the shake table is shown in Fig. 5b. To simulate the permanent design and live loads additional masses of 1848 kg and 361 kg were added to the first storey and the roof. The reference ground motion input consisted of two horizontal components of the AQG record from Colle Grilli (L'Aquila, Italy, April 6, 2009) which were applied to the  $x$  and  $y$  components. The response spectra of the two components of the ground motion are depicted in Fig. 5c. The sequence of the tests for each configuration is illustrated in Table 1.
