# The Garisenda Tower in Bologna: Damage Assessment Results from Principal Component Analysis, Acoustic Emission, and Nonlinear Finite Element Analyses Involving Creep and Smeared Cracking

The Garisenda Tower, along with the neighboring Asinelli Tower, is arguably the symbol of the city of Bologna. They are the sole remnants of about one hundred towers that formed the city's skyline in medieval times. As such, the monitoring of their state of health has been of great interest to the scientific community for more than a century—one example being the studies of Prof. Cavani in the early 1900s. The Garisenda Tower, famous for its impressive lean, is the object of Structural Health Monitoring (SHM) involving a multitude of devices. Some examples are a 30 m long pendulum installed on the inside of the tower to measure the planar displacement of the tower's top; Fiber-Optical Strings (FOSs) installed in the walls of the basement to measure their vertical deformation; and piezoelectric acoustic emission (AE) sensors, also installed on the walls of the tower's basement to detect elastic waves generated by micro-cracking. This rich experimental setup allows for the investigation of the tow

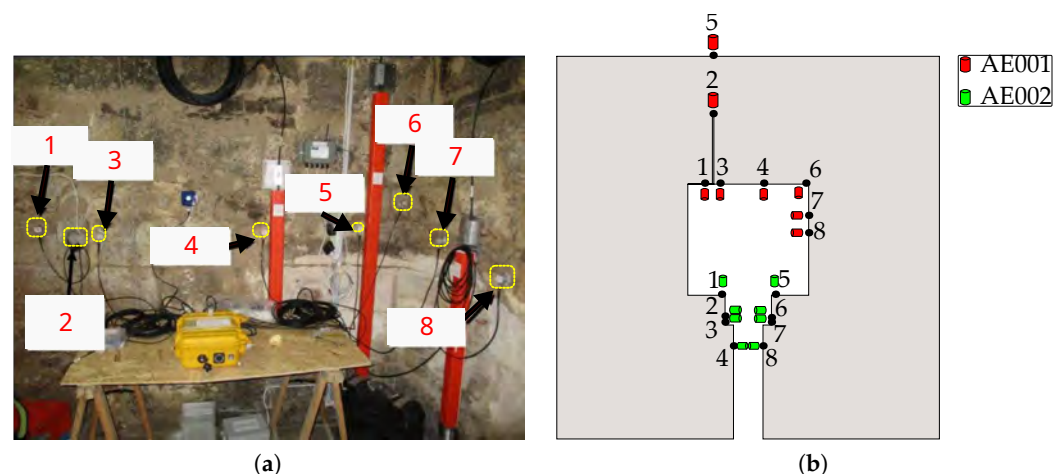
**Figure 2.** The AE sensors of device AE001 in the base of the tower. The numbers in the figure correspond to the channel (sensor) identifier, e.g., 1 corresponds to channel (CH) number 1 (CH1), 2 to CH2, and so on. Note: Sensor CH5 was later moved to the outside wall of the base (a). Schematic representation of the position of the AE sensors in the base (b).

A custom-designed monitoring system capable of detecting acoustic emissions (AEs) was installed at the base of the Garisenda Tower. The system is comprised of two devices, AE001 and AE002, each featuring eight channels connected to piezoelectric sensors. The system was installed in order to investigate micro-cracking and thus to allow for structural assessment of the base of the tower. The first device, AE001, was put in place on 31 May 2019. Its sensors are installed in the eastern (leaning) side of the tower, with sensor CH2 being located inside the base casing, and CH5 being close to the outside wall (it was previously also located in the inner wall but was relocated). The second device, AE002, was added on 14 March 2023. Its sensors are located on the western side of the tower, close to the entrance. The sensors (Lunitek AEmission LT18-003-PRD00-R0) have a frequency range of 15–625 kHz. They are securely fastened to the tower's inner wall using high-strength adhesive. Based on the ongoing AE field monitoring on the Garisenda Tower, only AE signals within a frequency range of 50–400 kHz, with an amplitude  $\geq 0.7$  mV, and a number of oscillations (ring-down count)  $\geq 3$  were considered, with signals that did not fall into these specifications discarded as noise. Figure 2 shows the installation of the piezoelectric sensors at the tower's base, as well as a schematic diagram of their arrangement, providing a visual representation of the setup.

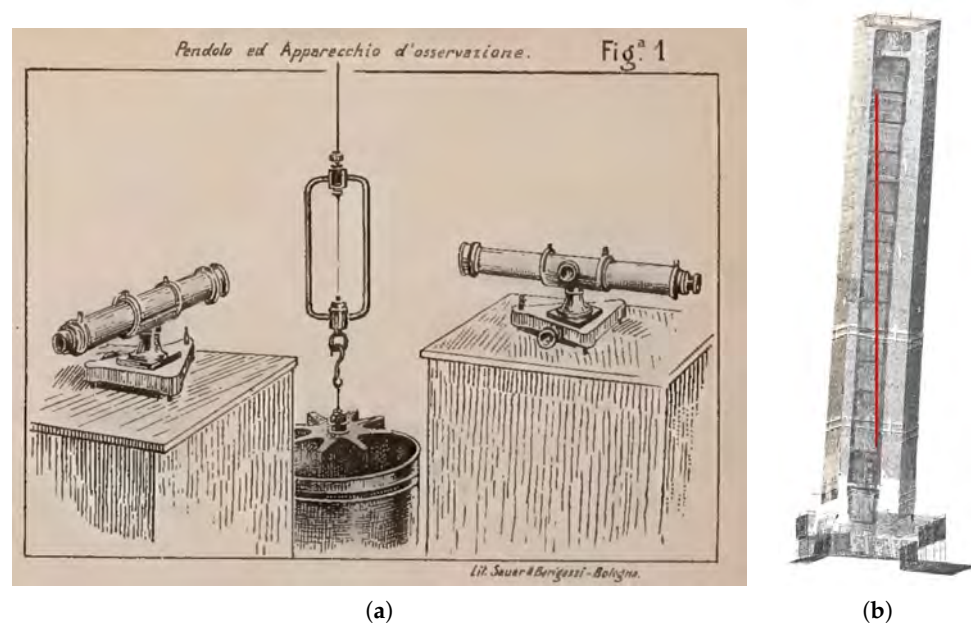
**Figure 3.** Schematic of the pendulum used by Prof. Cavani at the beginning of the 1900s [1] (a); laser scan of the pendulum inside the tower (b). Credit for the latter attributed to R.teknos srl.

In February 2021, a 30 m pendulum was installed inside the tower by the company RTeknos s.r.l (<https://www.rteknos.it/>, accessed 27 October 2025) to measure the planar movement of its top in comparison with the base. This modern monitoring system finds inspiration in a mechanical pendulum installed inside the Garisenda as early as the beginning of the 20th century by Prof. Cavani with the same scope (Figure 3). The pendulum consists of a steel wire attached to a 15 kg mass submerged in a viscous fluid, which serves to provide damping. The position of the wire is monitored by a telecoordinometer, comprising a unit equipped with photocells arranged in transmitter–receiver pairs, actuated by an electric motor and supplied with power through a cable fitted with connectors. It can detect displacements of up to 100 mm in the south-east direction (X-axis) and up to 50 mm in the north-east direction (Y-axis). The pendulum's margin of error is 0.075% of the maximum reading. This translates to an error range of 0.075 mm in the X direction and 0.0375 mm in the Y direction. The system also records the internal temperature at the base of the tower.

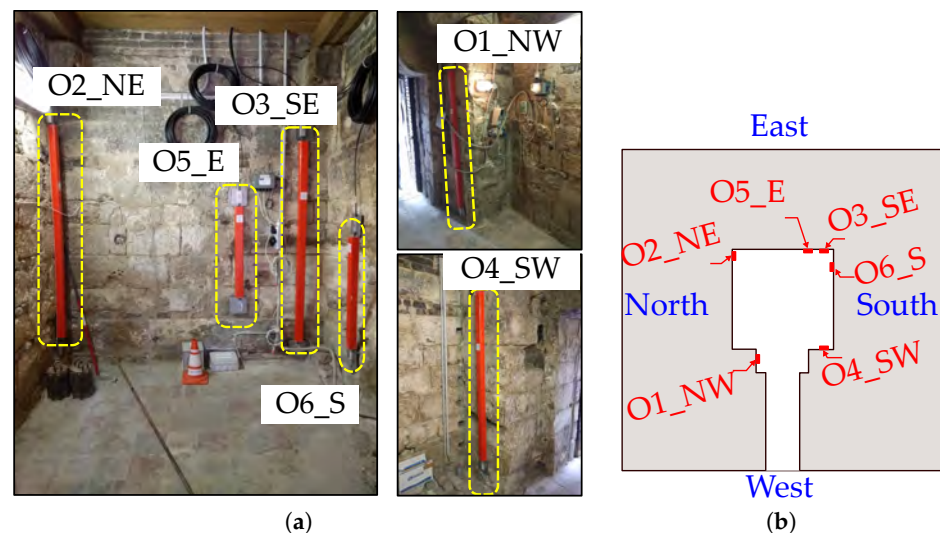
**Figure 4.** FOSs on the inner walls of the tower base (a). Credit is attributed to OSMOS Group. Schematic representation of the position of the FOSs in the tower base (b).

Eight FOS sensors were placed vertically on the inner walls of the base of the tower by OSMOS Group (<https://www.osmos-group.com/en>, accessed 27 October 2025). Six of them are shown in Figure 4; the other two were installed at the end of 2023 but were not considered for the present analysis. The FOSs were installed to measure strains in the base—the four 2 m long strings were installed to measure global strains in the base, while the two 1 m long strings were installed to measure local strains in the south-east corner, where the inner selenite presented signs of degradation. String O4\_SW was removed shortly after installation, due to interference with other works, and its readings were also discarded. The system records strain and temperature in the vicinity of the FOSs. Sampling frequency is up to 100 Hz for dynamic events (such as earthquakes). Of the eight FOSs, six of them are 2 m long and two of them are 1 m long (strings O5\_E and O6\_S in Figure 4).

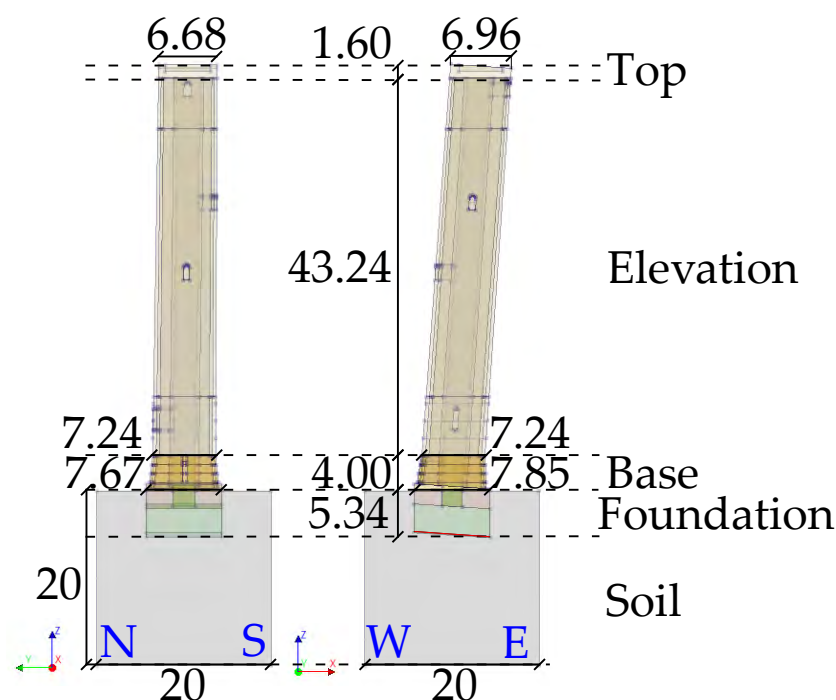
**Figure 5.** West (on the left) and south (on the right) views of the FE model geometry, with dimensions indicated in meters.

A 3D finite element model was developed utilizing the DIANA commercial package (<https://dianafea.com/>, accessed 27 October 2025). The computational mesh consists predominantly of quadratic brick and wedge elements, for a total of around 200,000 elements and 600,000 nodes. Mesh refinement strategies varied across different structural regions. In the elevation, an element size of 1 m was adopted (with the exception of the region close to the base, where the element size was set to 0.5 m). In both in the base and foundation, element size was set to 0.2 m, while in the soil a coarser discretization of 2 m was used. The base of the tower was modeled with four layers: two outer selenite layers, an intermediate infill (“sacco”), and an inner selenite layer. The outermost layer of selenite was discretized with one element, while the second exterior layer of selenite was modeled with two brick elements, for a total of three elements and seven nodes through the thickness. For the internal selenite layer, two elements were used through the thickness. West and south views of the geometry of the model in DIANA, with its dimensions, can be seen in Figure 5, while the geometry of the model, with the inner layers, is shown in Figure 6.

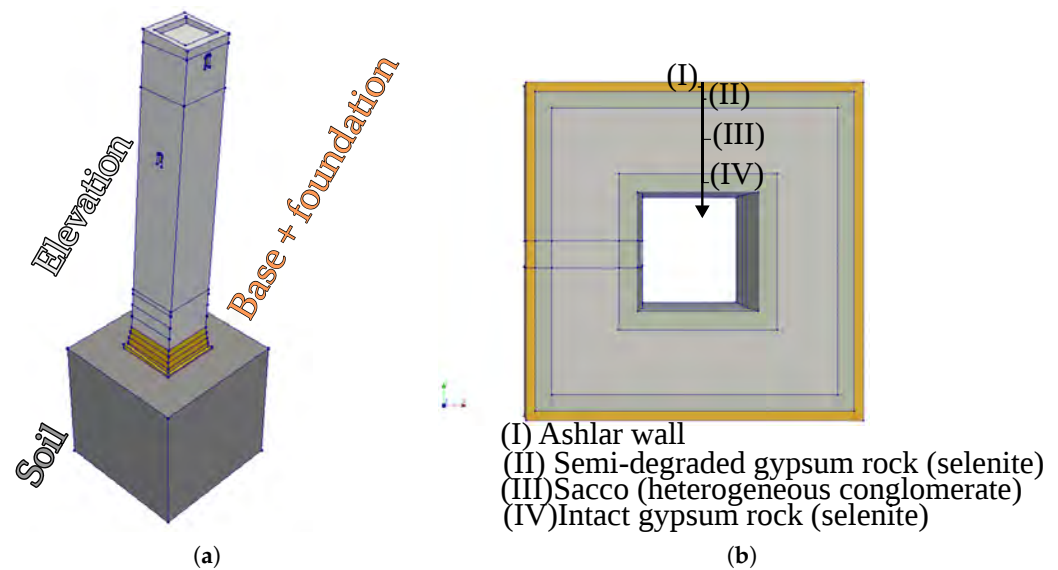
**Figure 6.** Isometric view of the FE model geometry. (a). Top view of the base section of the FE model, highlighting the different layers. (b).

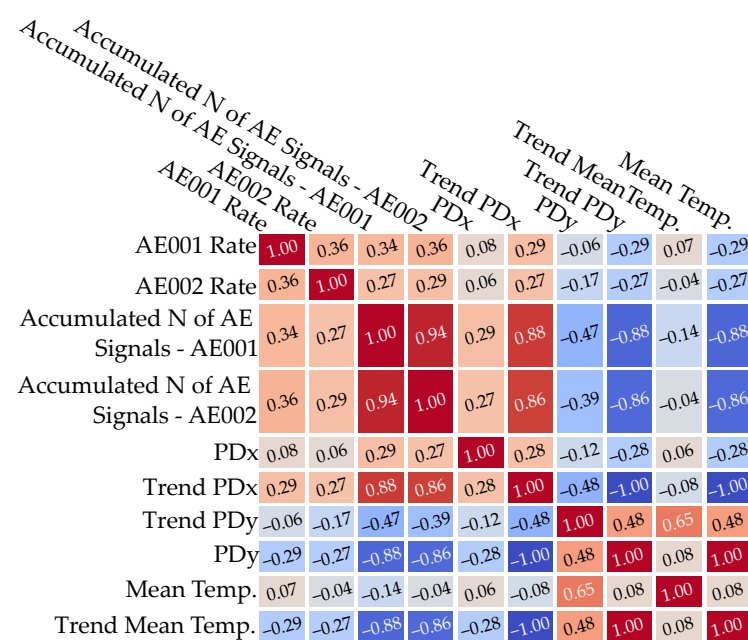
**Figure 8.** Correlation matrix of the variables analyzed. Red values indicate positive correlation and blue values indicate negative correlation.

Values were taken from 31 March 2019 to 31 May 2025. As per Equation (1), the variables were standardized and the correlation matrix was built (Figure 8).

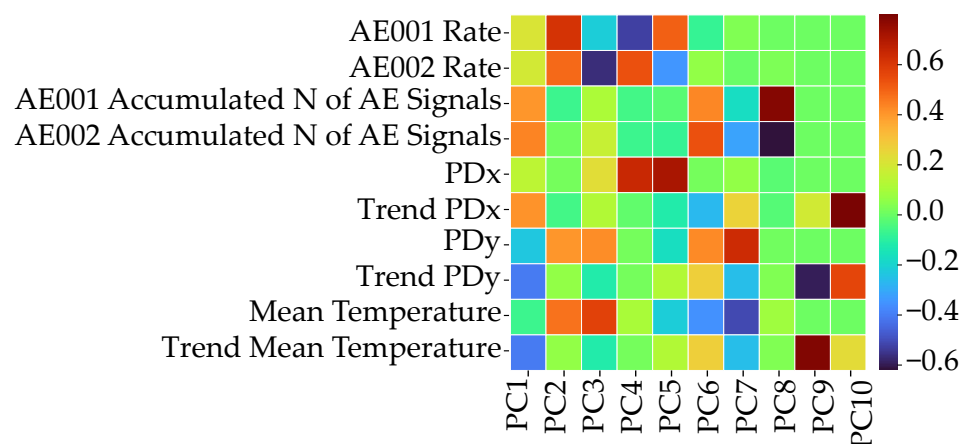
**Figure 9.** Heatmap representing the contribution of each original variable to each principal component.

From the correlation matrix, the principal components were determined. Since there are ten variables in the problem, ten principal components were calculated. The principal components, i.e., the impact of each original variable on each PC, are presented in the heatmap shown in Figure 9.

- The first PC aggregates accumulated AE, pendulum displacements, and the mean temperature. It is viewed as an indicator of damage caused by the increase in the inclination of the tower (which can also be seen by the pendulum movement).
- The second and third PCs aggregate AE rate (strong correlation for PC2, and strong anti-correlation for PC3), pendulum movement PDy (N-S motion), and mean temperature. They are viewed as changes in damage in the N-S direction due to thermal effects.
- The fourth PC, as with the second and the third, also aggregates AE rate and the pendulum movement (PDx), but this time without the temperature. It is viewed as pure damage caused in the W-E direction.

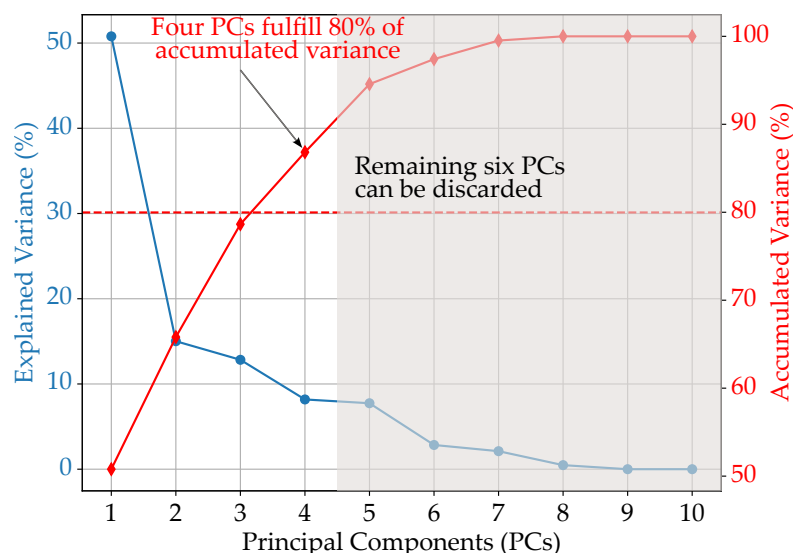
**Figure 10.** Scree plot used to determine the number of PCs to be kept in the analysis.

To understand how many principal components were sufficient for the analysis, the cumulative explained variance was calculated, shown in Figure 10. It was seen that the cumulative explained variance of the first four principal components was already higher than 80%, so the last six variables were discarded. In this study, however, attention is focused on the first two PCs. The higher-order components (PC3 and PC4), while not negligible, are associated with more localized effects and are therefore not discussed in detail in this work.

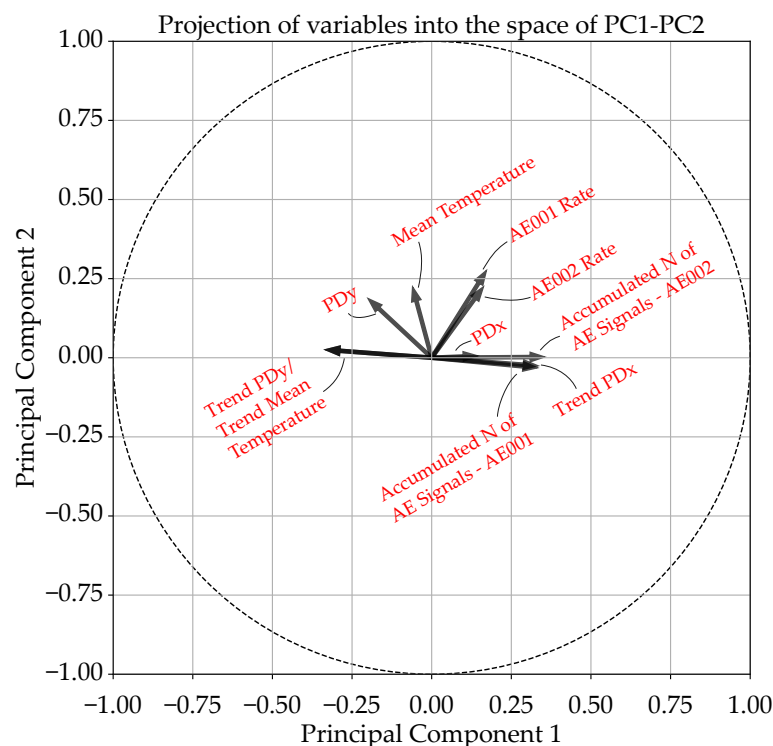
**Figure 11.** Circle of correlation: Projection of each original variable into the space of PC1-PC2.

To aid with the interpretation of the results, all variables were projected in the space of PC1-PC2, as can be seen in Figure 11.

- The variables PDx, Trend PDx, and both of the accumulated numbers of AE signals point strongly in the direction of PC1, but they point weakly in the direction of PC2. This could mean that they are correlated to damage caused by the pendulum movement in the S-E direction. This is the opposite behavior of the variables Trend PDy and trend mean temperature, which point strongly (and negatively) in the direction of PC1. An interpretation of this fact would be that, when temperatures and PDy increase, the damage related to the movement of the pendulum decreases.

- The AE rates point in the direction both of PC1 and PC2, which suggests that they are correlated to damage due to pendulum motion, specifically in the N-S direction. Interestingly, the AE rates seem to be more sensitive to the damage due to the pendulum movement in the N-S direction, as they point more in the direction of PC2 than in the direction of PC1. The variables PDy and mean temperature point in the direction of PC2, but point in the negative direction of PC1. This reflects that they are correlated to damage in the N-S direction (PC2), but anti-correlated to the damage considering the overall pendulum movement. An interpretation of this fact would be that, when temperatures and PDy increase, the overall effect of damage decreases, while increasing in the N-S direction, as if the damage shifted from W-E to N-S movement.

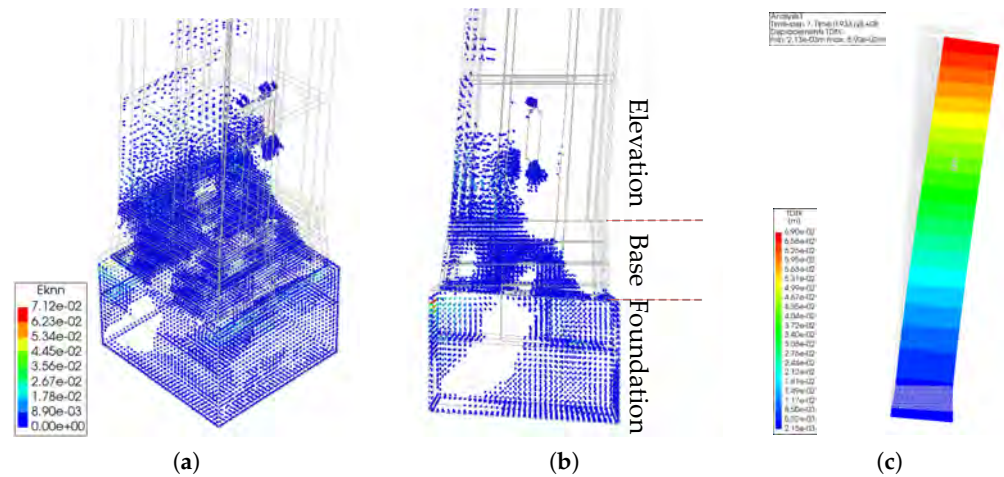
**Figure 12.** Cracks in the tower after 2.5° of tilt, where it can be seen that cracking mostly occurs in the region under tension, closer to the entrance (a,b). Eastwards displacement of the tower after 3.5 years, as a result of viscoelastic creep (c).

The numerical analysis converged up to an additional base rotation of approximately  $2.6^\circ$ . Beyond this value, convergence could not be achieved due to the development of diffuse cracking and strain localization, which can be interpreted as a physically meaningful indication of structural instability rather than a purely numerical issue. Figure 12a shows the diffused cracking pattern in the lower region of the tower, with the region under tension (closer to the entrance) being apparently the most affected.

If we consider a purely rigid body rotation, the displacement at the top would be around  $48 \text{ m} \times \tan(2.6^\circ) = 2.18 \text{ m}$ . In the numerical model, the total displacement at the top is around 3.39 m, which corresponds to 2.18 m of rigid rotation and thus 1.21 m of rotation due to deformable effects. It is noticeable that 3.39 m is very close to the current lean of the tower of about 3.2 m. If we consider only the lean due to elastic effects, 1.21 m, the value is still not negligible. As such, this configuration is indicative of a kind of upper bound for failure due to tilting.

In relation to the viscoelastic creep model, the displacement in the east direction is shown in Figure 12b. Additional tilting clearly occurs in the presence of viscous deformation. A comparison between experimental and numerical results is presented in Figure 13.

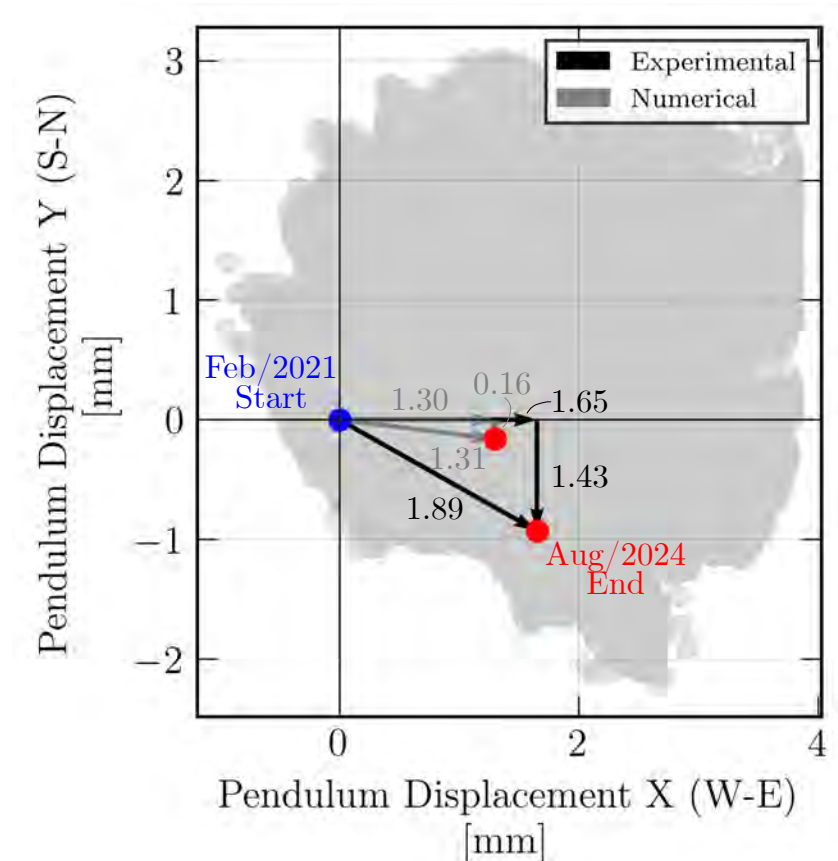
**Figure 13.** Experimental and numerical (due to creep) inelastic pendulum displacement after 3.5 years. The north–south displacements are not as well represented as the east–west displacements in the numerical model.

The creep model built in DIANA reflects well the long-term behavior observed experimentally in the tower, at least considering the displacement in the east direction. The behavior still has room for improvement in the north–south direction.
