The Garisenda Tower in Bologna: Damage Assessment Results from Principal Component Analysis, Acoustic Emission, and Nonlinear Finite Element Analyses Involving Creep and

# The Garisenda Tower in Bologna: Damage Assessment Results from Principal Component Analysis, Acoustic Emission, and Nonlinear Finite Element Analyses Involving Creep and Smeared Cracking

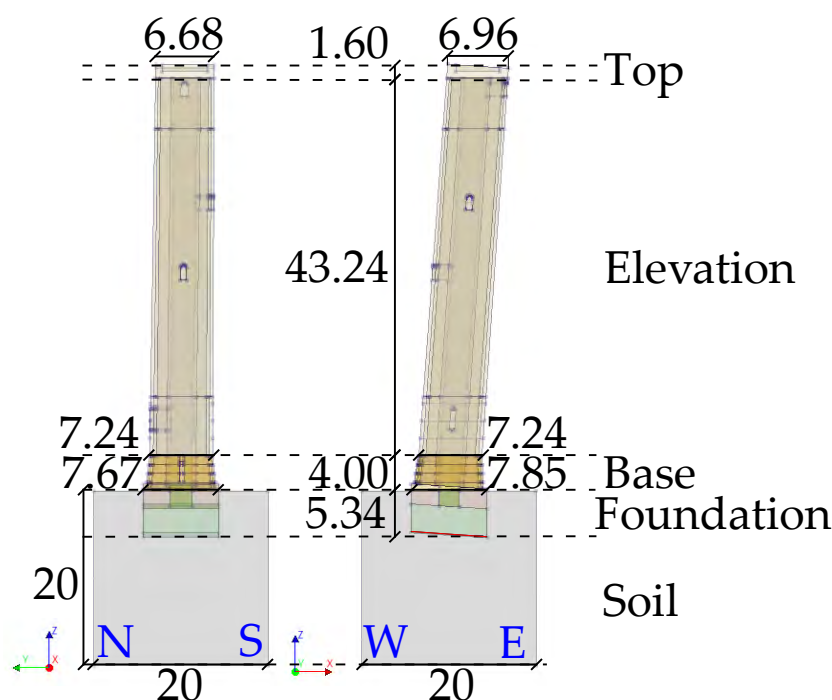
A 3D finite element model was developed utilizing the DIANA commercial package (<https://dianafea.com/>, accessed 27 October 2025). The computational mesh consists predominantly of quadratic brick and wedge elements, for a total of around 200,000 elements and 600,000 nodes. Mesh refinement strategies varied across different structural regions. In the elevation, an element size of 1 m was adopted (with the exception of the region close to the base, where the element size was set to 0.5 m). In both in the base and foundation, element size was set to 0.2 m, while in the soil a coarser discretization of 2 m was used. The base of the tower was modeled with four layers: two outer selenite layers, an intermediate infill ("sacco"), and an inner selenite layer. The outermost layer of selenite was discretized with one element, while the second exterior layer of selenite was modeled with two brick elements, for a total of three elements and seven nodes through the thickness. For the internal selenite layer, two elements were used through the thickness. West and south views of the geometry of the model in DIANA, with its dimensions, can be seen in Figure 5, while the geometry of the model, with the inner layers, is shown in Figure 6.

**Figure 5.** West (on the left) and south (on the right) views of the FE model geometry, with dimensions indicated in meters.
