# **Numerical Analysis of Cervo Cliff Stability Due to Basal Marine Erosion**

## **Abstract**

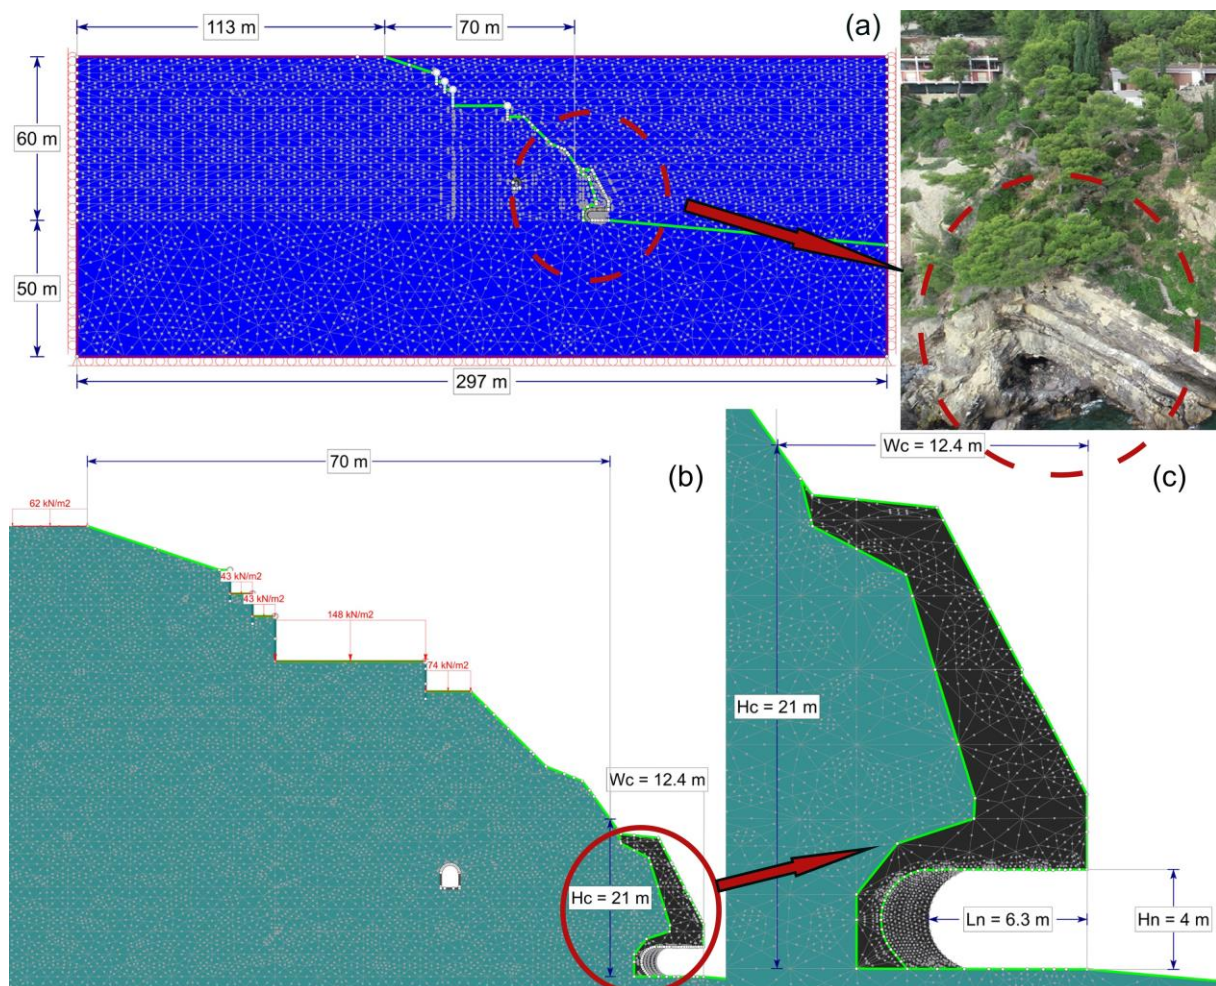
Figure 1. Numerical model setup: (a) overall geometry, dimensions, and boundary conditions, together with a field photograph of the cliff and basal notch; (b) applied external actions represented as equivalent uniformly distributed loads (building floors and road surfaces); (c) detail of the cliff-toe region showing the cliff geometry ( $H_c$ ,  $W_c$ ) and notch geometry ( $H_n$ ,  $L_n$ ), with local mesh refinement. The black layer represents the weathered rock layer.

from UCS laboratory tests performed on undisturbed core samples. Additional Schmidt hammer and point-load tests conducted on rock outcrops and samples exposed to the marine environment were used to estimate the compressive strength of the weathered rock. The rock-mass Hoek–Brown parameters and deformability modulus were estimated assuming a Geological Strength Index (GSI) of 30, according to the chart proposed by Marinos and Hoek (Marinos & Hoek, 2000). The parameters adopted in the numerical analyses are summarised in Table 1. External distributed loads were applied to account for the presence of the building and the adjacent roads (Table 2; Fig. 1b).

The analysis was performed using the shear strength reduction (SSR) method to determine the strength reduction factor (SRF). The alteration of the external layer of the slope and the progressive notch retreat was simulated through a staged excavation scheme (Fig. 1c). The numerical model includes 32 stages, of which: 20 provide the creation of the slope profile by progressively removing the ground layers (Fig. 1a), the following one is used for applying external loads and excavating the tunnel, and

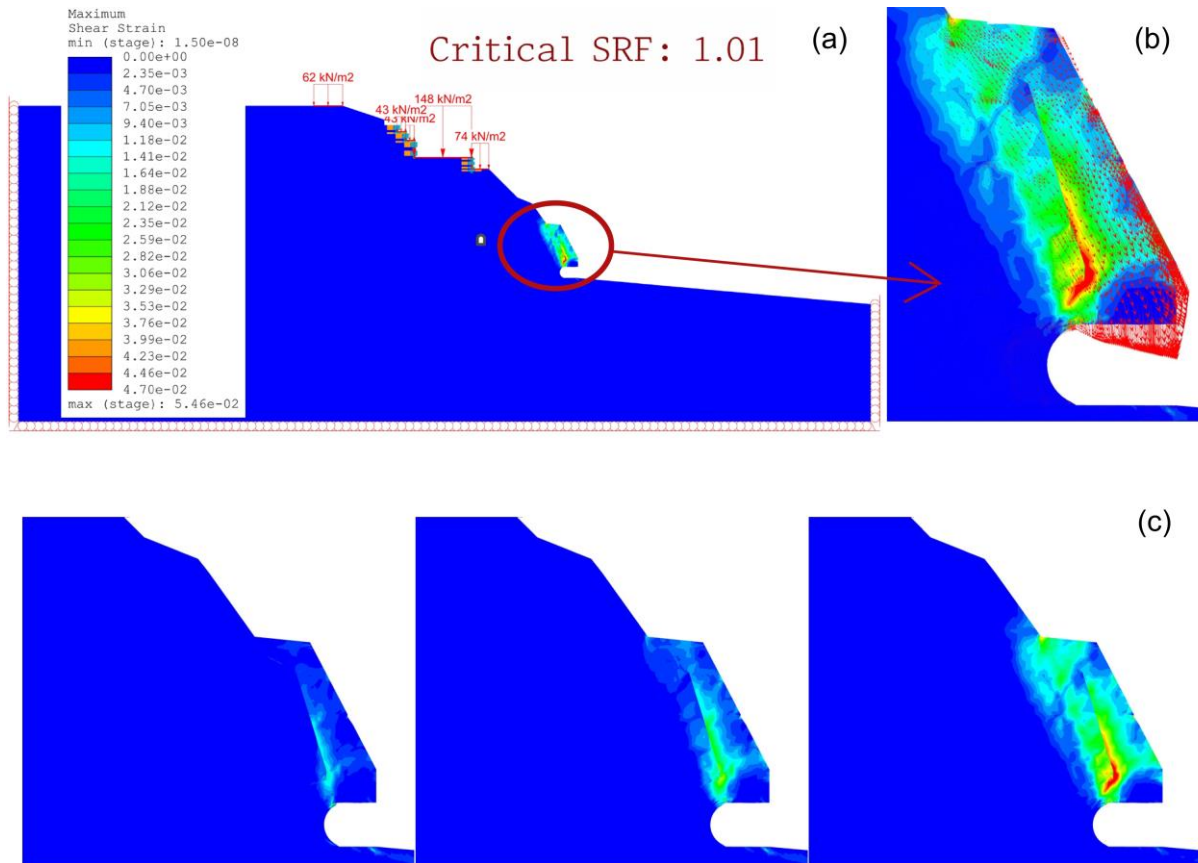
Figure 2. Maximum shear strain contours and critical SRF (a); maximum total displacements (b); evolution of the maximum shear strains with the progressive retreat of the notch (c).

the final nine simulate the notch-retreat phases. The critical condition ( $\text{SRF} = 1.01$ ) was reached after seven stages of notch retreat, corresponding to a final notch depth of 6.3 m. At this stage, progressive shear strain localization led to the collapse of the rock volume above the notch. The resulting failure mechanism, shown in Figure 2 in terms of maximum shear strain and total displacement, is consistent with field observations, confirming the representativeness of the model. These results are also consistent with the findings of Napoli et al. (2024a, b), who observed that when the ratio between the height of the cliff overhang (above the notch) and the notch depth is high, a shear failure mechanism is expected.

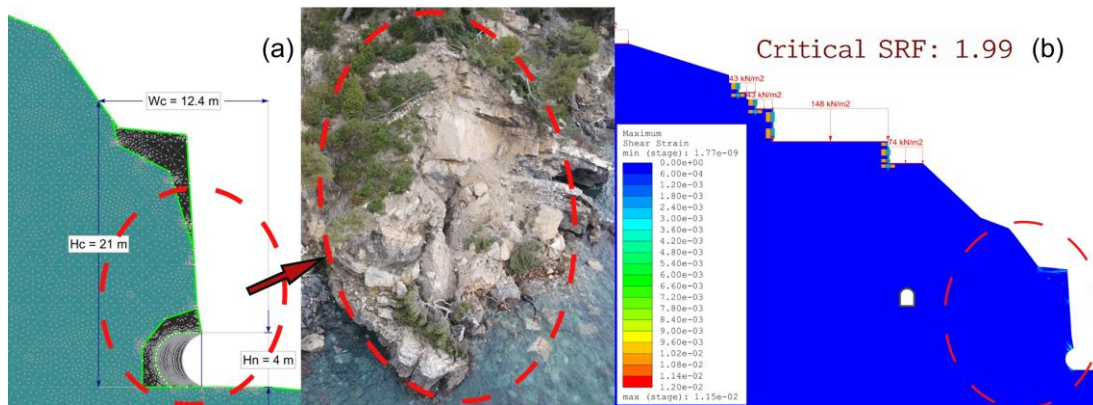
Figure 3. (a) Cliff geometry used for the current (post-collapse) scenario, together with a field photograph of the post-rockfall condition; (b) maximum shear strains.

Two post-collapse scenarios were analysed to investigate the current stability condition of the rock cliff and its possible potential evolution driven by progressive rock-wall alteration and the deepening of the notch over time. The model geometry was updated to represent the post-collapse condition, modifying the cliff profile to account for the failure of the seaward portion (Fig. 3a). As shown in Fig. 3b, the cliff currently exhibits global and local stability with a factor of safety of 1.99, millimetric maximum displacements at the roof of the residual notch and negligible concentration of shear strains.

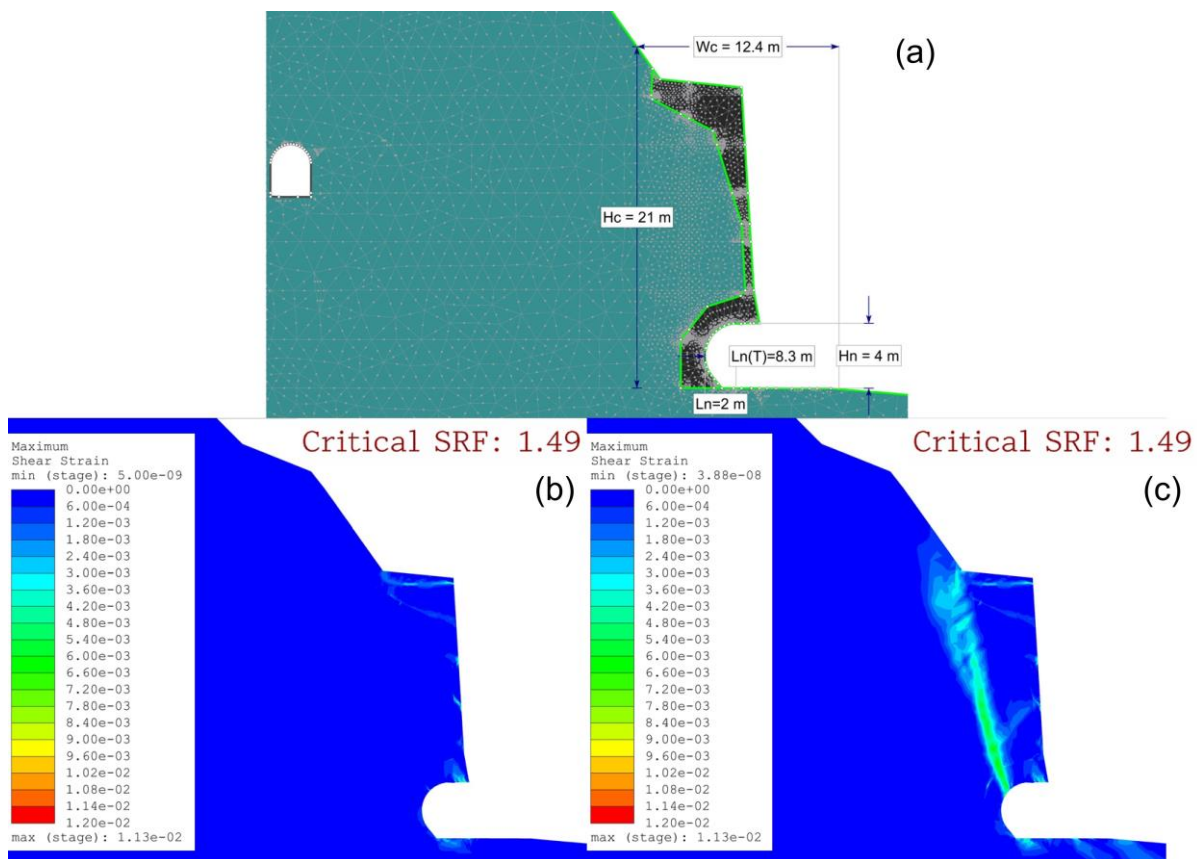
Figure 4. (a) Post-collapse cliff geometry used for the forecasting scenario; (b) maximum shear strains; (c) progressive increase of the maximum shear strain up to limit conditions.

A predictive scenario was modelled to evaluate the impact of marine-induced weathering. The model incorporates a propagation of the weathered layer of approximately 0.5 m in the shallow part of the wall most exposed to marine actions, along with a progressive basal erosion of the rock for additional 2 meters. The deepening of the notch was simulated in 2 additional stages (Fig. 4 a). Under these conditions, the critical SRF was found to be 1.49, indicating a reduction of the global stability but a general still stable configuration (Fig. 4 b).

Based on the maximum shear strain and total displacements obtained at limit conditions (SRF = 1.49), it can be stated that the damage induced by the marine environment is concentrated at the base of the cliff, close to the notch, and can spread progressively upslope (Fig. 4b, c). According to the slenderness of the cliff above the notch, shear failure is expected within the potential unstable rock volume. This effect seems not to affect the above structures, while remaining a hazard for the sea area below the cliff.
