# Pattern recognition approaches for the detection of alteration and degradation phenomena in hyperspectral and UAV multispectral imagery: the case study of a historical masonry water bridge

Alessandra Spadaro <sup>1</sup>, Francesca Matrone <sup>1</sup>, Andrea Maria Lingua <sup>1</sup>, Ramin Rashidi Alavijeh <sup>1</sup>

**Keywords:** Hyperspectral imaging, Multispectral imagery, Decay mapping, UAV, OBIA, Machine Learning.

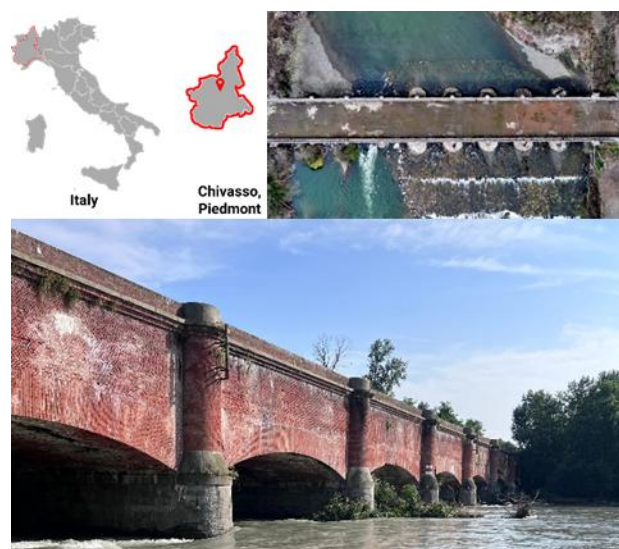
Figure 1. The Cavour Canal water bridge over the Dora Baltea River (Saluggia, Italy), a 19th-century masonry hydraulic structure characterized by a multi-arch configuration and a continuous water conveyance system.

The selected case study is the Ponte Canale Cavour over the Dora Baltea River (Figure 1), located near the municipality of Saluggia in Vercelli, north-western Italy. This structure represents the first and one of the most important hydraulic crossings within the canal system, completed in 1864. The bridge is characterized by a monumental masonry architecture, consisting of approximately 193.6 m in length, with nine masonry arches supported by eight piers and two abutments. The structural system is primarily composed of fired clay bricks, with localized use of stone elements (e.g., granite slabs) in the lower portions of the piers to enhance resistance to hydraulic erosion.
