Quantifying the seismic resilience of bridges: a pathway towards a Resilience-Based Design

A.I. Sarkis & A. Palermo
University of Canterbury, Christchurch, New Zealand

O. Kammouh & G.P. Cimellaro
Politecnico di Torino, Turin, Italy

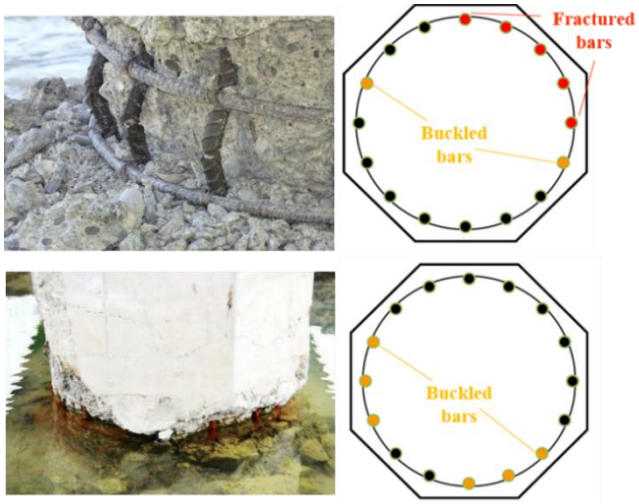
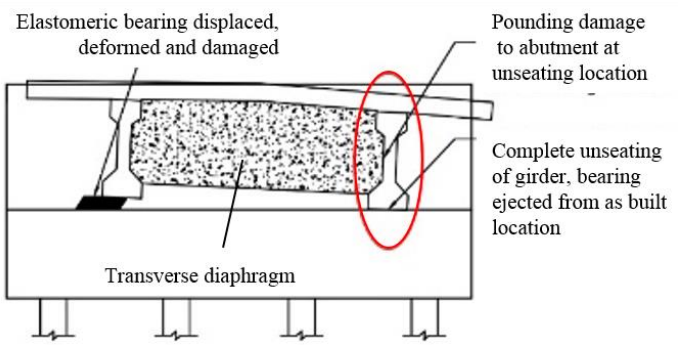
At the Lower Mason Bridge, all piers, except for the central, formed fully developed plastic hinges (PH) at the base. As mentioned, the central pier is located below a movement joint in the deck and has shear keys restraining the superstructure. Extensive cover spalling and a significant number of buckled and fractured longitudinal bars were seen. Pier damage at the Lottery River Bridge was similar but without an evidence of bar fracture. Figure 4 illustrates the damage patterns found on the column rebar of both bridges.

Figure 4. Pier damage sustained by Lower Mason River Bridge (top) and Lottery River Bridge (bottom).

Together with the PH zones, observed damage common to both bridges, Lower Mason and Lottery, included: damage to the knock-off block at the central pier movement joint, failure of the abutment knock-off blocks; residual displacement of most of the elastomeric bearing pads at the piers and abutments; and residual displacements at the central pier and abutment movement joints. Damage to the abutments is illustrated in Figure 5.

Based on the assumption that the WMTC records are a reasonable representation of the bridge site ground motions, the displacement demands on the bridges were considerably greater than the DCLS capacity displacements, explaining the severe damage observed in the PH zones.

repairs and re-levelling. To reinstate the original seismic capacity, a pile jacketing was issued for all pier columns, which was finished around mid-January (point 2 in Figure 7). After the pile jacketing was completed, the one-heavy-vehicle-at-a-time restriction was removed but the 30km/h restriction remained due to the uneven road surface.

The recovery process for the Lottery Bridge was very similar to the Lower Mason, since they share similar structure type and damage. Pier columns were unable to be inspected on the first days after the earthquake due to the bed and water level, yet, damage was anticipated to be less than at Lower Mason due to the shorter bridge columns. Excavation of pier piles occurred on November 25th confirming that damage was of a lesser extent, and pier jacketing was issued and completed around mid-February (point 3 in Figure 7).

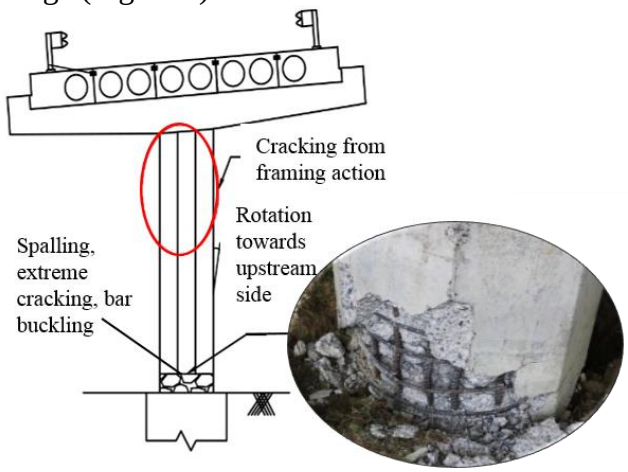
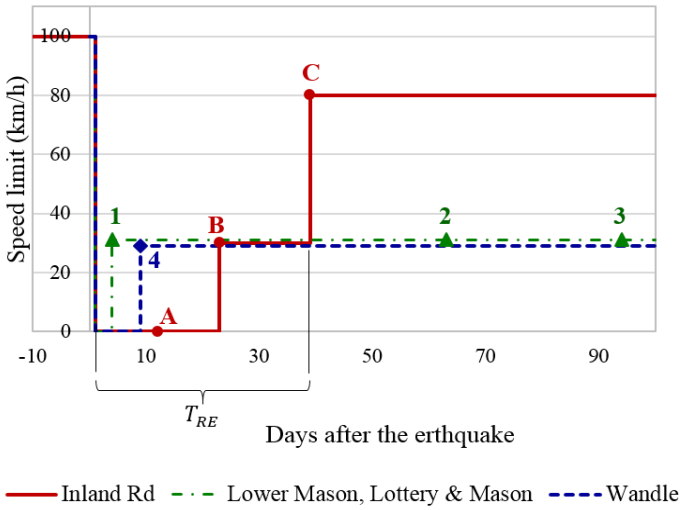
The damage observed to the Wandle River Bridge was extensive, and included: separation between the hollow core deck units at the south end of the bridge; translation of deck units in the downstream direction; hinging and rotating of piers towards the upstream side (up to 7° rotation); opening of the deck joints at the abutments, along with significant approach damage (Figure 6).

Figure 6. Damage schematics for the Wandle River Bridge (modified from: Palermo et al., 2017)

It can be concluded that the piers performed well, as they developed PH at the pier bases and went through the expected failure mechanism. However, significant instability was visible in the Wandle Bridge, where most likely all orthogonal motions were interacting with the bridge structure, causing large displacements and separation gaps between some of the deck beam units.

For the Wandle River Bridge, decision was made on November 15th to install a Bailey bridge upstream with a 33m span. Installation was completed by November 21st and opened to traffic on the 22nd, nine days after the earthquake (point 4 in Figure 7). The Bailey bridge was able to be erected so quickly, within eight days, because New Zealand Transport Agency (NZTA) maintains an emergency stock of Bailey bridges with a contractor also in place to respond in the event of emergencies. The Bailey bridge provided largely unrestricted access across the Wandle River, however, a 30km/h speed restriction was installed due to the alignment and to provide impact protection to the bridge. The Wandle Bridge was demolished in May 2017 and a new bridge design is programmed with a low priority for 2018.
