RESTORATION OF A LANDMARK BALANCED CANTILEVER BRIDGE CONSIDERING DIFFERENT
RESILIENCE AND SUSTAINABILITY STRATEGIES

RESTORATION OF A LANDMARK BALANCED CANTILEVER BRIDGE CONSIDERING DIFFERENT RESILIENCE AND SUSTAINABILITY STRATEGIES

Marco Domaneschi[1], Stergios A. Mitoulis[2], Raffaele Cucuzza[1], Valentina Villa[1] and Roberta Di Bari[3], Gopika Siva[2]

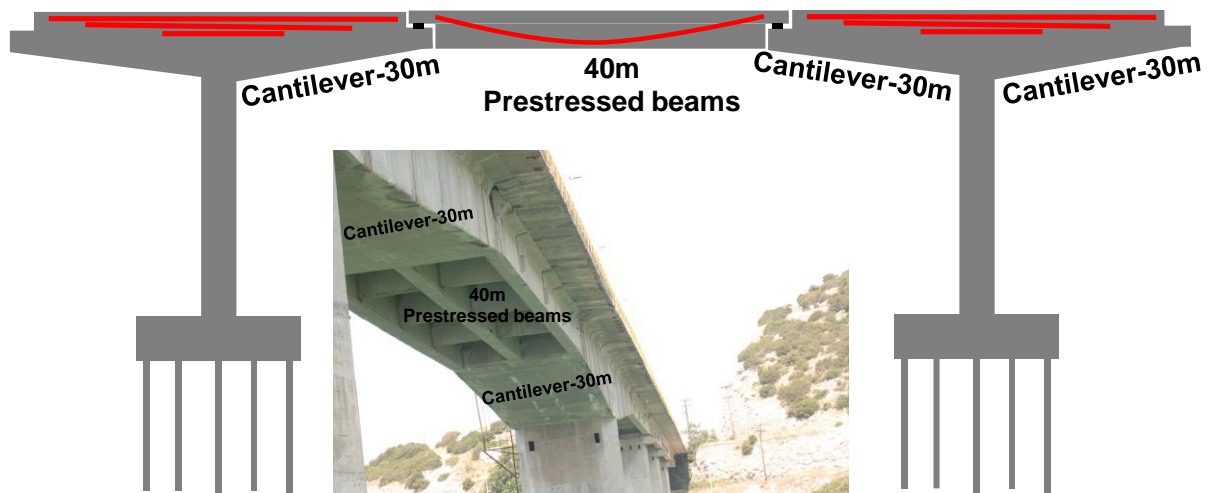
Figure 3: Schematic (not true) configuration with prestressing cables (red lines) and the actual view of the deck between Piers 23-24.

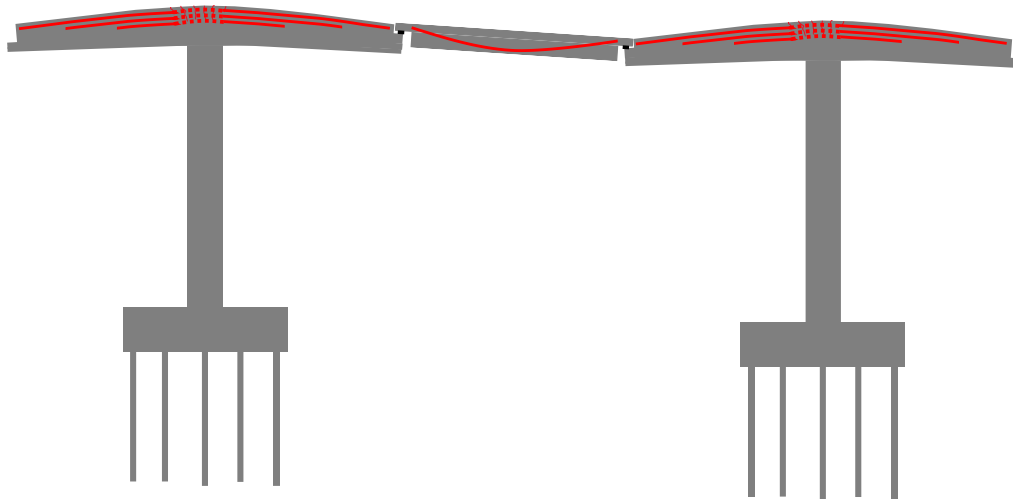
Herein, corrosion was assumed to be the main source of deterioration for the investigated bridge essentially disregarding additional failure mechanisms that might contribute (e.g. scouring, spalling of the reinforced concrete). In fact, when a strand is exposed to moisture its exposed interface becomes particularly prone to corrosion induced damages. Of particular concern is the so-called "localized corrosion" that could lead to substantial local reductions in the cross section of the stand and consequently to severe reductions of its tension capacity. Each strut could have (a) corroded and uncorroded wires within the same section and (b) corroded and uncorroded parts across its length.

Figure 4: Current deteriorated condition of the cantilevers of the bridge after 48 years of service. The sketch shows the corrosion of the tendons above the piers (hypothesis based on extensive cracking observed on the locations) and the deflection of the deck (measured on a point cloud).

h) External prestressing system realized by the addition of 4 cables along each cantilever in order to restore the original deflection. At this design stage, additional cables are supposed to be of the same section of that one recognized in the technical drawings. Moreover, the level of compression stress introduced into the system should be designed aiming to avoid cracking as depicted in Figure 8.

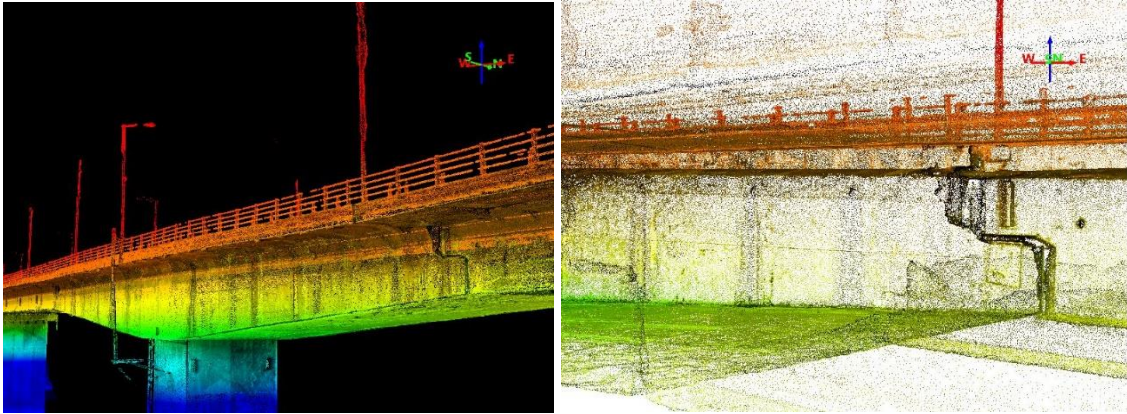
The point cloud of the bridge with some details of the cantilever and the half-joint is depicted in Figure 6. The deflection of the most critical cantilever of the bridge is reported in Figure 7, where the dashed line is the expected elevation, while the solid line is the measured position, i.e. 133mm and 207mm lower than the expected. Such deflections are the cantilever displacements downward at the tip (end) of the most critical cantilever.

Figure 6: point cloud.

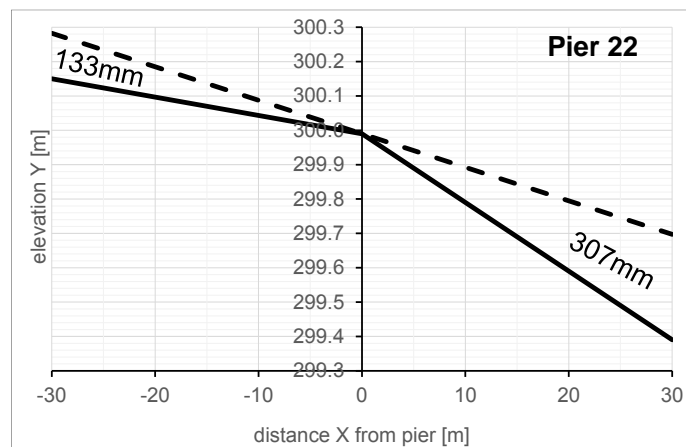
Figure 7: Measured deflection of the critical cantilever. Dashed line shows the hypothetical original elevation. Solid lines show the measured deflected cantilevers.
