Atmospheric corrosion of outdoor bronze artefacts: The case study of 'Katarsis', by Magdalena Abakanowicz

Leila Es Sebar[1], Leonardo Iannucci[1], Marco Parvis[2], Sabrina Grassini[1] and Emma Angelini[1]

This paper presents the characterization of the conservation state of a bronze artwork exposed outdoor, which is part of the Gori Art Collection, situated in Fattoria di Celle, in Pistoia (Italy) [4]. This collection was founded in Prato (Italy) in 1950 and then enriched in the following decades thanks to the contributions of many international artists. Since 1970, the Gori Collection was moved to the private garden of the Fattoria di Celle, a location large enough to host all the artifacts. The overall artistic concept is to create a space where sculptures and multi-material installations are directly connected to the surrounding environment, without any separation. A previous study characterized three bronze statues belonging to the collection, highlighting different corrosion morphologies related to different exposure to the environment [6]. Actually,

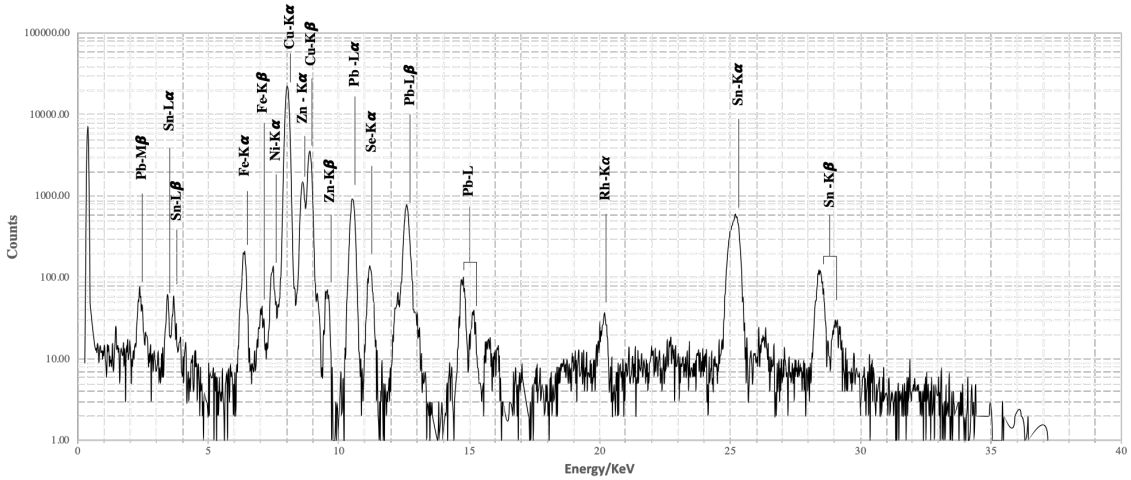
XRF measurements allowed to identify the constituent elements of the alloy. In particular, the following elements were identified: Cu, Zn, Sn, Fe, Se, Pb, Ni. As an example, Fig. 2 shows the spectrum acquired on one of the bronze figures, while the main characteristic X-ray line energies (keV) of the identified elements are reported in Table 1.

It is possible to describe the artworks constituent material as a lead-bronze alloy. The presence of selenium can be explained considering the selenium corrosion-resistant coating, usually used on modern bronze sculpture.

It is worth to notice that the peak at 20.216 KeV corresponds to characteristic Kα line of rhodium and it is due to the anode material.

Figure 2. XRF spectrum acquired on one of the 'figures' of the 'Katarsis'.

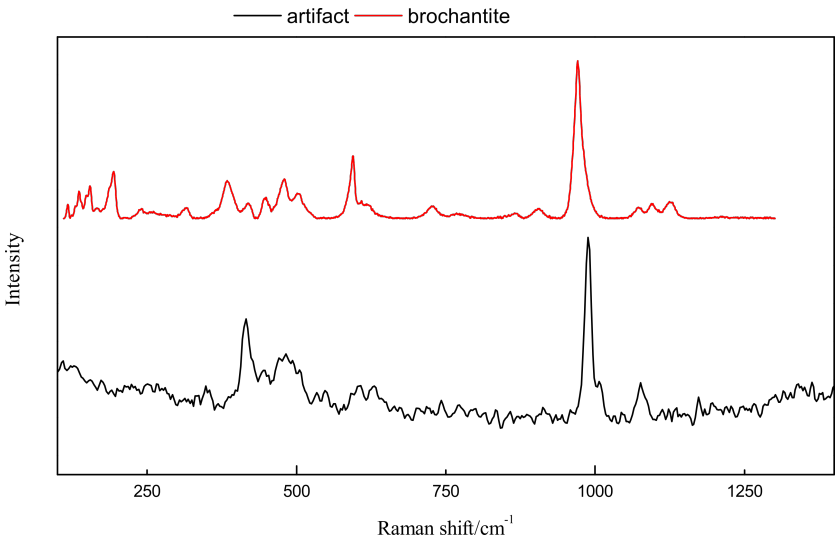
The application of RS on different points on the bronze figures allowed to identify the corrosion products mainly as sulphates, in particular as brochantite. In Fig. 3 a collected spectrum

of brochantite is reported, as an example, together with a reference spectrum of brochantite (RRUFF ID: 060117) [7].

Figure 3. Raman spectrum measured on one bronze figure and reference of brochantite.

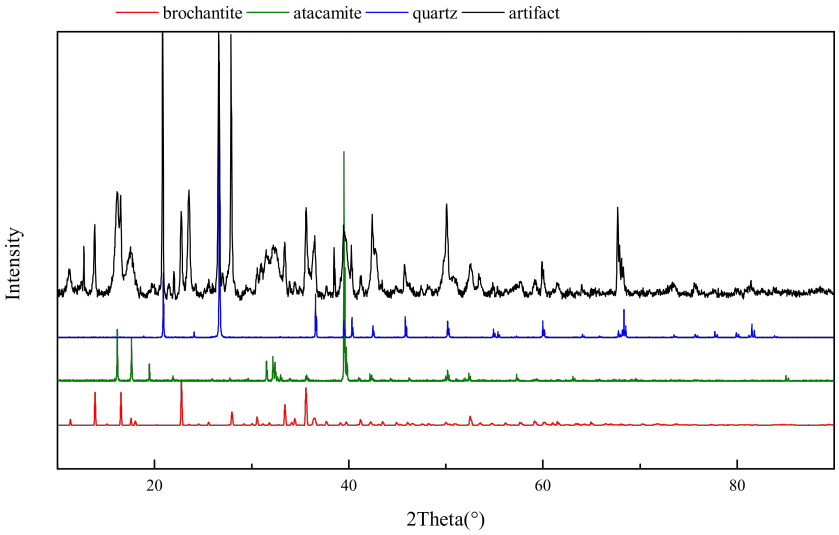
The nature of the corrosion products was confirmed also by XRD. Indeed, the collected pattern, displayed in Fig. 4, shows the characteristic peaks of sulphates and confirmed the presence of a mixture of brochantite (RRUFF ID: 100199, atacamite (RRUFF ID: 050098) and quartz (RRUFF ID: 040031), which is probably due to external contamination.

Figure 4. XRD pattern of a corrosion product sample collected on the same area analized by RS, whose spectrum is shown in Fig.3, and reference of brochantite, atacamite and quartz.
