Garden building diagnostic systems for sustainable preservation

25 VERDE is the object of this paper that deals with the application of diagnostic systems for a long-lasting sustainable preservation.

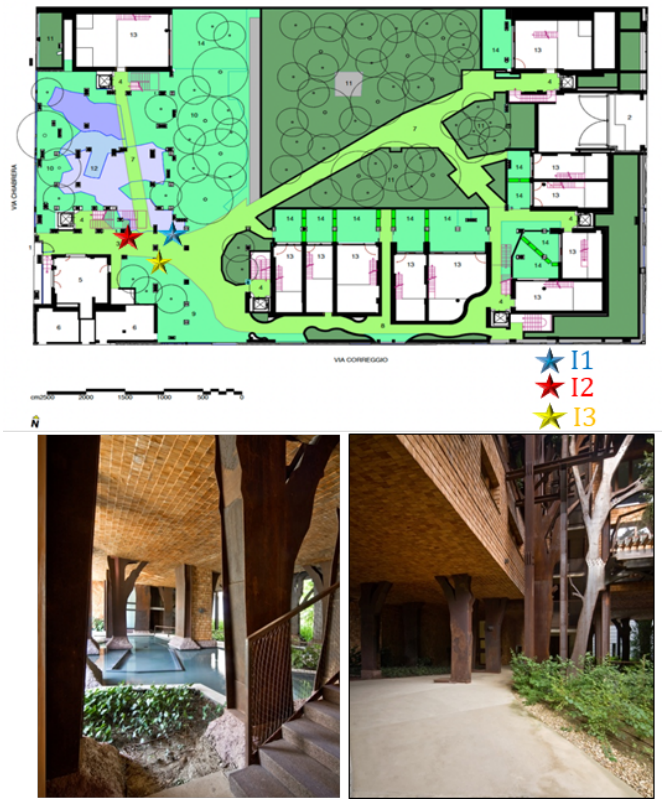
Fig. 5. Map of the ground floor of 25 VERDE (top) and pictures of the building (bottom).

Fig. 6. The map of the second floor of 25 VERDE (top) and picture of the façade (bottom).

Thanks to the visual inspection, the primary step of every building inspection, the monitoring points were identified, as shown on the maps of ground floor and of the second level of the building, Fig. 5 and Fig. 6. Particular attention has been paid to the appearance of the structural and non-structural components of the building, observing the presence

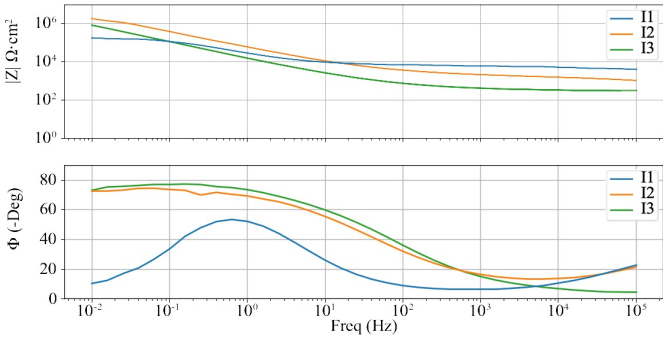
Fig. 8. Bode plots of EIS measurements collected on a weathering steel load-bearing structure located in the building interior.

The EIS diagnostic campaign was performed on different weathering steel structures of 25 VERDE in distant years. In particular, six specific structures were investigated: three trunk shaped columns placed in the exterior of the building, and three load-bearing structures located in the building interior. The measurements were carried out on different areas of the previously mentioned structures, which showed rust layers of different colors and morphology. Thus, different corrosion behaviors were observed, as highlighted by different values of the impedance modulus, $|Z|$, which can be correlated to the corrosion process arising at the rust layer/metal interface. This latter, is directly linked to the electrochemical stability of the rust layer, the higher impedance modulus, the higher is the electrochemical stability. A good electrochemical stability of the rust layer provides a better protective efficiency against further corrosion. All impedance spectra are scaled to an equivalent area of 1 cm^2. The impedance spectra collected on the weathering steel load-bearing structures placed in the interior of the building, one of them close to a small pool, are shown in Fig. 8. In particular, the measurements performed on the I2 area, as well as on I3 structure, show a high impedance modulus at low frequencies and a pure capacitive behavior. The protective rust layer, well adherent to the metallic surface, offers a good retarding action towards further corrosion. Thanks to the solid brown-black colored corrosion products layer, due to the high Cu percentage of the weathering steel analyzed in this case. On the other hand, a different electrochemical behaviour has been observed on the I1 structure, which is characterised by a lower impedance modulus. Moreover, the impedance phase, assessed on the area I1, shows diffusion phenomena at low frequency, connected to the poor insulating properties of the analyzed rust layer. Above all, the closeness of the pool of the I2 structure limits the formation of a homogeneous protective rust layer on the entire weathering steel surface, which cannot reach a stability. Fig. 9 shows the measurements collected on the weathering steel tree trunk shaped columns on the exterior of the building, which present a protective corrosion products layer due to the exposure conditions. Particularly, sunlight and fast wet/dry cycling enable the formation of a protective rust layer, as described in literature [24]. Hence, the EIS spectra of Fig. 9 present a more homogeneous electrochemical behavior of rust patina, characterized by a pure capacitive behaviour with by high impedance modulus values at low frequency.

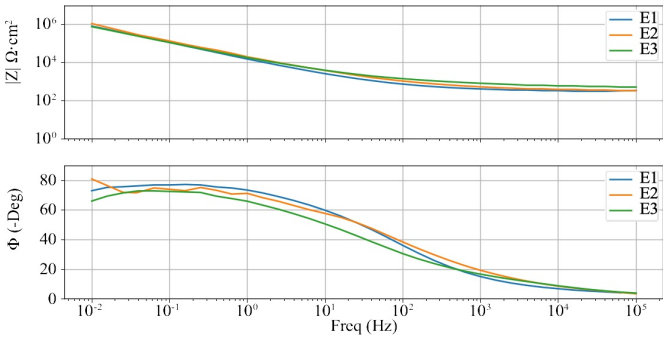
Fig. 9. Bode plots of EIS measurements collected on a weathering steel trunk shaped column placed in the exterior part of the building.

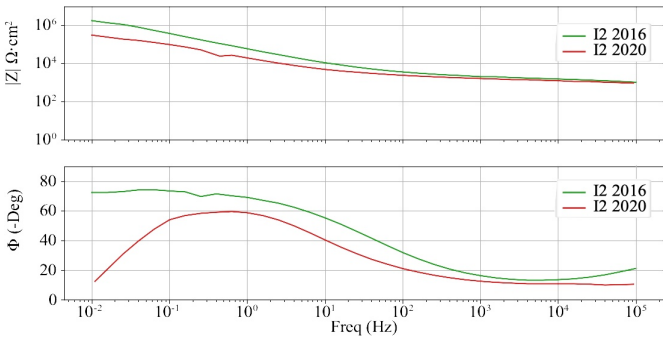
Fig. 10. EIS measurements collected in 2016 and 2020 on a weathering steel structure located in the building interior.

Fig. 10 shows the impedance spectra recorded on the weathering steel surface of the interior structures measured in 2016 and 2020, in particular the aforementioned area I2. Over years, the surface exposed in the interior of the building shows a lowering of the protective capacity of the rust patina, indeed, the impedance modulus value is lowered. This behavior highlights that the patina has not yet reached its stability; this is due to the proximity of the pool of the interior area, and the impossibility of guaranteeing inside the building the normal wet/dry cycle which enables the formation of a protective rust layer. In fact, in the graph that represents the comparison of the measurements made on the external surfaces of the building, in particular as an example in the area E1, Fig. 11, shows the same impedance behaviour over the time, hence,

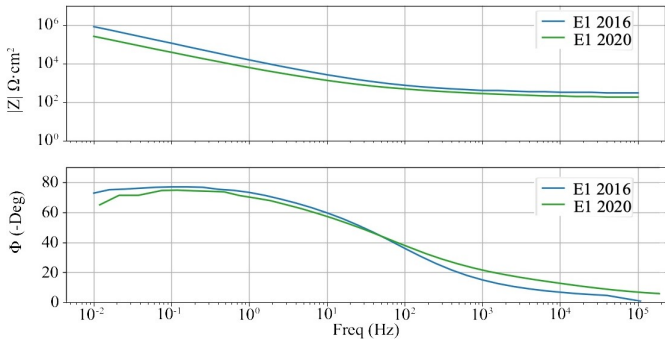
Fig. 11. EIS measurements collected in 2016 and 2020 on a weathering steel structure in the exterior part of the building.

an appreciable stability of the patina and, therefore, a greater protective capacity is appreciable. However, measurements collected on another point of the exterior building, area E3 of Fig. 12, over the time, show a higher sensitivity to the corrosion due to the different exposition to the atmospheric conditions.

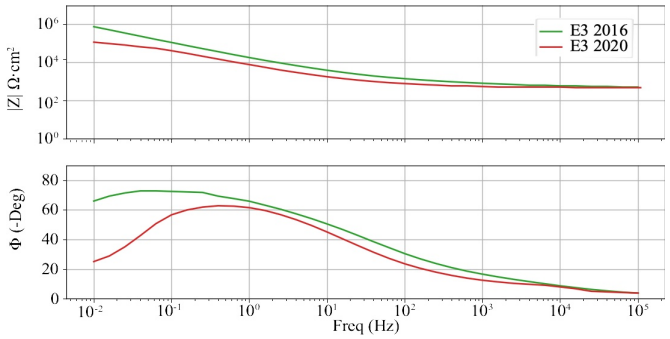
Fig. 12. EIS measurements collected in 2016 and 2020 on a weathering steel structure in the exterior part of the building.
