Damage of repeatedly nitrocarburised steel dies for aluminium extrusion

# Damage of repeatedly nitrocarburized steel dies for aluminium extrusion

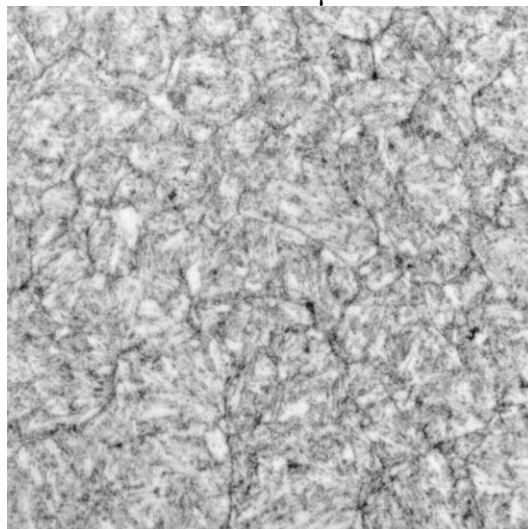
Fig. 2 – Core microstructure of the C die (tempered martensite), Cogne etch.

The substrate microstructure (as evaluated several millimetres below the nitrided case) was tempered martensite in all cases, with partially evident previous austenitic grain boundaries, (Fig.2). The substrate hardness was 561 and 543 HV respectively, in the A and B dies, corresponding to a 4 hour temper at approximately 570-580 °C[7,8,35], whereas it was 441 HV in the C die, tested at the

end of the entire service life. Thus the dies' bulk microstructure undergoes a sensible softening due to the long exposure at the service temperatures, as foreseen on the basis of a much larger Hollomon-Jaffe parameter[36]; this softening is consistent with previous results, obtained from microstructural examinations[37], softening tests[8,9], and actual dies[5].

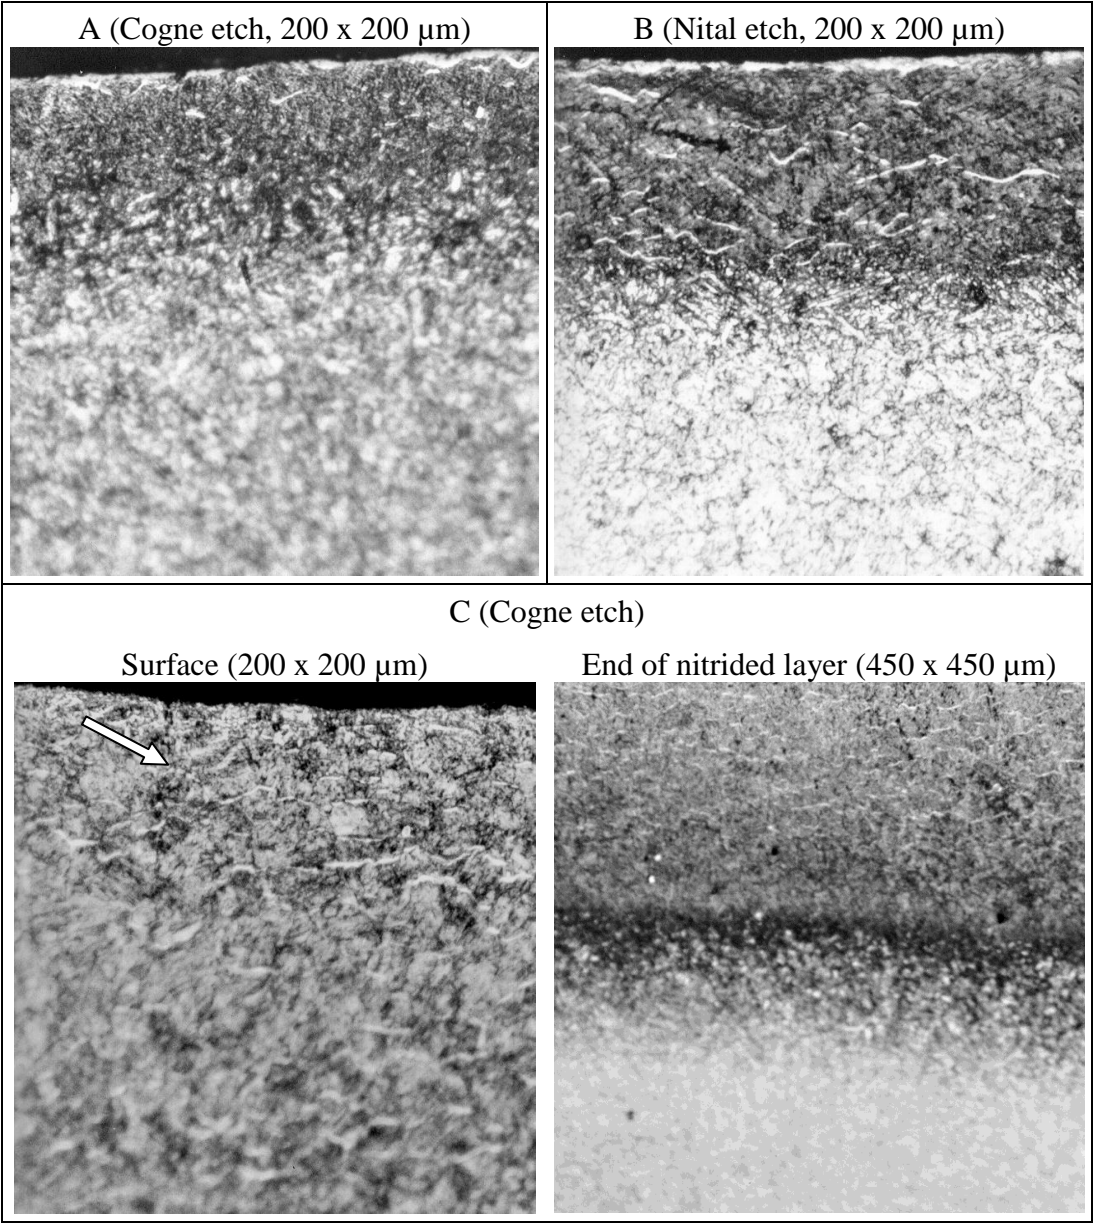
The maximum measured case hardness was 976, 894 and 918 HV, respectively, in the A, B and C dies (at about 35 μm from the surface). A white top surface layer, of the order of 10 μm thick (Fig. 3), was evidenced by the metallographic examination at the nitrocarburized bearing surfaces of the dies A and B. Consistently with the employed nitrocarburizing process[12,14,17], the top layer consisted almost completely of the ε phase ( Fig. 4). Overall, the as-fabricated maximum case hardness and top layer structure and thickness are compatible with those previously observed in the same steel after liquid nitriding[3] or nitrocarburizing[13] processes.

The diffusion layer depth observed in the metallographic cross-sections (Fig. 3) was about 75 and 100 μm, respectively, in the A and B dies, but it was much larger in the C die. The effective depth, defined as the depth where hardness is 100 HV units higher than at core[38], was 458 μm in the C die, as opposed to 124 and 118 μm, respectively, in the A and B dies (Fig. 5). Thus, the well-known square root proportionality[25,27] is substantially respected, the case depth ratio of the as-fabricated and end-of-life dies being 3.69 (458 μm / 124 μm), only slightly higher than the square root ratio of their cumulated nitrocarburizing times (i.e. of their numbers of equal-duration nitrocarburizing stages), that was 3.46 ($\sqrt{12}$). It is inferred that, after each nitrocarburizing stage, the observable case depth depends upon the cumulated nitrocarburizing time, notwithstanding the intermediate service time.

The comparison of the metallographic cross sections reported in Fig. 3 show that the homogeneous wear of the top layer was negligible after 23 press cycles in the once-used die, but it was sufficient to completely remove the top layer from the bearing surface of the end-of-life die, probably because the last service stage of the latter die was much longer (155 press cycles).

Microcracks connected with the bearing surface were evident in metallographic cross-sections (Fig. 3C and 6C) and in some cases nitrides and carbonitrides had been formed at the microcrack surfaces (Fig. 6C). Although these compounds may initially provide a form of beneficial crack closure, their comparative brittleness (in respect to the surrounding steel) probably enhance the crack propagation rate until the crack tip overcomes the transformed region; thus, the net effect of each re-nitrocarburizing stage upon the overall growth of the fatigue microcracks is uncertain, but probably small.

Fig. 3 – Nitrocarburized layer at the bearing surfaces of the dies A (as fabricated and nitrided), B (after one production run), and C (at end of life). Top layer and diffusion layer in the A and B dies. Thick diffusion layer, without remaining top layer, in the C die. Grain boundary precipitates in the B and C dies. Microcrack (arrow) in the C die.

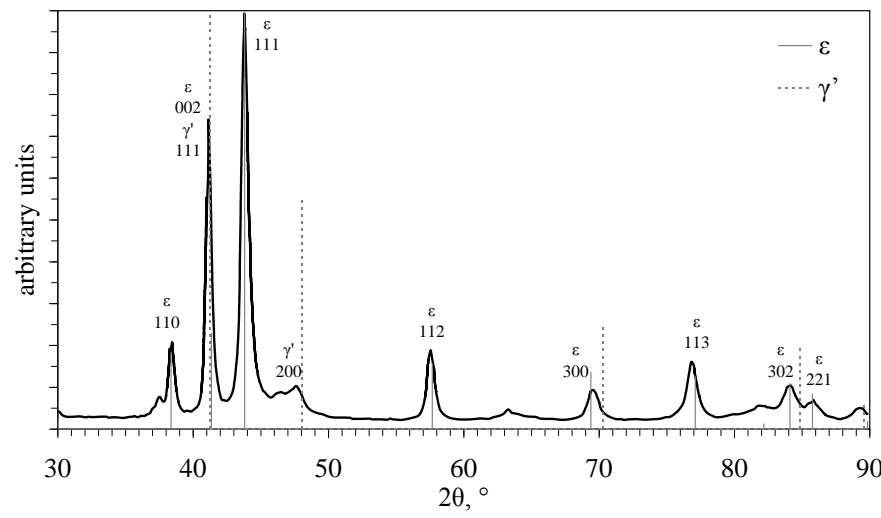
Fig. 4 - X-ray diffraction angular profiles of the bearing surface of the A die; theoretical diffraction angles of the ε and γ' phases.

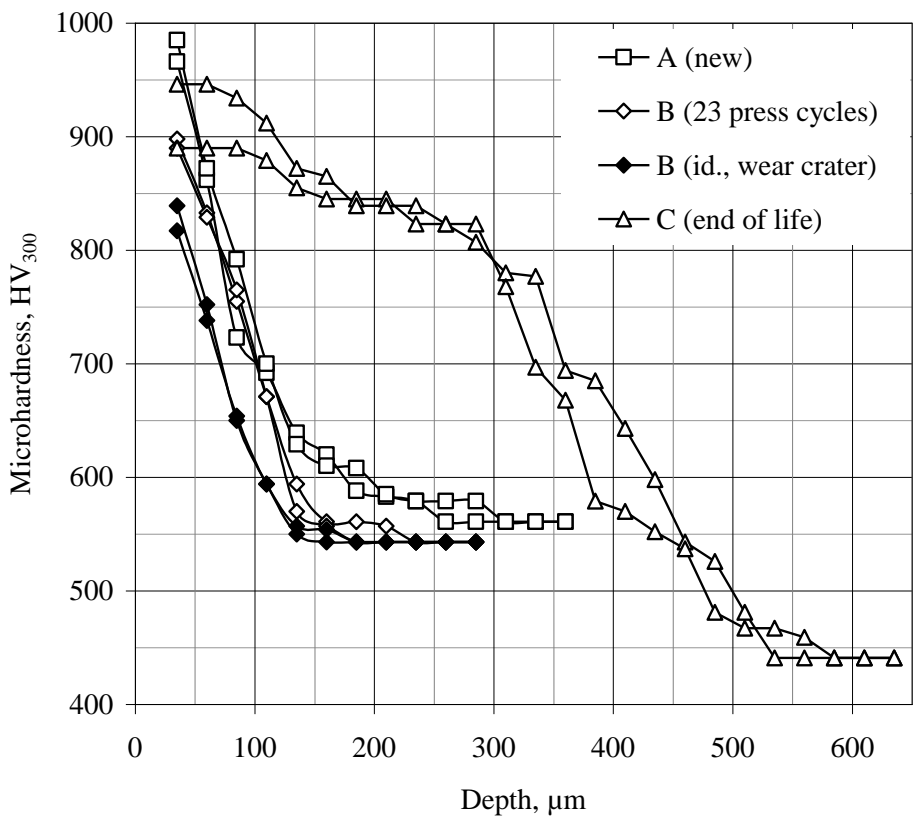
Because the die tempering, nitrocarburizing, and service temperatures are expectedly close one to the other (at least near the bearing surface as it regards the service temperature), a microstructural evolution can be foreseen during the die service stages, not only in the substrate (as noted above), but also in the nitrided case. The substantial constancy of the metallographic case depth and of the microhardness profile shape (Fig. 5) before and after the first service stage (A and B dies) implies

that the inward in-service N diffusion was modest and consistent with previous results[24], probably because most N atoms were bound in alloy-element nitrides[21,26], and the inward diffusion of those dissolved in the matrix was hindered by the competition with nitride-precipitation phenomena (discussed below). Nevertheless, grain boundary precipitates, either parallel or at small angles in respect to the surface, were observed in the diffusion layers of the B and C dies, but not in the as-fabricated A die ( Fig. 3), and the B die hardness profile was 30 to 80 HV units lower than the A die one throughout the diffusion layer (Fig. 5).

Fig. 5 – Microhardness profiles of a bearing surface of the examined dies: as fabricated and nitrocarburized (A die); after one production run, both below an undamaged area and below a wear crater (B die); at the end of the useful tool life, after repeated nitrocarburizing and production stages (C die).

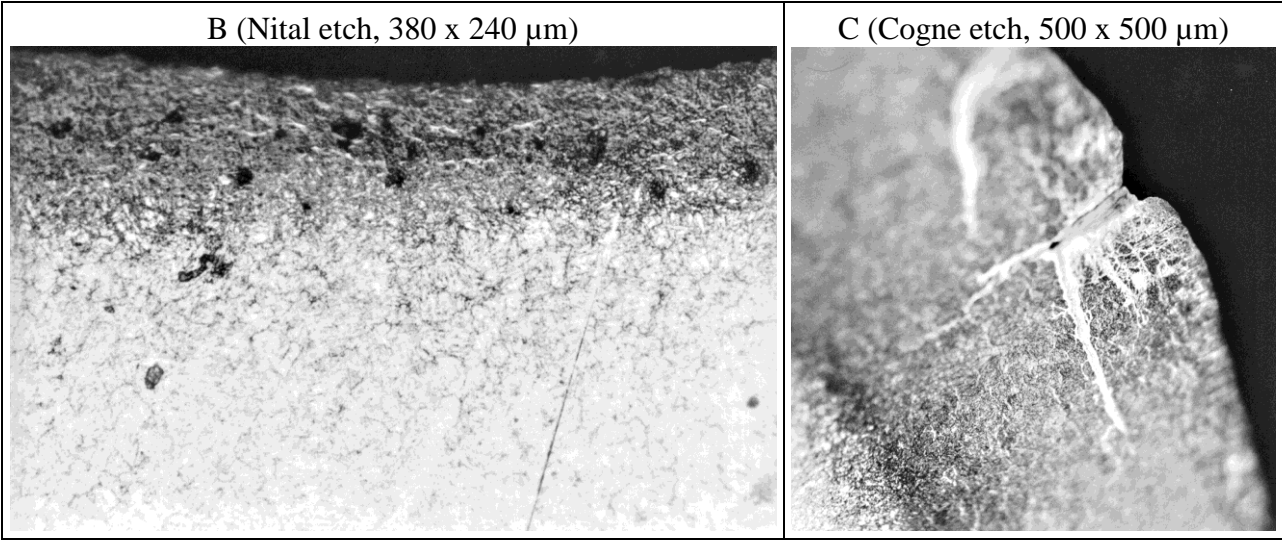
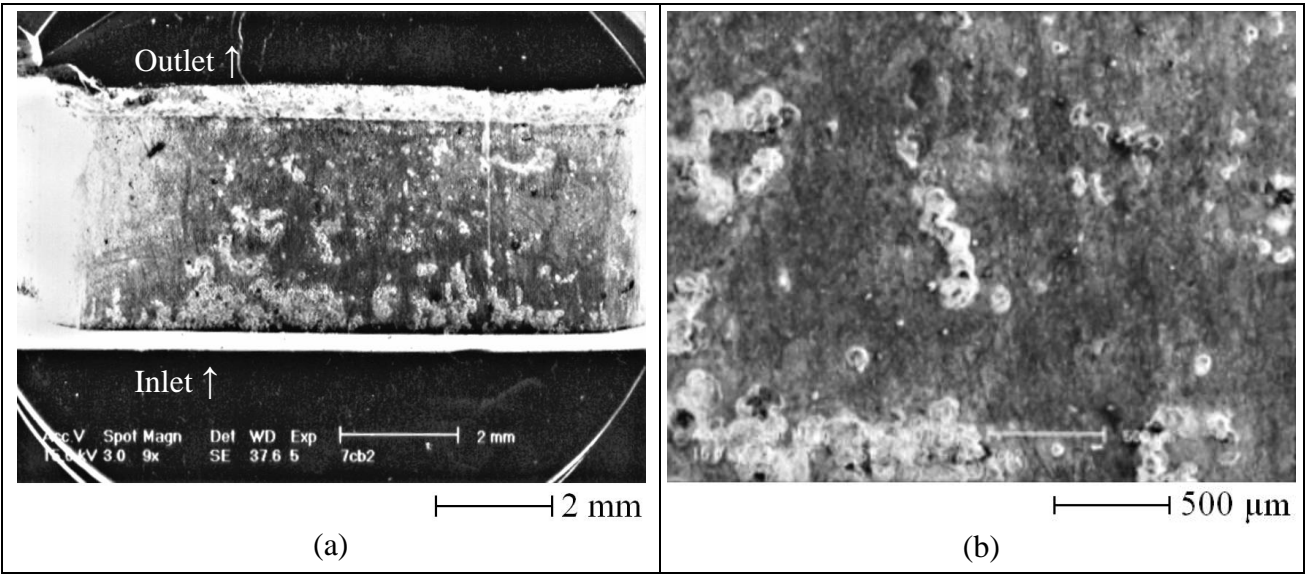
The bearing surface after service, as observed in the B die, presented discrete (inhomogeneous) wear craters (Fig. 6B and 7), typically 15 to 30 μm deep (as evaluated either optically, Fig. 6B, or

Fig. 6 - Damage mechanisms at the bearing surfaces evidenced on metallographic cross-sections. Wear crater in the B die after one production run (B). Microcracks in the C die after repeated nitrocarburizing and service stages, with white-etching regions intruding towards the interior along previously formed cracks (C).

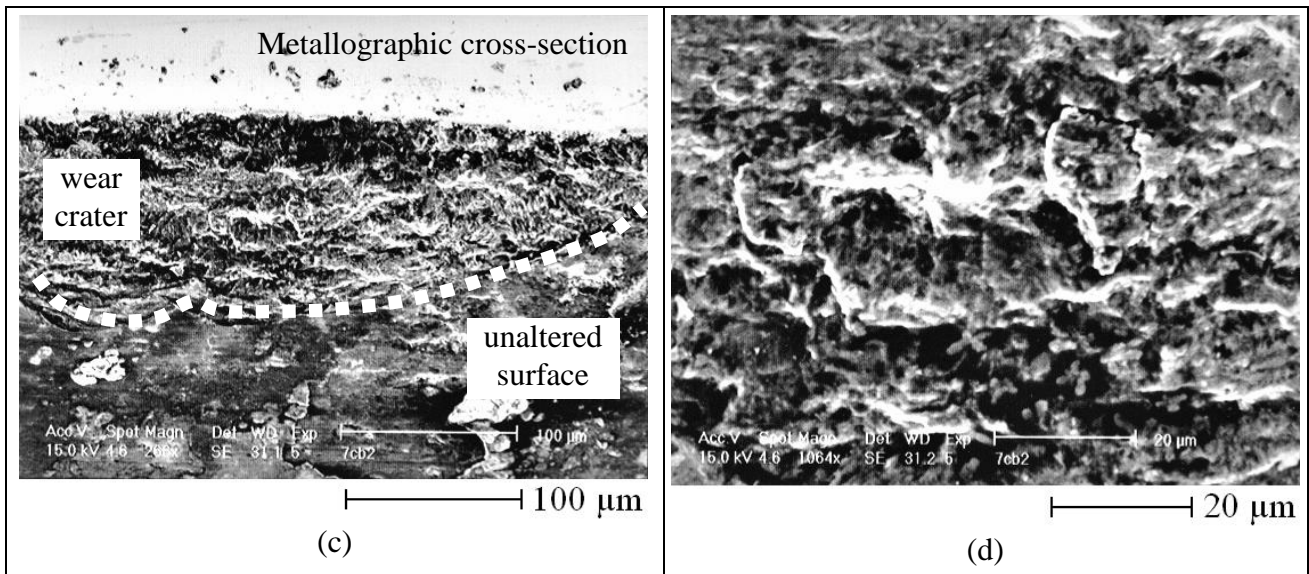
from the microhardness profile offset, Fig. 5), which prevalently occurred close to the bearing inlet (Fig. 7a,b). This distribution is consistent with the abovementioned adhesive wear mechanism, because in the inlet region, as opposed to the outlet one, the contact between the aluminium and the tool is characterized by a higher pressure (directly due to the extrusion forces, or residual during the extrusion interruptions) and by the absence of the oxide layer developed further on upon the aluminium surface. Moreover, the inner surface of the wear craters (Fig. 7c,d) showed microvoids, whereas the bearing surface outside them was comparatively smooth (Fig. 7c). This fact and the observation of several surface microcracks with different lengths confirm that the wear craters arose from discrete fracture events, occurring when a fatigue microcrack reaches a critical size.

Fig. 7 – Bearing surface of the B die. Distribution of the wear craters along the bearing channel (a) and mid-point detail (b). Surface appearance of a wear crater and of the surrounding unaltered area (both cross-sectioned by a metallographic cut, c). Higher magnification of the inner surface of the same wear crater (d).

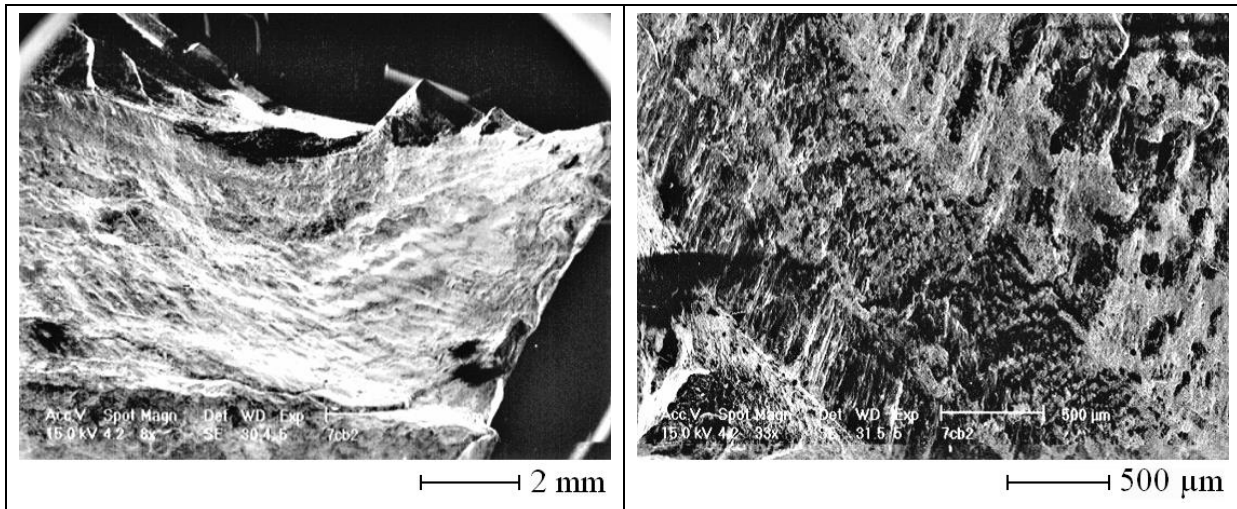
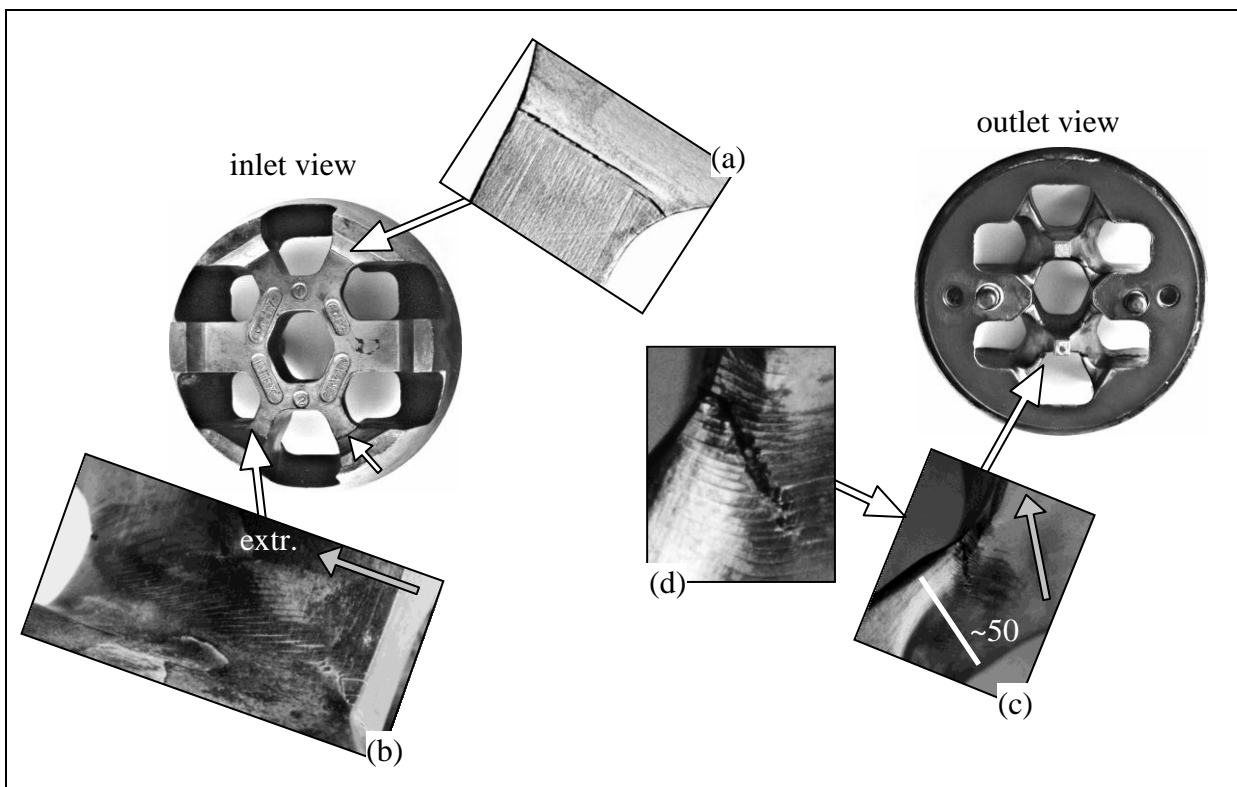
Several macroscopic fatigue cracks were developed in the smaller bridges of the C mandrel, within macroscopic plastic zones showing parallel surface marks (Fig. 8). Because the number of press cycles in a die life is of the order of $10^3$ only, these cracks pertain to the domain of low-cycle fatigue, and occurred by large advancements.

Some cracks started from bridge surfaces faced to extrusion dead metal zones at the mandrel's inlet (Fig. 8a,b), and showed a plastic zone extended trough the whole bridge thickness (Fig. 8b) corresponding to generalized yielding of the bridge, thus not only the fatigue cracks reduced the mandrel stiffness, but also the bridge plastic deformation contributed to deteriorate the mandrel shape, and ultimately both contributed to critically modify the extrudate geometry.

A macroscopic spalling area close to the abovementioned plastic zone (Fig. 8b) may have been induced by the inability of the nitrided case to deform with the substrate.

Other cracks started at the mandrel's outlet (Fig. 8c) and showed a serrated path with steps dictated by surface marks (Fig. 8c,d).Moreover, the not oxidized (inner) part of the examined crack surface presented large striations (Fig. 8e,f), consisting of alternated tearing and shear regions (Fig. 8f). This allows to hypothesize that the crack advancements occur alternatively by plastic tearing (at press-cycle starts, when the load is first applied) and by plastic shearing across or along previously formed localized shear bands, which are evidenced by the abovementioned surface marks.

Fig. 8 – Fatigue cracks and plastic deformation surface marks at end-of-life in the smaller bridges of the C mandrel. Cracks originating from inlet dead metal zones (a,b); deformation marks extended throughout the bridge thickness (b); crack originating from the outlet extrusion welding zones (c), with surface steps of the order of 1 mm (d). Fatigue beach-marks on a crack surface (SEM, e) and detail showing alternated tearing and shear regions (f).

Some fatigue cracks were developed from surfaces scarcely subjected to wear damages (e.g. surfaces facing dead metal zones), that had been re-nitrocarburized although their top layer was probably unaltered. Albeit this fact in part arises from the design of the examined die, it suggests that selective re-nitrocarburizing treatments may be tried to prevent the excessive increase of the case depth in these zones.

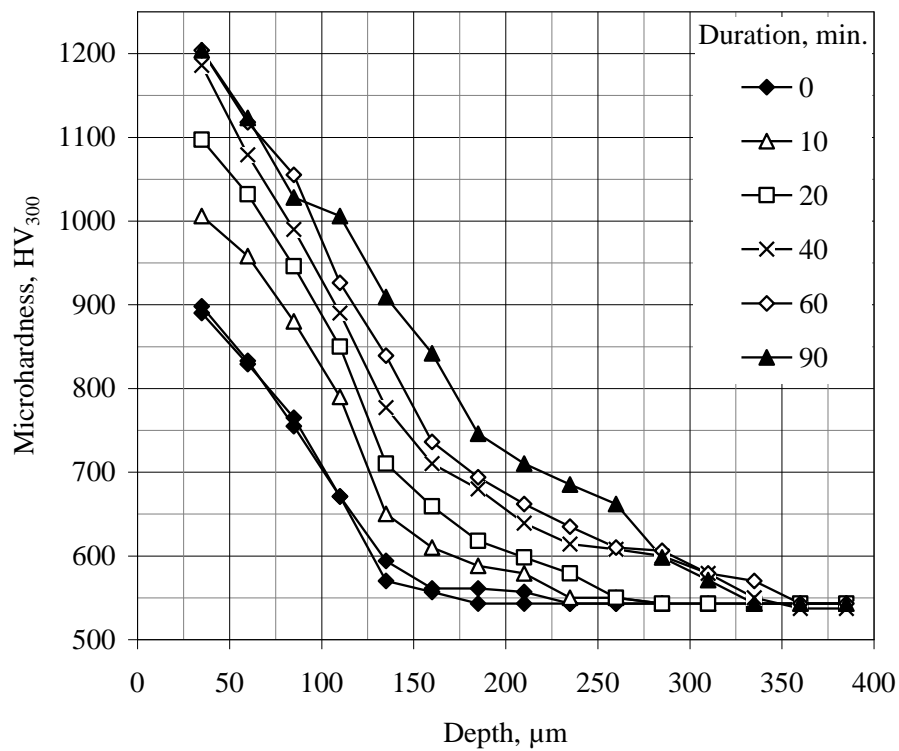
Representative microhardness profiles obtained after the re-nitrocarburizing tests are shown in Fig. 9. The maximum measured diffusion layer hardness increased continuously with the re-nitrocarburizing time, from the original 894 HV to a maximum of 1204 HV after the 90 min test, while the hardness gradient was almost unaltered (Fig. 9). The case depth increase was more rapid (on the basis of the square root relationship) than observed in the die nitrocarburizing stages, perhaps because the salt bath recirculation was better around the sectioned samples than inside the narrow die bearing channel; thus, each re-nitrocarburizing test represents a somewhat longer die re-nitrocarburizing stage.

Fig. 9 - Microhardness profiles of samples taken from the B die bearing surface area, after one production run; before (0 min) and after re-nitrocarburizing tests of increasing duration.

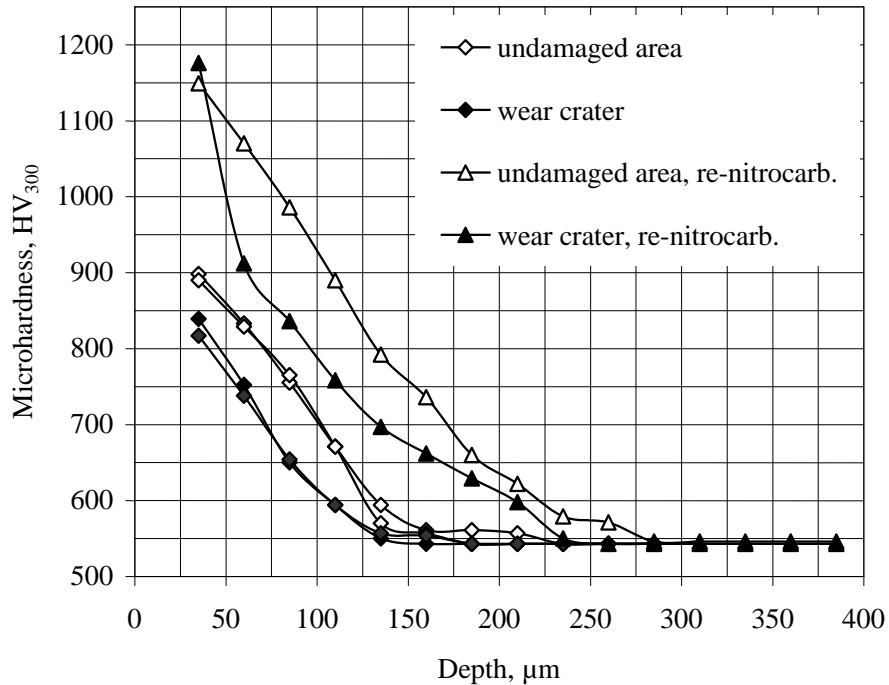
The microhardness profile below a previous wear crater, examined after the 30 min re-nitrocarburizing test, presented a larger hardness increase and a steeper hardness gradient, than below the undamaged areas (Fig. 10), the N intake being expectedly somewhat faster because surfaces free from the top layer were exposed[40,12].

Fig. 10 - Microhardness profiles of samples taken from the B die bearing surface area, after one production run, before and after the 30 min re-nitrocarburizing test, below an undamaged area and below a wear crater.

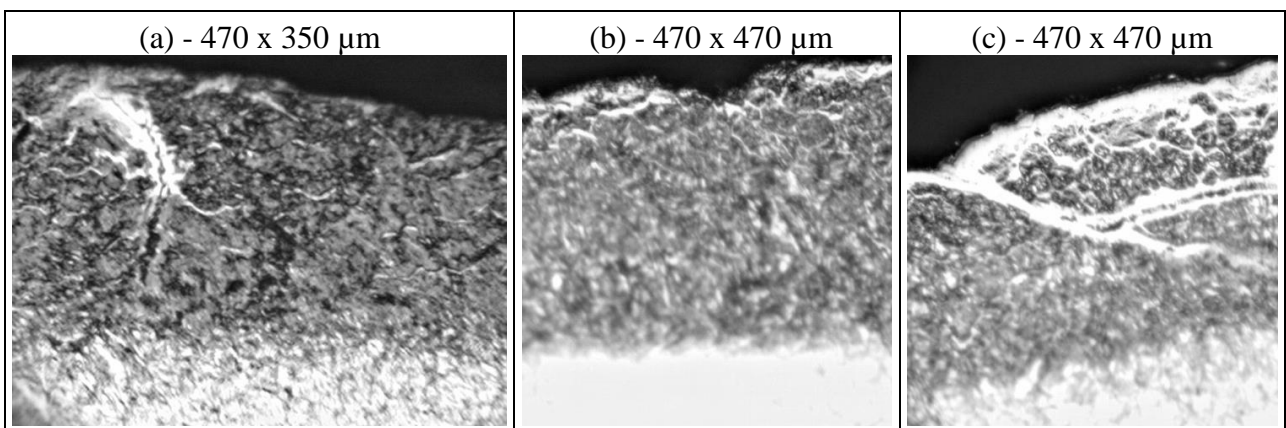
Generally, the top white layer was more rapidly formed inside the microcracks (due to the previous service stage) than on the surface of the wear craters: it was already observed inside one microcrack after the 10 min test (Fig. 11a) and several similar cases where observed after longer durations (Fig. 11c); this may happen because the salt bath infiltrates the microcracks, or because they influence the N diffusion paths. Instead, some wear craters did not yet showed a continuous newly formed top layers after the 50 min re-nitrocarburation test (Fig. 11a,b); this may arise from the presence of oxides or other impurities, that, prior to re-nitrocarburizing, are not as easily removed from the rough bottom of the wear craters as from the rest of the bearing surface.

Fig. 11 - Metallographic cross-sections of the B die bearing surface, after a service stage and re-nitrocarburizing tests of increasing duration. 10 min test: white layer formed in a microcrack (a, left), but not yet on a previous wear crater (a, right). 50 min test: white layer not yet completely formed on a wear crater (b). 70 min test: evident white layer at the surface and inside the microcrack (c).

Thus, re-nitrocarburizing stages shorter than those employed would probably not be sufficient to reform the top layer, and, consequently, the formation of nitrides and carbonitrides inside the microcracks appears unavoidable in the examined industrial practice.
