AE monitoring and structural modelization of the Asinelli Tower in Bologna

Stefano Invernizzi[1], Giuseppe Lacidogna[1], Gianni Niccolini[1], Amedeo Manuello[1], Alberto Carpinteri[1]

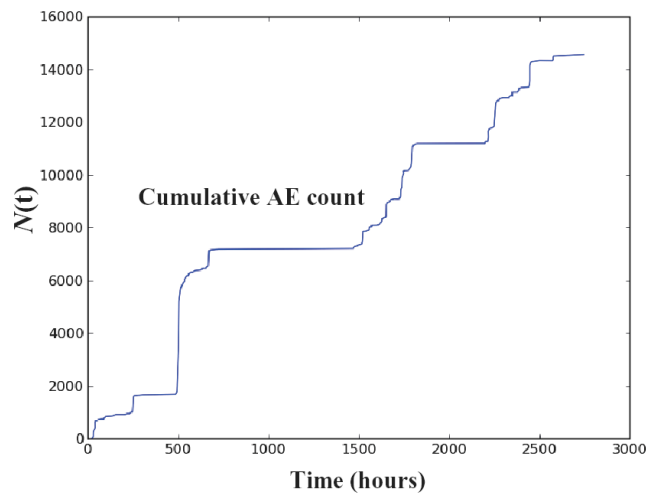
From the curve in Fig. 6 it can be seen that the masonry is actually undergoing a damage process. The plot of the cumulative AE count, in fact, is characterized by jumps reflecting sudden increases in N that are seen to occur at certain time intervals. The discontinuities in the cumulative AE count curve denote the critical moments during which the release of energy from the microcrack formation process is greatest.

Figure 6. Cumulative AE count based on the data collected at the northeast corner of the tower, from 5:40 PM of 23 September 2010, to 1:00 PM of 28 January 2011.

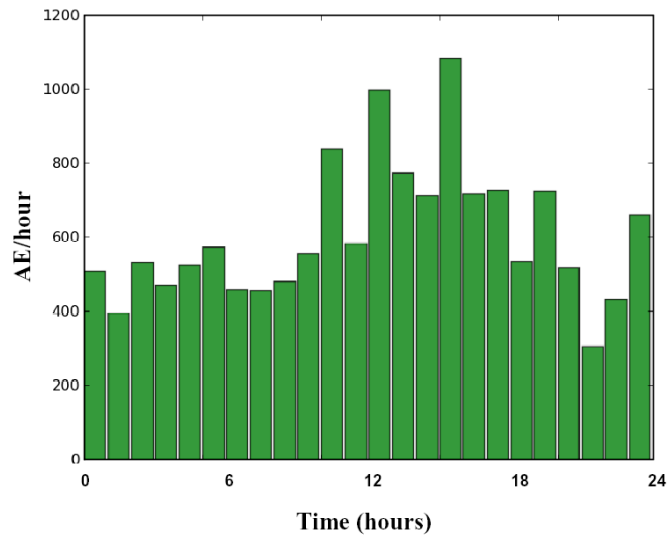
The AE count hourly distribution chart over a 24 hour time span, as determined for the entire monitoring period, is shown in Fig. 7.

Figure 7. AE count hourly distribution chart over a 24 hour time span, as determined for the entire monitoring period.

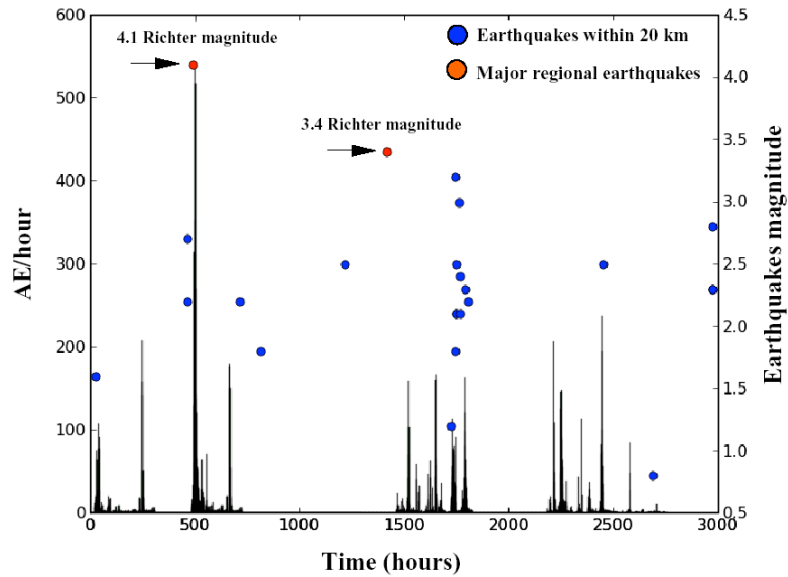
Fig. 8 reveals a *correlation between the AE events recorded experimentally and the seismic events*. As can be seen, in fact, the energy peaks measured through the AE count rate almost invariably occurred during a seismic event. In particular, the highest AE count peak (ca 500) was detected on 13 October, at 11:43 PM, when the Rimini area was hit by the 4.1 magnitude quake. Hence, this seismic event is the pulse phenomenon that resulted in the highest damage effect on the tower.

The second strongest earthquake, i.e., the 3.4 magnitude quake that hit the Modena Apennines on 21 November at 4:10 PM, does not introduce any significant change to the chart shown in Fig. 8, since the AE activity detected during this event was rather limited.

Figure 8. Historic series of the AE differential count and the earthquakes detected within a 20-km radius from the Bologna city center. The chart also shows the two strongest regional earthquakes, which occurred in Rimini area and in the Modena Apennines. This chart refers to the entire monitoring period.

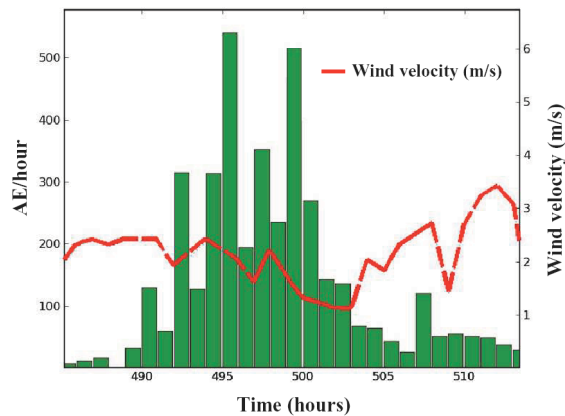
Figure 9: AE rate and wind velocity measurements during the monitoring period in a time window of 30 hours just after the earthquake of 13 October 2010.

In the chart of Fig. 9 are represented in detail the AE count rate and the wind velocity in a time window of 30 hours just after the earthquake that hit the Rimini area on 13 October 2010. The graph shows that the peaks in the AE count rate do not correspond with those of the wind velocity.

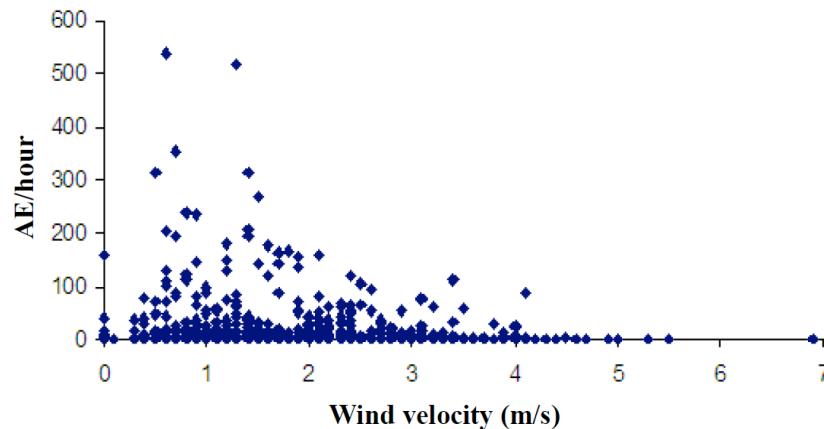
Moreover, the chart of Fig 10 relates the wind velocities and the AE count rate obtained during all the monitoring period (2915 hours). This graph makes clearer that the two phenomena are completely statistically unrelated.

Figure 10: Chart relating the wind velocity and the AE count rate during all the monitoring time, the two time series seem to be statistically unrelated.

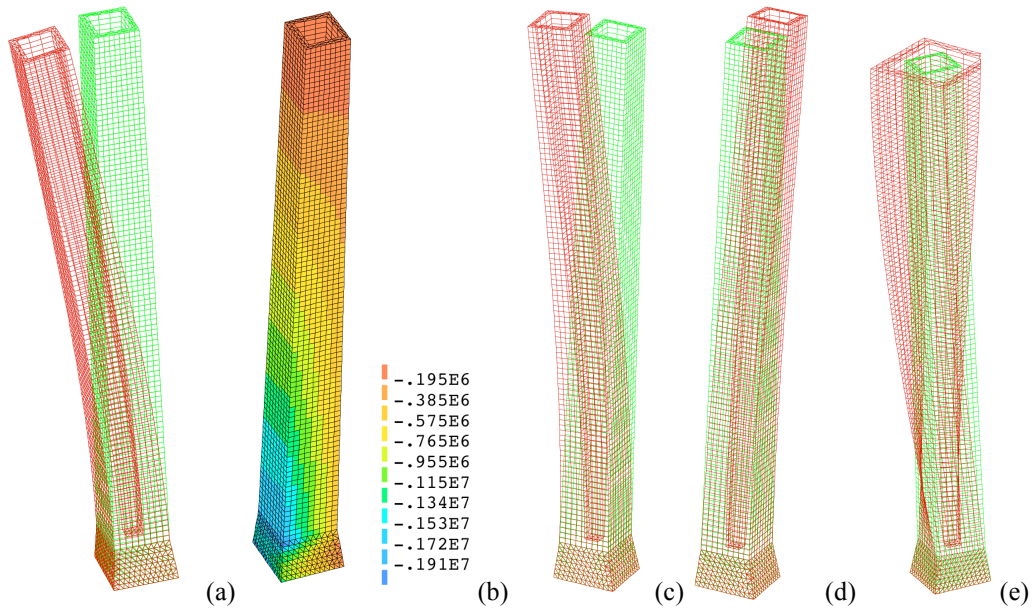
The preliminary linear elastic analysis considered only the self-weight of the tower (Fig. 11a). It was possible to assess that the elastic deformation of the tower is about 8 cm, which is about 1/30 of the present total deviation from verticality.

The level of stress in the masonry of the tower (Fig. 11b) is generally low, although in proximity of the monitored area, the level of vertical stress approach 2.1 Mpa, which can be critical in case of very poor masonry.

The preliminary modal analysis showed that the first mode is bending in the west-east plane, with a resonance frequency of 0.357 Hz (Fig. 11c). The second mode is bending in the orthogonal plane, with an eigen-frequency equal to 0.365 Hz (Fig 11d). The third eigen-frequency is 1.75 Hz, and the fourth is 1.78 Hz. The fifth mode is torsional (Fig. 11e) with an eigen-frequency of 3,07 Hz. Those results agree quite well with more detailed dynamic analyses carried out by other Authors [11].

The maximum vertical stress in the tower is compatible with the acquire rate of acoustic emissions from the monitored region. The fact that the first modal shape tends to increase the stress in the same area agrees well with the increase of acoustic emissions connected with seismic events.

Figure 11. Deformation due to the effect of gravity (a); vertical stress expressed in MPa (b); first modal shape (c); second modal shape (d); fifth modal shape (e).
