Techniques and Experimental Results for Performance Analysis of Photovoltaic Modules Installed in Buildings

8th International Conference on Sustainability in Energy and Buildings, SEB-16, 11-13 September 2016, Turin, ITALY

F. Spertino [a]*, J. Ahmad [a], A. Ciocia[a], P. Di Leo[a]

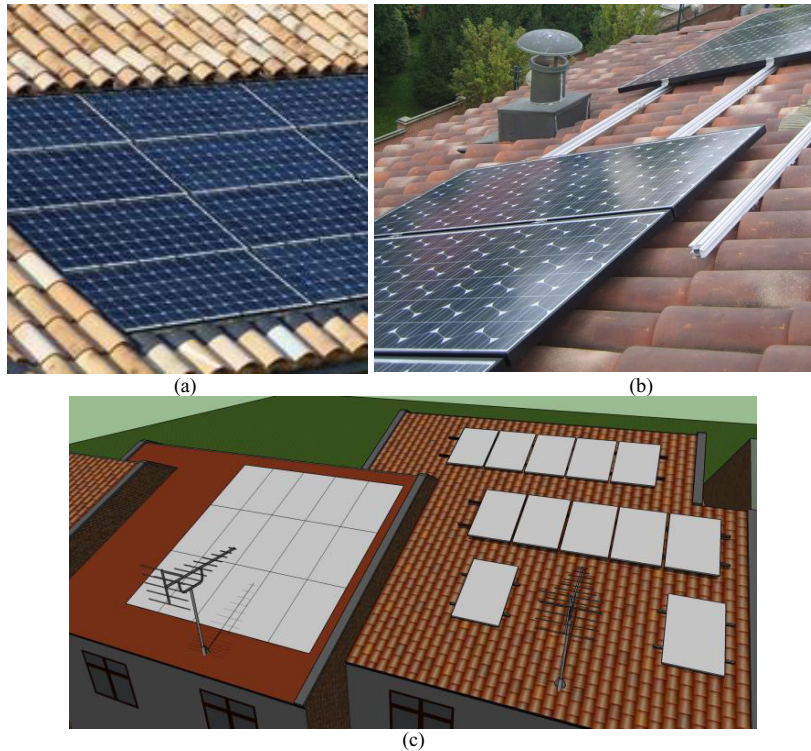
- It is necessary to install the conventional PV modules above a waterproof and thermally insulated layer, because they are not waterproof, if placed close each other at the same height of the roof tiles. This type of installation (called in Italy "totally integrated" Fig 1a) exhibits, thus, *poor ventilation*. Furthermore, the tiles may carry dirty rain and dust on the PV modules, if the tiles are at a higher level than the PV modules (Fig. 1a). This implies a *major impact of dirt* with respect to the installation above the tiles thanks to metallic structures with brackets (Fig. 1b called in Italy "partially integrated").

- Sometimes obstacles are present on the roof or near it: they may be chimneys, antennas, poles and masts. They can create *partial shading* on the PV array during the day. Continuous shadowing is source of both hot spots in the PV cells and long operation of bypass diodes. In Fig. 1c, an antenna creates partial shading on two of the 15 PV modules regularly placed to form a rectangle (left side). A solution is the installation of fewer modules with higher efficiency (e.g., heterojunction of monocrystalline and amorphous silicon) [3], as shown in the right side of the same figure.

Fig. 1. PV modules on rooftop in "totally integrated" version (a), in "partially integrated" version (b) and their comparison (c).

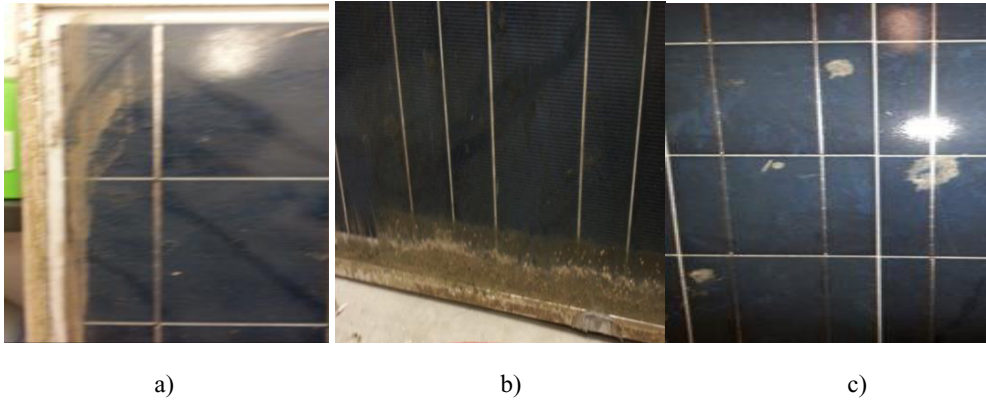
Fig. 3. Group #1: PV modules affected by extreme dirt (a) (b) and bird droppings (c).

- extreme dirt on all the surface of the modules with high concentration close to the edge of the metallic frame (Fig. 3a and 3b) and many bird droppings (Fig. 3c);
- possible mechanical damage (shoe footprints were detected on the glass surface during inspection);
- snail tracks on many solar cells.

Regarding the dirt impact, the *I-V* scan was performed before and after cleaning. The measurement of the *I-V* curves and correction to STC have highlighted that the maximum power $P_{mpp,c}$ of dirt modules were much lower than the declared values $P_{mpp,d}$. The values of ΔP_{rel} ranged from -31% to -53%, corresponding to $P_{mpp,c}$ values between 107 and 157 W. After cleaning, ΔP_{rel} decreased and ranged from -21% to -48%, corresponding to $P_{mpp,c}$ values between 118 and 180 W. As in [11] and [12], losses due to dirt sometimes can be ≥4%: in this case, they ranged from -4% to -10% and the average was ≈7%.

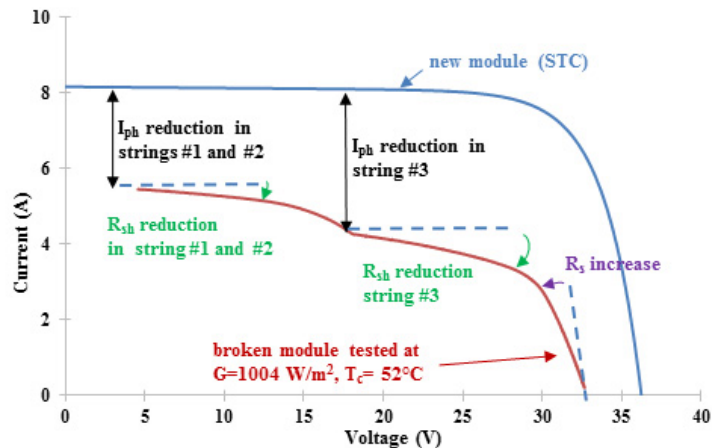
As written before, the modules were affected by snail-tracks and showed high underperformances, also after cleaning. The results of three tests on one of the PV modules are presented in Table 2: the maximum power was more than halved. The power loss is totally due to the high reduction of current: it decreased from 7.65 A (declared by manufacturer) down to ≈3.54 A (measured at STC), corresponding to a deviation ΔI_{mpp}≈-53%. In Fig. 4 the I-V curve of test #2 is compared with the I-V curve at STC declared by manufacturer. Experiments are performed at irradiance G≈G_{STC} and at cell temperature (T_c=52°C) higher than T_{STC}. For this reason the open circuit voltage (V_{oc}=32.82 V) of the defective module was lower than the declared value ($V_{oc,d}$=36.2 V). The main issues in the I-V characteristic were the following:

- current I_{ph} was strongly reduced for each string of cells with #3 as the worst string;
- the lowest current (string #3) caused discontinuity in the slope of the I-V curve, corresponding to the voltage of two 20-cell strings as a consequence of the bypass diode conduction;
- slope of the I-V curve near I_{sc} higher than the normal slope, corresponding to a decreased R_{sh} value;
- slope of the I-V curve near V_{oc} lower than the normal slope, corresponding to an increased R_s value.

Fig. 4. Comparison between the *I-V* curves of a new module at STC and a broken module during test.

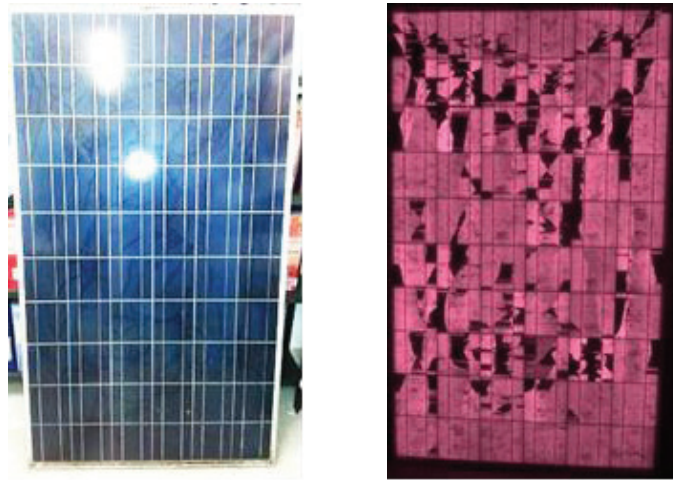
In order to check the presence of mechanical defects in solar cells, the electroluminescence test was performed. The results demonstrated a high number of cracks and isolated portions of cells in each module: these defects were observed mainly along snail-tracks, which affect at least 24 cells in the least damaged module up to all the cells in the worst one. The image, related to one of the analysed modules (Fig. 5), is representative of the whole group of 10 modules: broken cells were many and randomly distributed. Generally, a uniform distribution of cracks occurs when a heavy distributed load (like snow) is on the whole front of the module [14]. The abovementioned presence of shoe footprints on the glass surface, the absence of broken cells in new modules and the random distribution of cracks confirmed that they were stepped on during maintenance (or installation). The electroluminescence indicated the presence of cracks and inactive parts of cells. When a cell is broken, parts of it can be disconnected from the circuit and becomes inactive. The result, in the equivalent circuit, is a decreased current I_{ph}, proportional to the active area.

As written in [15], cracks are localized in the emitter region of the solar cells and act as a shunt. They can be modelled as additional low parallel resistances inside the cells (called volume shunts) between the sides of the p-n junction. The creation of further paths for the leakage current is modelled with a decreased R_{sh} value. The partial disconnection of a busbar provokes a dark colour in the portion of the cell where the busbar collects the photovoltaic current, while the other portion of the cell appears more bright than a normal cell. The result is an increment of R_s.

Fig. 5. Photo and electroluminescence image of a PV module of the group #1.

As a result of preliminary study of underperformance, two groups of PV modules on rooftops were identified. The first group was selected from PV systems affected by the presence of snail-tracks, extreme dirt and bird droppings. The scanning of the *I-V* curve was performed before and after cleaning and results were compared. By itself, the dirt caused in average power losses 7% with a peak of ≈10%. After cleaning, power losses due to other causes ranged from 21% to 48%. The results of electroluminescence demonstrated a high number of cracks randomly distributed and isolated portions of cells where the snail-tracks were present. The cause was: PV systems installed without walkways and workers' stepping on them during maintenance. The consequent power losses advise the replacement of the PV modules.

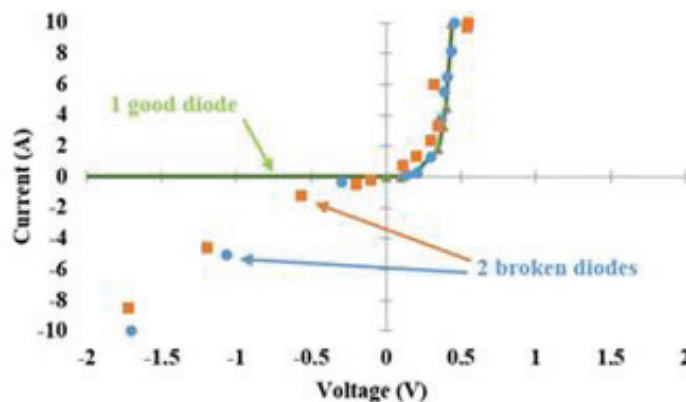
During the inspection, the modules in group #2 exhibited negligible open circuit voltage and short circuit current, while the junction-box covers were extremely hot. After removal of the junction-box covers, most of the bypass diodes had changed their original black colour into an opaque brown colour. Thus, all the bypass diodes were disconnected. They were supplied by a regulated power supply and some points of the *I-V* curve were measured. Most of the diodes revealed irreversible short circuit failure: at least two diodes per each module were broken. As shown in Fig. 6, the *I-V* curves of broken diodes affected by overheating corresponded to low resistances (≈400 mΩ) in both the quadrants. The typical unidirectional behaviour of a diode was no longer verified.

Fig. 6. Result of I-V test on three diodes: 1 well working and 2 affected by overheating.

The second group of tested modules were selected from PV systems affected by partial shading and poor ventilation. During the inspection, the PV modules exhibited negligible open circuit voltage and short circuit current. Moreover, the junction-box covers were extremely hot. After removal of junction-box covers, it was observed that many bypass diodes had changed their original appearance. The *I-V* curves of all the diodes were scanned: most of them revealed irreversible short circuit fault. On the contrary, the *I-V* scanning of PV modules without diodes exhibited maximum powers within the declared values at STC and the EL tests clarified the absence of cracks. In this case, the simultaneous presence of partial shading and poor ventilation, for the PV modules applied to the rooftops, provoked the fault of bypass diodes. After diode replacement, the PV modules can return to work.
