High Voltage Temperature Humidity Bias Test (THB) customized system and methodologies for reliability assessment of power semiconductor devices

High voltage temperature humidity bias test (THB) customized system and methodologies for reliability assessment of power semiconductor devices

D. Cimmino[a,b], R. Busca[a,b], S. Ferrero[a], F. Pirri[a], G. Richieri[b], R. Carta[b]

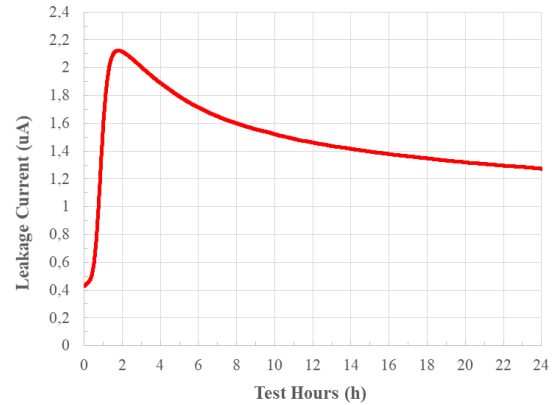
A typical curve of 650V with 80% voltage rating applied is reported in Fig. 3. At the beginning of the test, all devices exhibit a slow initial increasing and decreasing evolution of the leakage current. This phenomenon can be attributed to moisture penetration and interface charge relocation, and in particular to local charge distribution inside the termination of the devices, when interacting with the applied electric field. After the initial phase, typically lasting around 10 h, all devices stabilize asymptotically toward a stable current level.

Fig. 3. Leakage current evolution in the first 24 hours of the test for a 650V diode polarized at 80% V_{nom}

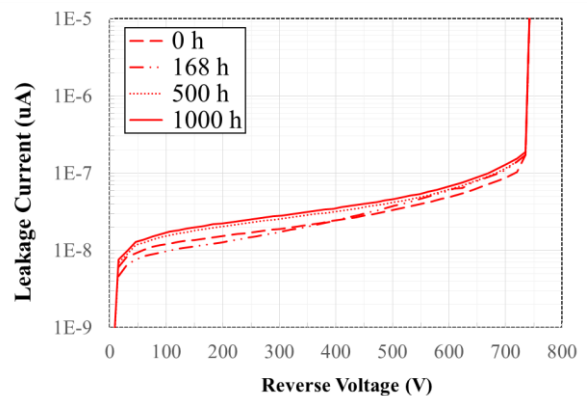
Fig. 4. I-V reverse characteristic of a 650V diode, tested at 0h, 168h, 500h and 1000h, exhibiting no electrical degradation.

During the test, the monitoring presented a stable leakage current level up to 1000h. This stability is then confirmed by the curvetracer analysis, the shape of the characteristic remains the same even after 1000h of testing, and further optical and SEM inspections confirm the absence of morphological or physical wear of the device.

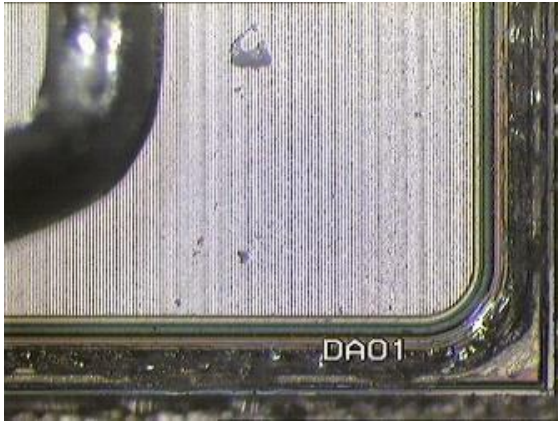
Fig. 5. Optical inspection of a 650V tested diode after 168h at 80% V_{nom} shows consistent lifting of the secondary passivation layer on the whole device edge termination, due to moisture penetration.

allowing for a more accurate failure analysis of the DUTs. After the initial testing, the analysis flow continues with an optical inspection of the selected DUTs, followed by a FIB/SEM analysis. One example of optical inspection is reported in Fig. 5, performed on a DUT failed at 168h. In such case, the leakage monitoring shows electrical degradation, but only due to the inspection we can link this phenomenon to the consistent morphological variation of the surface. The curvetracer analysis also confirms a significant variation of the breakdown voltage (BV) limit of the reverse I-V characteristic.

This variation can be identified as the cause of leakage drift observed during the monitoring phase, confirming what has been evidenced in previous studies [6].

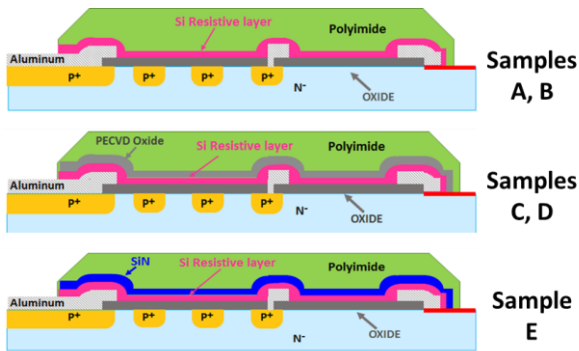
Fig. 6. Sample structures involved in the testing of passivation schemes resulting in the SEM/FIB analysis reported in Fig. 7. A combination of Oxide – LTO and resistive silicon is used as a primary passivation layer, while secondary passivation differs according to each device group. All samples have been realized with an upper polyimide layer, under which an additional insulating layer has been added, being PECVD Oxide for samples C and D, and SiN for sample E.

In sample A, device degradation is visible as polyimide lifting with the formation of "bubbles" on the surface of the die, as reported in Fig. 6. This effect is due to gas formation caused by electro-chemical migration phenomena at the interface between the resistive silicon and oxide layers. At high electric fields, a resistive silicon layer degradation appears to be the main factor of device failure, acting in combination with surface moisture permeating through the polyimide layer. Final degradation and expansion of the bubble can be attributed to the formation of leakage current paths generating additional stress due to joule heating. In sample B, which was hold in test for 300 hours, degradation is more severe and extending down to the aluminium metal field plate, where electrochemical migration generates erosion of the aluminum layer. Differently from sample A and B, optical inspection performed on samples C and D does not reveal any sign of physical degradation, for this reason a FIB/SEM analysis becomes fundamental in determining the fine details of failure mode, as expected by degradation of the characteristics seen during electrical testing. For the same reason, in samples C and D, it is possible to see the formation of holes at the interface between resistive silicon and oxide layers, appearing at the field peaking point of the termination structure.

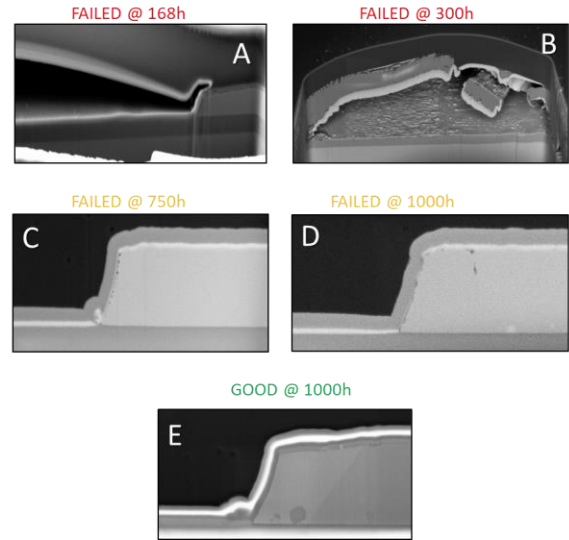
Fig. 7. SEM cross-section of selected DUTs termination. Both samples A and B show significant secondary passivation lifting, **which** involv**es** also the underlying layers. Samples C and D show small voids at the interface between primary and secondary passivation layers, while sample E shows no degradation at all.

In the case of sample E, electrical testing and optical inspection do not show any sign of degradation after 1000 hours of testing. This result is confirmed by the FIB/SEM analysis, and is justified by the presence of the SiN layer, which remarkably increases shielding against the combined effect of high voltage and humidity, enhancing the overall performance of the sample in HV-THB test and consequently its ruggedness.
