Residual Strength Evaluation for the Damaged Structures of Notre-Dame De Paris: A Way for a Correct Reconstruction

Amedeo Manuello Bertetto
Corresponding Author: Amedeo Manuello Bertetto

Keyword*: Notre-Dame fire; Lutetian limestone; Safeguard; Grid shell*

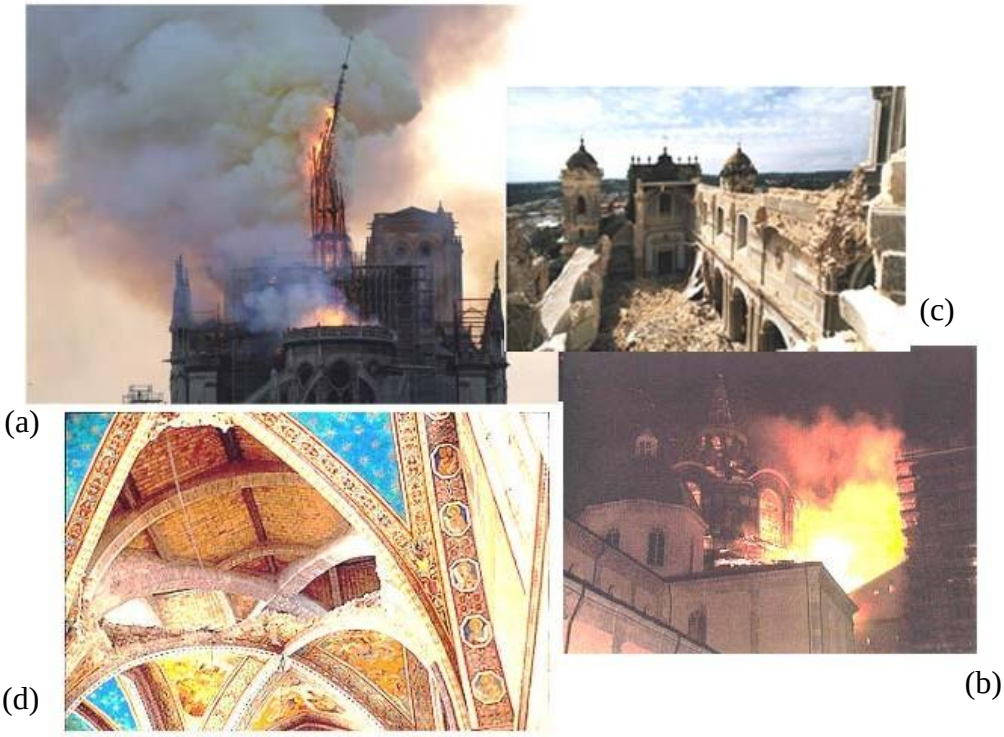
While the structures of Notre-Dame was burning, the collective memory ran to two past disasters that have marked the European religious and cultural conscience (Fig.1a). Three episodes which, for various reasons, have particular similarities with the tragedy of Notre Dame: The first is the burning of the roof of the Turin Cathedral – where the weel-known Holy Shroud is kept [4]. It occurred during the night between April 11st and 12nd 1997. The second event is represented by the collapse of the vault frescoed by Giotto in Assisi in 1290 and stroke by the earthquake on September 26th , 1997, at 11.42 a.m [5]. The third is the collapse of the structure of the Noto Catheral on March 26th, 1996 [6] (Fig.1b-d). The similarities between the fire of Paris and that of Turin are impressive. The first similarity, undoubtedly, concerns the almost perfect anniversary. The dome of the architect Guarino Guarini built in 1680 in Turin, representing a masterpiece of the Italian Baroque, burned 22 years and 4 days before the explosion of the Notre-Dame fire. In both cases the origin of the fire is to

Fig.1: Notre Dame fire, April 15th 2019. Collapses of the ancient roof and the spire (a), Fire of the Turin Cathedral. The baroque dome of the architect Guarino Guarini built in 1680 risked the collapse, April 11st 1997 (b). Dramatic failure of the The Cathedral of Noto in March 13th 1996 damaged after the earthquake that hit Sicily in 1990 (c) .Collapse of the vault frescoed by Giotto in Assisi in 1290 and stroke by the earthquake on September 26, 1997 (d).

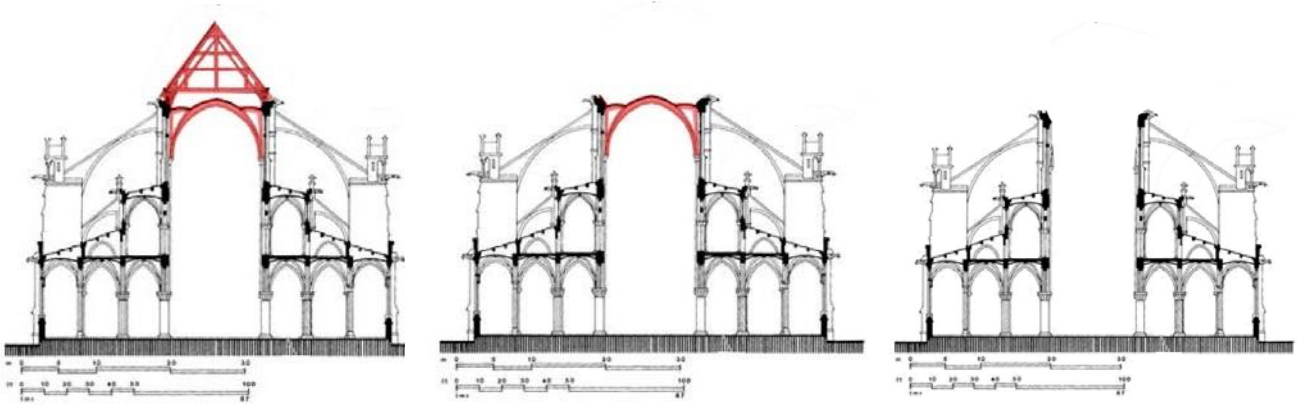
The spire has represented a symbol in the monument for the last two hundred years but probably with its several hundreds of tons placed at the intersection of the naves and a height of 45 m above the timber structure, it was determinant in the collapse speed of the entire roof. Contrary to what is indicated today, the Author opinion is that a quick questioning to the experts must concern the best solution for the temporary shelter for the cathedral that today is defenseless against weather. This temporary solution is of fundamental

Fig.2: Phases of the collapses of the forest. After the spire breakdown the timber roof collapsed with the masonry vaults above the naves. A the end the cathedral remained without a protection against weather.

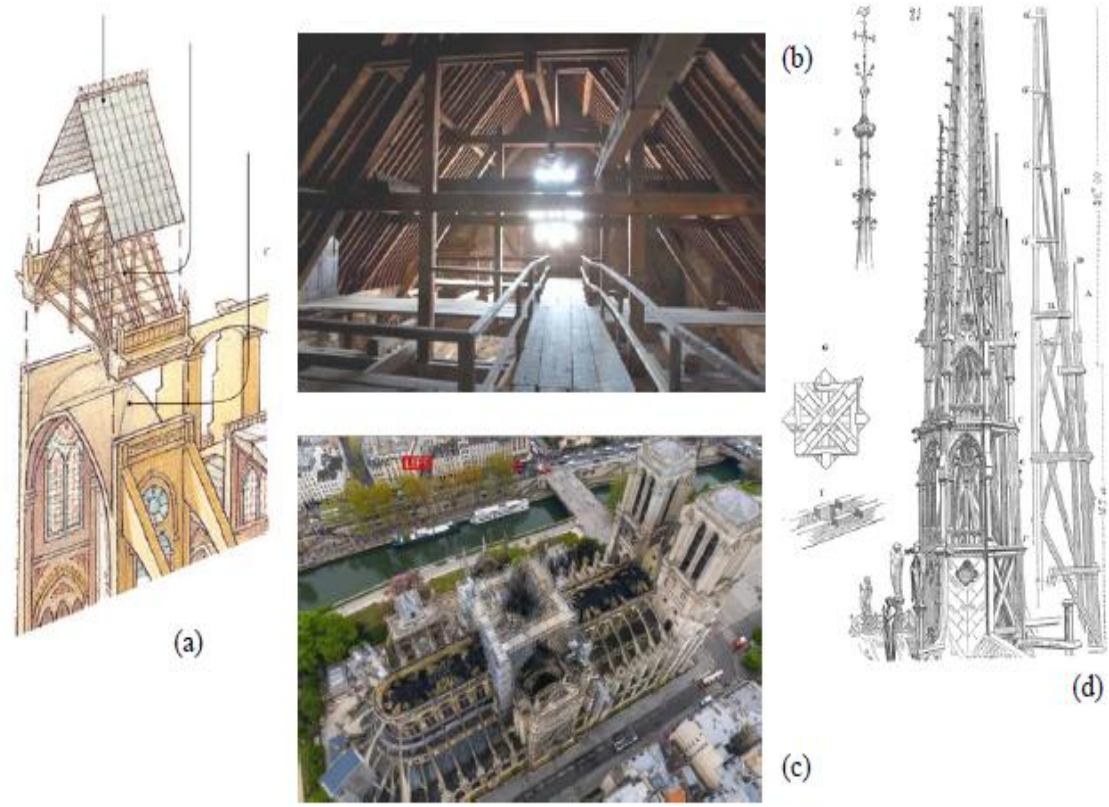
Fig.3: Axonometric view of the Notre-Dame structure of the roof – the original forest erected by Viollet-le-Duc (a). The original structure of the roof get before the fire (b). The state of the burned roof today. Top view from drone recognition (c). Original representation of the spire structure designed by Viollet-le-Duc (d).

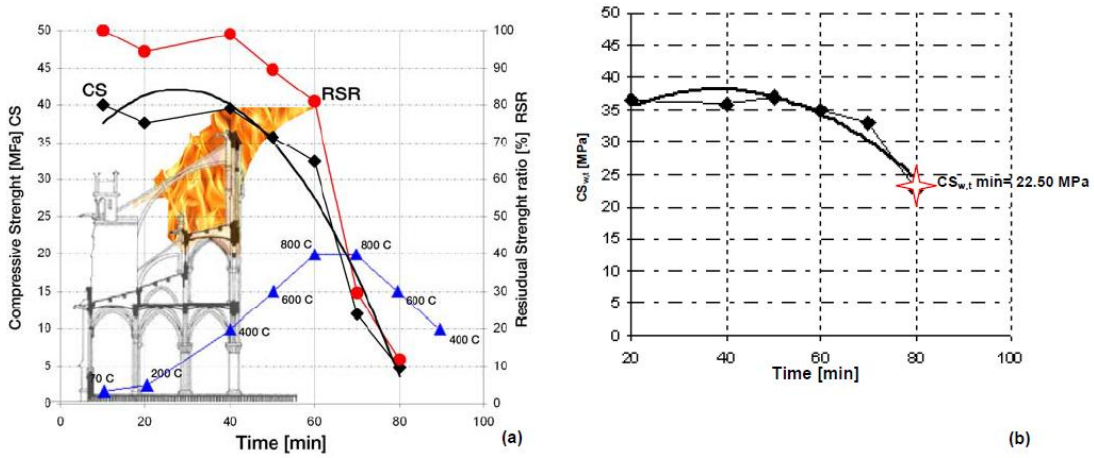
In Fig. 4 evaluations related to the residual strength ratio (*RSR* – percentage strength reduction vs. fire time), and the compressive strength (*CS*) can allow us to develop an objectively sustainable solution in order to avoid further collapses of the masonry. The *CS* behaviour reported n Fig. 4 for the Notre-Dame Cathedral limestone can be also described by the relation reported in Eq (1) as a function of the fire time (*t*).

In Eq (1) the constants *a*, *b*,*c* are respectively 0.0141, 0.785 and 31.19. As reported in the previous Section, in correspondence with the maximum temperature reached during the fire (800 °C), it can be considered a reduction of *CS* down to 4 MPa. At the same time, it must be considered that the cooling of the masonry due to the extinguishing works allowed to estimate a restoration of the bearing capacities. In any case, it is believed that the thermal shock suffered by the masonry, in particular in the stone strip close to the roof, generated a non-reversible effects. The bearing capacity in term of *RSR* and *CS* reported in Fig. 4 follow the behavior of experimental tests reported in literature according to the different shock thermal sequence performed on limestone samples [19]. Subsequently, the level of saturation of the stone due to the large quantity of water jet on the structures could have generated further and seriously compromising of the stability of the stone. Under the light of all these considerations and in the absence of a specific "in situ" experimental campaign, a load-bearing reduction to 50% of the Lutetian limestone, placed in the upper order of the cathedral, is estimated 3 weeks after from the fire. In Eq. 2 the fire-water $CS_{w,t}$ value is estimated taking into account the coexistence of the different effects:

In Eq. (2) CS_t is referred to Eq. (1), the function s(*t*) is the function of the saturation in the limestone due to the extinguishing works, *k* is a constant assumed to be 0.5 for this case and CS_w is the compressive strength function taking into account the saturation level. The $CS_{w,t}$ is calculated equal to 22.5 MPa at the end of the fire shutdown (see Fig 4b). This evaluation appears as an estimation and should be supported by the necessary tests on the cathedral stones or the limestone fragments collapsed after the fire. These results are well adaptable to the Lutetian limestone of the Cathedral.

Fig.4 : Compressive strength (*CS*) and residual strength ratio (*RSR*) behaviors, during the fire time, are reported together with the estimated temperature evolution in the masonry (upper level).
