Condition Assessment of an Early Thin Reinforced Concrete Vaulted System

Erica Lenticchia[1,2] · Gaetano Miraglia*[1,2] · Antonino Quattrone[1] · Rosario Ceravolo[1,2]

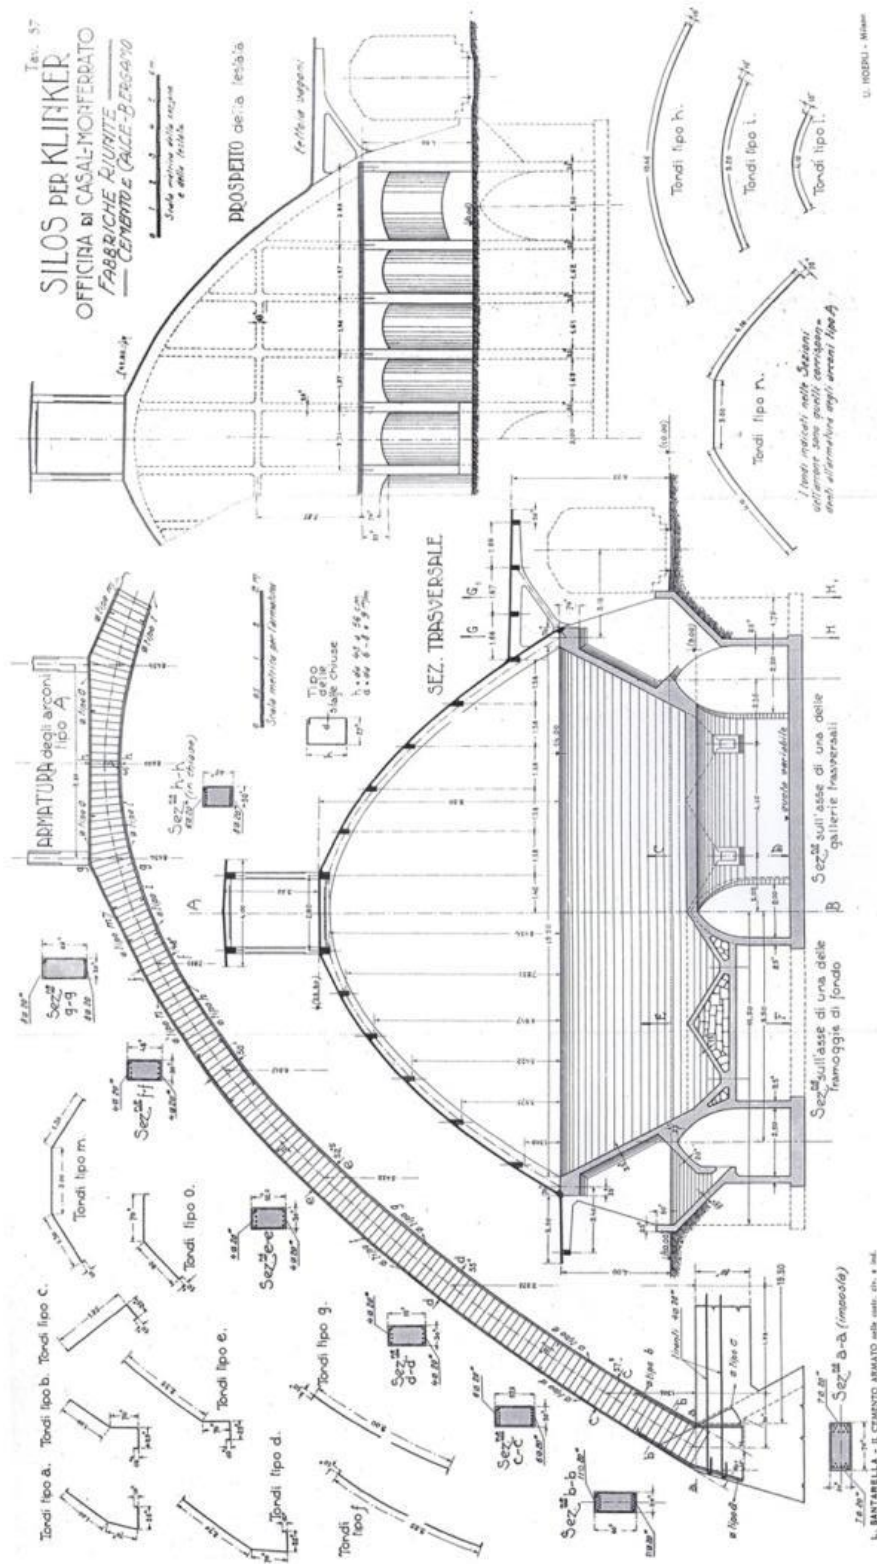
Figure 6: One of the two original drawings reported by Santarella in his manual [12], in which he reported the silos project for clinker warehouse in Casal Monferrato. Client: Fabbriche Riunite Cemento e Calce, Bergamo. Designer ing. Radici.

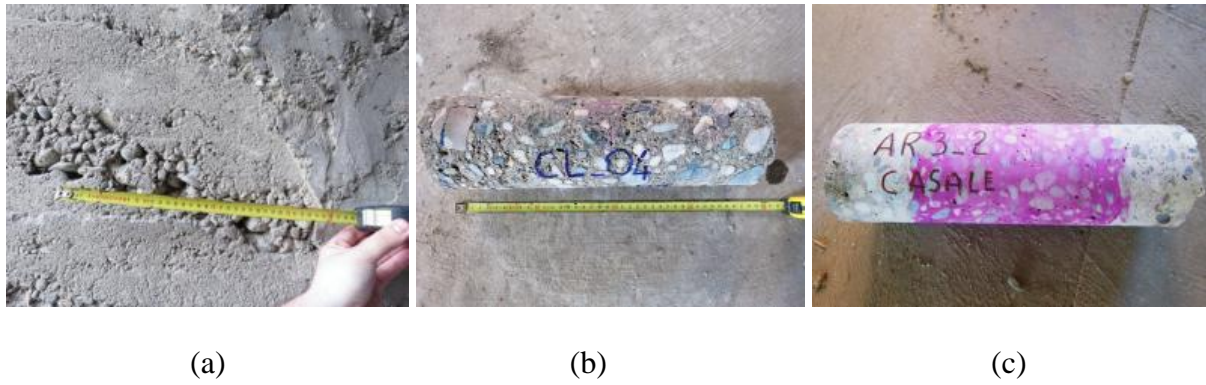
The analysis of the cores extracted denotes, at best, a concrete of modest mechanical characteristics (essentially at the level of the reinforced elements, the arches in particular) and poor in the lower part of the building (buttresses and edge beams). Based on the original documentation, it is not possible to estimate of the mechanical characteristics of the concrete used; in addition to the two mentioned design drawings, no documentation was found that contained information on the materials used. Considering the fact that the building was built in the early 1920s, we can estimate the mechanical characteristics (which are then used as a benchmark for comparison with the results obtained from laboratory tests) based on a study of the mechanical characteristics of the concrete of the period. In [18], a database has been reported of certifications attesting the compressive strength values of specimens created between 1915 and the early 2000s in the archives of the Politecnico di Torino. By examining four time intervals (from 1915 to 1935, from 1936 to 1955, from 1956 to 1975, from 1976 to 2002), the authors of [18] report the probability density curves obtained for each of these periods. Based on this study, the expected characteristic resistance of the concrete of the Paraboloide is around 18.3 MPa (value μ of the real distribution) [18].

Figure 9: Differences in the aggregate's size of different structural elements: (a) Segregation in concrete in the buttresses elements; (b) a complete carbonated element in a passing core drill of a secondary buttress; (c) the core drill of a parabolic arch and the results of the phenolphthalein test. It is possible to notice the smaller size of the aggregates in the parabolic arch.

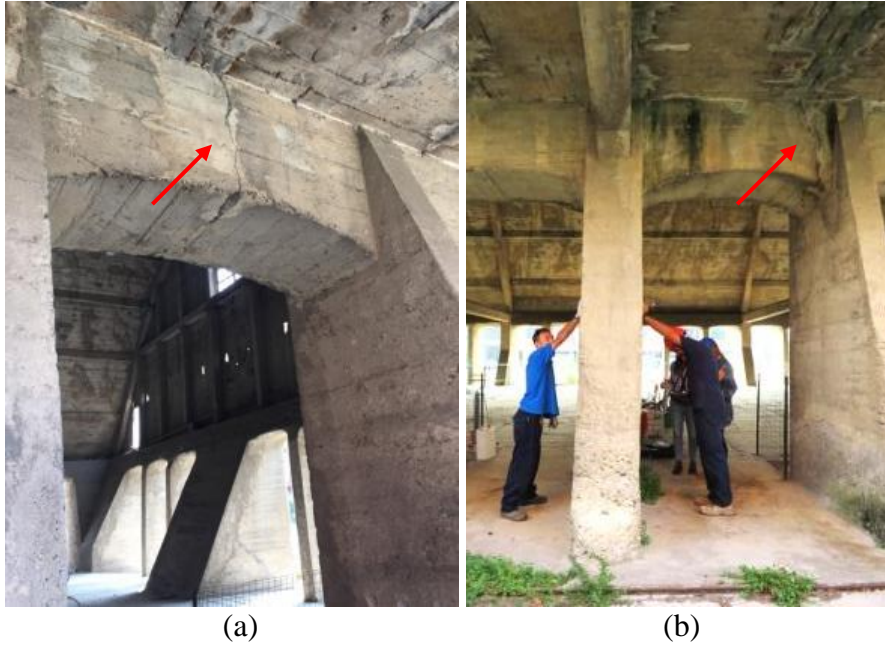
Figure 13: Pass-through vertical cracks identified on some edge beam elements.

Referring to one of the investigated elements of the Paraboloide, the presence of conspicuous cracking phenomena in the perimeter arched beams (Figure 13) almost leads to a halving of the equivalent elastic modulus of the corresponding model components.

- Similarly, the updating procedure revealed a severe reduction in equivalent elastic modulus of non-reinforced concrete elements of the Paraboloide affected by important cracking phenomena. Specifically, the cracks in the arched beams of the edge curb component nearly halved the equivalent elastic modulus.

Figure 13: Pass-through vertical cracks identified on some edge beam elements (TR).
