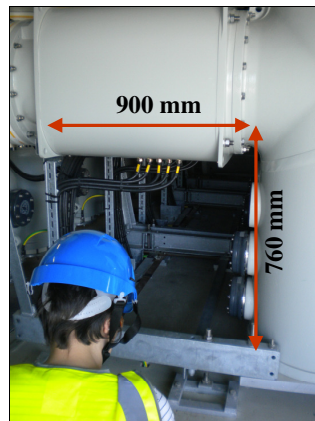
It seems that some basic principles of accessibility were not properly taken into account in the design of the equipment. The lack of basic ergonomics principle in design is reflected in the difficulties encountered by the operators to manually open or close the circuit breakers in case of failure of automatic activation. The risk is that the worker fails to resolve situation in time because he must reach the high position and turn the mechanism shaft in an awkward position and if the operation has to be performed for bays internally located the operator has to walk over the pipelines containing the live cables and the insulating Gas. No platforms were in fact provided to access those areas.

Figure 22: Cables to be reached during commissioning and testing. The picture shows that they are positioned in a confined area accessing which the operator needs to maintain a crawling awkward position**.**
