Quantifying the seismic resilience of bridges: a pathway towards a Resilience-Based Design

A.I. Sarkis & A. Palermo
University of Canterbury, Christchurch, New Zealand

O. Kammouh & G.P. Cimellaro
Politecnico di Torino, Turin, Italy

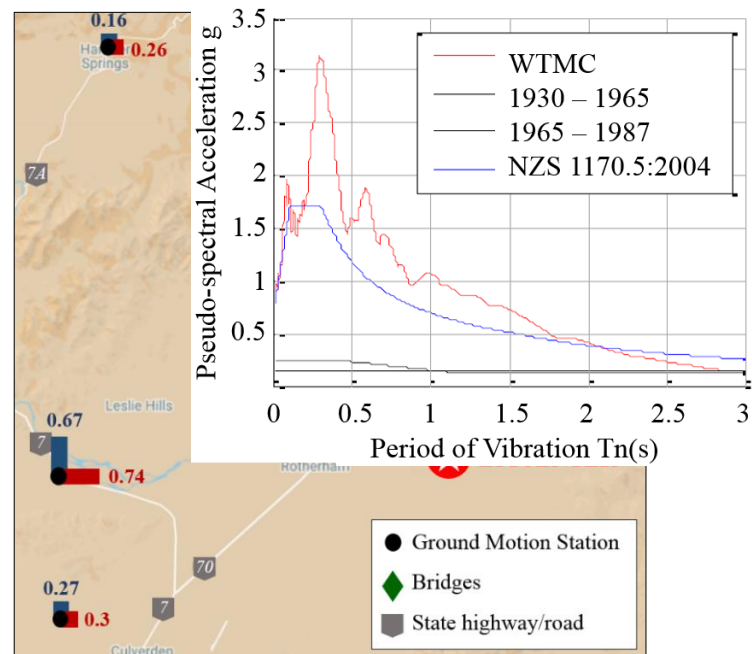
Figure 2. Geometric mean of the pseudo-spectral acceleration measured at WTMC strong motion station (Palermo et al., 2017)

The bridges studied were designed in the period ranging from 1980 to 1987, hence, using the design spectra from the 1965-1987 era. The corresponding design spectra was greatly exceeded, as it can be seen in Figure 2. Most bridges had elastic periods of vibration within the range of 0.2 s to 1.0s, which is the period of vibration where the ground shaking at WTMC exceeded even the modern design spectra (Figure 2). The bridges had a transverse period of vibration in the range of 0.2s to 0.6s and the pseudo-spectral acceleration experienced by these bridges greatly exceeded 1.5g.

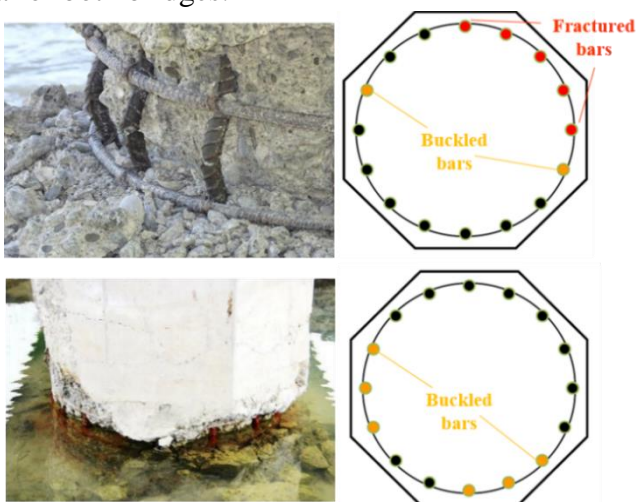
At the Lower Mason Bridge, all piers, except for the central, formed fully developed plastic hinges (PH) at the base. As mentioned, the central pier is located below a movement joint in the deck and has shear keys restraining the superstructure. Extensive cover spalling and a significant number of buckled and fractured longitudinal bars were seen. Pier damage at the Lottery River Bridge was similar but without an evidence of bar fracture. Figure 4 illustrates the damage patterns found on the column rebar of both bridges.

Figure 4. Pier damage sustained by Lower Mason River Bridge (top) and Lottery River Bridge (bottom).

Together with the PH zones, observed damage common to both bridges, Lower Mason and Lottery, included: damage to the knock-off block at the central pier movement joint, failure of the abutment knock-off blocks; residual displacement of most of the

repairs and re-levelling. To reinstate the original seismic capacity, a pile jacketing was issued for all pier columns, which was finished around mid-January (point 2 in Figure 7). After the pile jacketing was completed, the one-heavy-vehicle-at-a-time restriction was removed but the 30km/h restriction remained due to the uneven road surface.

The recovery process for the Lottery Bridge was very similar to the Lower Mason, since they share similar structure type and damage. Pier columns were unable to be inspected on the first days after the earthquake due to the bed and water level, yet, damage was anticipated to be less than at Lower Mason due to the shorter bridge columns. Excavation of pier piles occurred on November 25th confirming that damage was of a lesser extent, and pier jacketing was issued and completed around mid-February (point 3 in Figure 7).

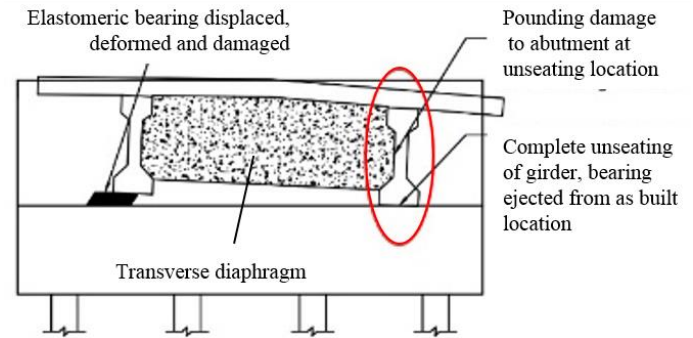
elastomeric bearing pads at the piers and abutments; and residual displacements at the central pier and abutment movement joints. Damage to the abutments is illustrated in Figure 5.

Figure 5. Abutment damage schematics for the Lower Mason

River Bridge (modified from: Palermo et al, 2017)

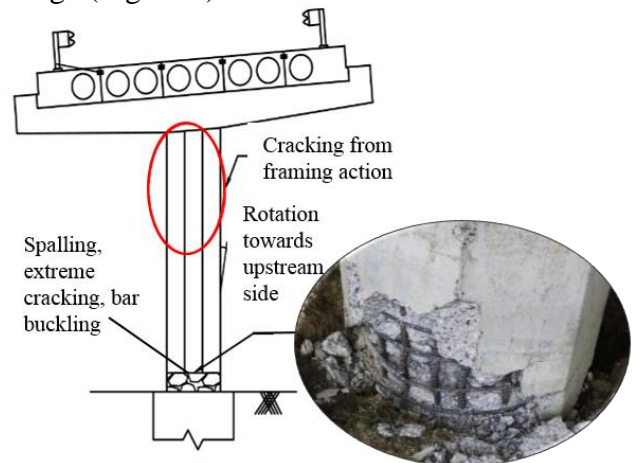
The damage observed to the Wandle River Bridge was extensive, and included: separation between the hollow core deck units at the south end of the bridge; translation of deck units in the downstream direction; hinging and rotating of piers towards the upstream side (up to 7° rotation); opening of the deck joints at the abutments, along with significant approach damage (Figure 6).

Figure 6. Damage schematics for the Wandle River Bridge (modified from: Palermo et al., 2017)

It can be concluded that the piers performed well, as they developed PH at the pier bases and went through the expected failure mechanism. However, significant instability was visible in the Wandle Bridge, where most likely all orthogonal motions were interacting with the bridge structure, causing large displacements and separation gaps between some of the deck beam units.

For the Wandle River Bridge, decision was made on November 15th to install a Bailey bridge upstream with a 33m span. Installation was completed by November 21st and opened to traffic on the 22nd, nine days after the earthquake (point 4 in Figure 7). The Bailey bridge was able to be erected so quickly, within eight days, because New Zealand Transport Agency (NZTA) maintains an emergency stock of Bailey bridges with a contractor also in place to respond in the event of emergencies. The Bailey bridge provided largely unrestricted access across the Wandle River, however, a 30km/h speed restriction was installed due to the alignment and to provide impact protection to the bridge. The Wandle Bridge was demolished in May 2017 and a new bridge design is programmed with a low priority for 2018.

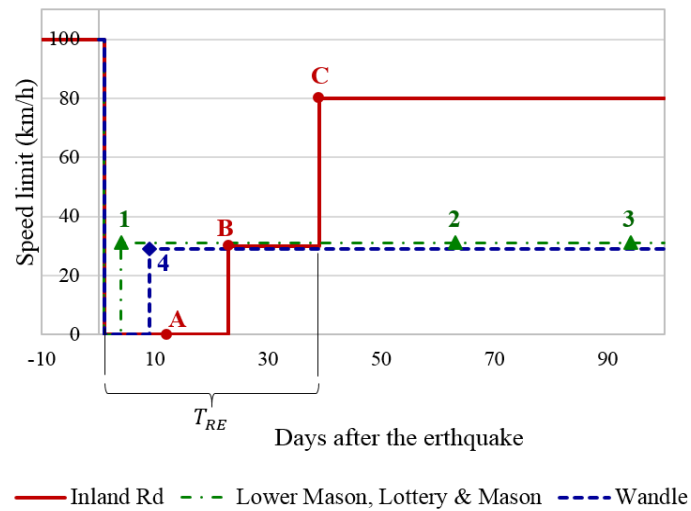
Figure 7. Functionality based on the maximum speed limit for the Inland Route and the four bridges under study.

Figure 7 illustrates the recovery rate of the Inland Route and the bridges under study during the first one hundred days following the earthquake using the maximum speed allowance as a functionality indicator for normal, Class 1, vehicles. The earthquake occurred at 12:02 am on the 14th of November, causing the Inland Route to be immediately closed by the Civil Defense Emergency Management. The route remained closed until it was given access for the NZ Defense Force convoys to get through with emergency supplies to Kaikōura, on November 25th, 12 days after the earthquake (point A in Figure 7).

The route remained fragile and hazardous, closed to the general public until the 6th of December, day 23 after the earthquake (point B in Figure 7), when controlled emergency and resident access was allowed with a speed limitation of 30km/h, 70% less than the pre-earthquake speed limit of 100km/h. Works undertaken during these days to make the severely damaged road safe enough included clearing the road of more than fifty slips, stabilizing slopes, and assessing the damage to the bridges.

It was only until the 21st (point C in Figure 7) of December when the public were granted unrestricted access to the Inland Road, bringing the first unrestricted road connection back to Kaikōura, for a total recovery time T_{RE} of 38 days after the earthquake.
