# Engineering Reconnaissance Following the October 2016 Central Italy Earthquakes

## *Version 2*

Geotechnical Extreme Events Reconnaissance Association
Report No. GEER-050D
8 May 2017

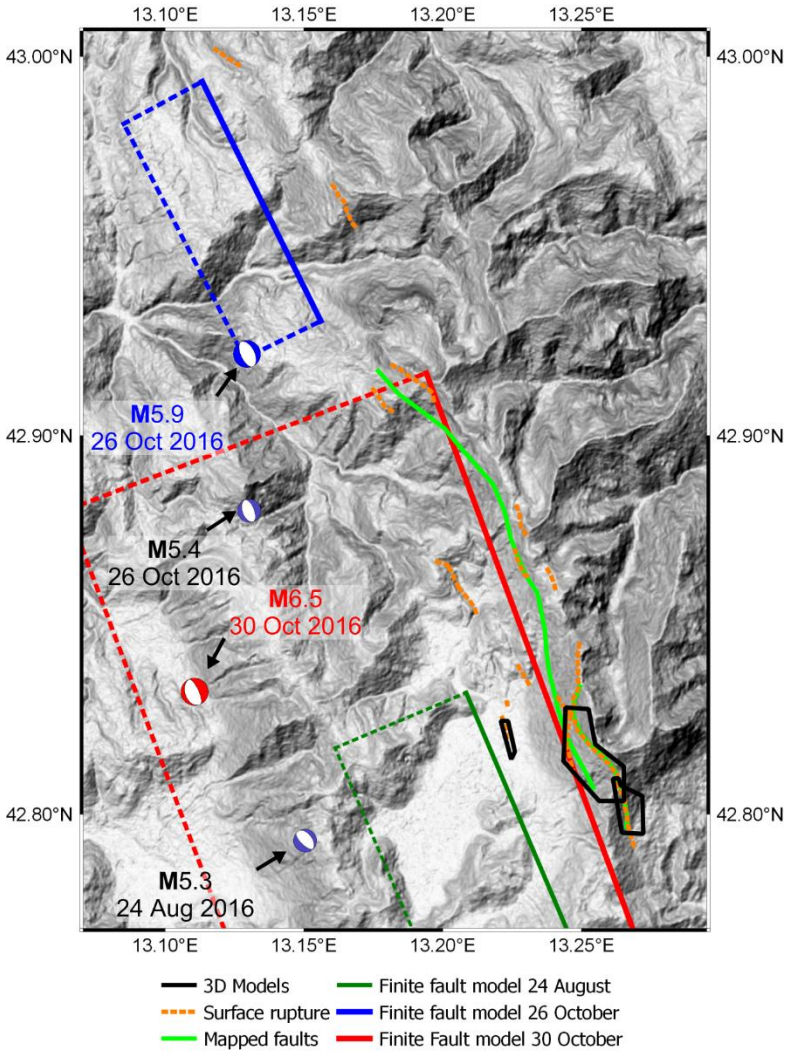
**Figure 2.4**. Detailed map of surface fault rupture, pre-event mapping of Mt. Vettore-Mt. Bove (green) fault system, and locations of 3D models.

As shown on Figure 2.4, the locations of the observed surface ruptures coincide with a segment of the Mt. Vettore fault as mapped by Falcucci et al. (2016). This segment of the fault did not rupture in the 24 August event. No information about the last known rupture of this fault segment is available. It has likely ruptured during past events on the Mt. Vettore fault as identified by Galadini and Gali (2003) through paleoseismological studies.

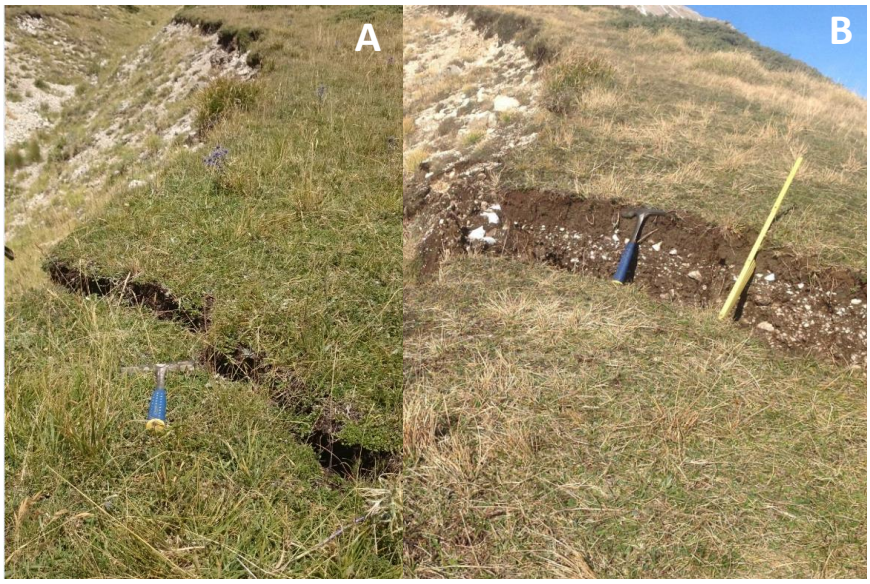
**Figure 2.5**. Comparative fault offset of 10cm. (a) Vertical offset from the August event, and (b) 30cm Vertical offset from the October 2016 events on the south face of Mt. Vettore near road SP477. Horizontal offsets were 0cm and 2cm. Lat = 42.79795, Long = 13.26607.

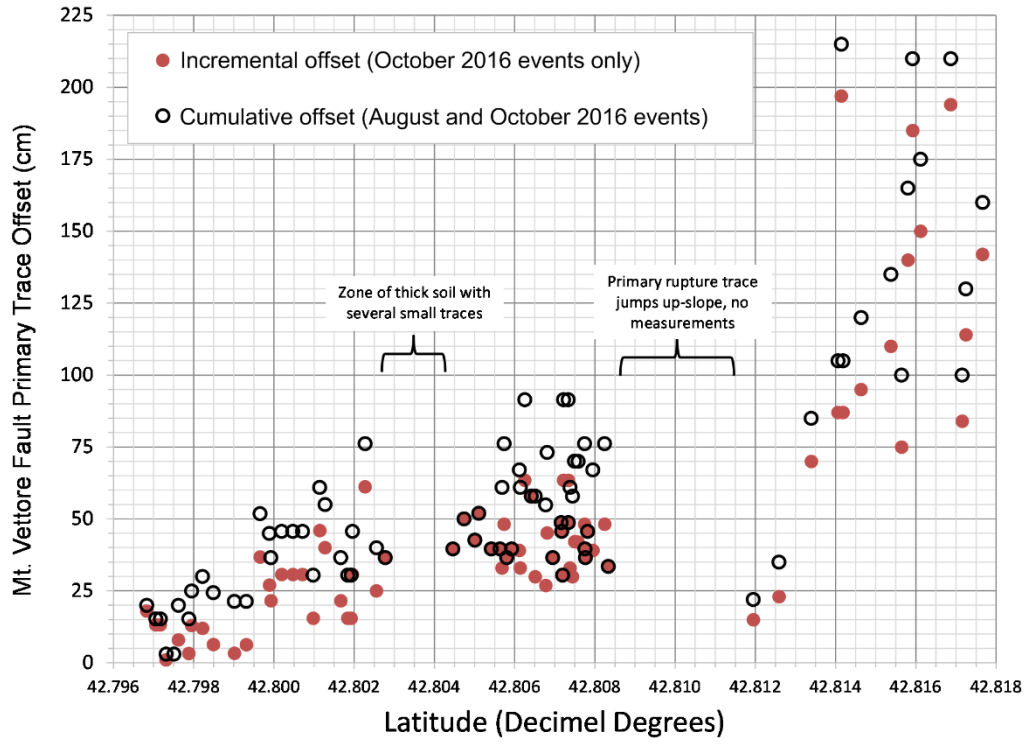
**Figure 2.6**. Distribution of incremental and cumulative fault offsets for the southern half of the Mt. Vettore fault. All data in this Figure from hand measurements.

In the southern portion of Mt Vettore fault, slip occurred on three segments. The primary segment is on the ridge of Monte Vettore at the contact between bedrock and thin overburden talus and alpine deposits. An apparently secondary segment occurs lower on the ridge, which ruptured in the 30 October event but not in the earlier events. Another secondary segment is in the lower-lying basin, Piano Grande, in lacustrine and alluvial deposits that have infilled the basin. Rupture on this segment was only observed following the 30 October event.

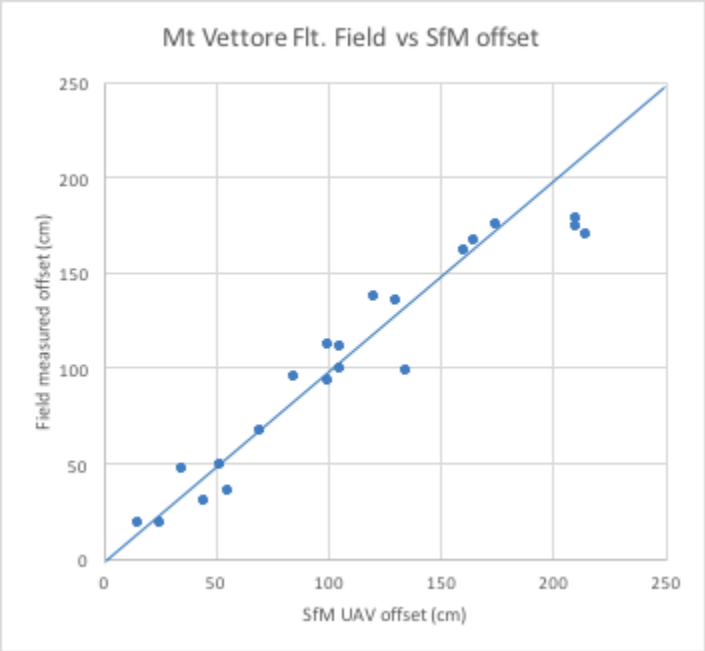
In Figure 2.7 we compare displacements along the primary (highest elevation) segment of the Mt. Vettore fault as measured by hand and from the 3D terrain model. These displacements were made along the portions of Mt. Vettore that are on the west face of the ridge and on the branch descending the ridge towards SP477. Figure 2.7 shows cumulative displacements across

all events, which for this portion of the fault arise from the 24 August and 30 October events. The 3D model in these areas is based on UAV point cloud data, and the displacements were measured from the model using the program Dronedeploy. The comparison is considered quite good, with no clear evidence of bias. Further comparisons in other areas will be undertaken in future work.

**Figure 2.7**. Surface fault rupture displacements from August-October event sequence as evaluated from hand measurements in the field and UAV-based 3D model.

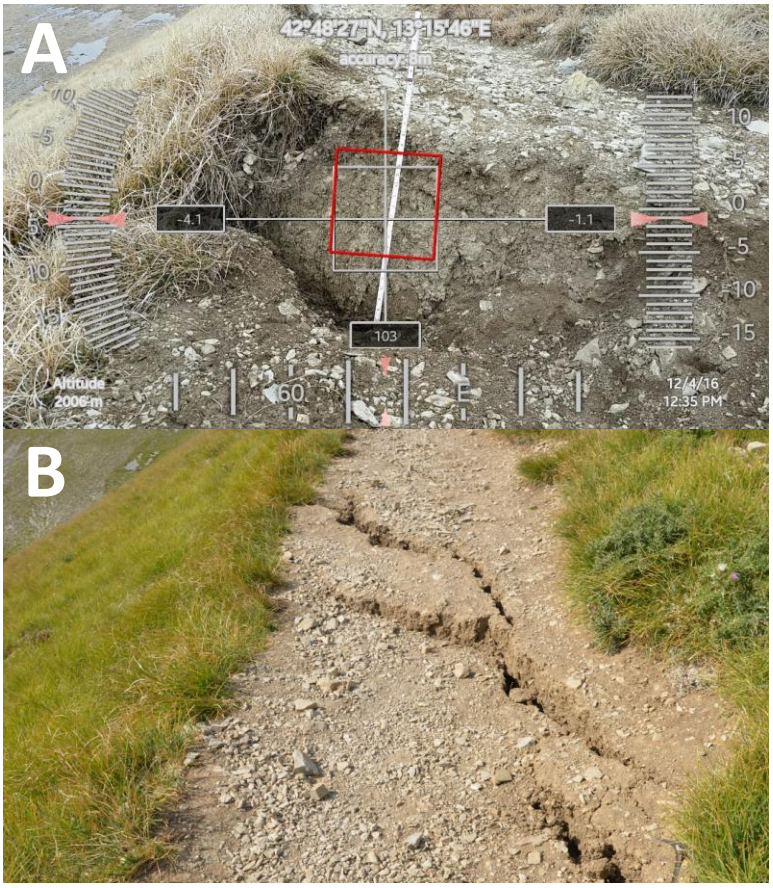
**Figure 2.15**. Fault offset measurement across the footpath on the west face of Mt. Vettore. Offset measured as 80 cm following October events (a). This offset was 30 cm following August events (b). Lat = 42.807379, Long = 13.262966.

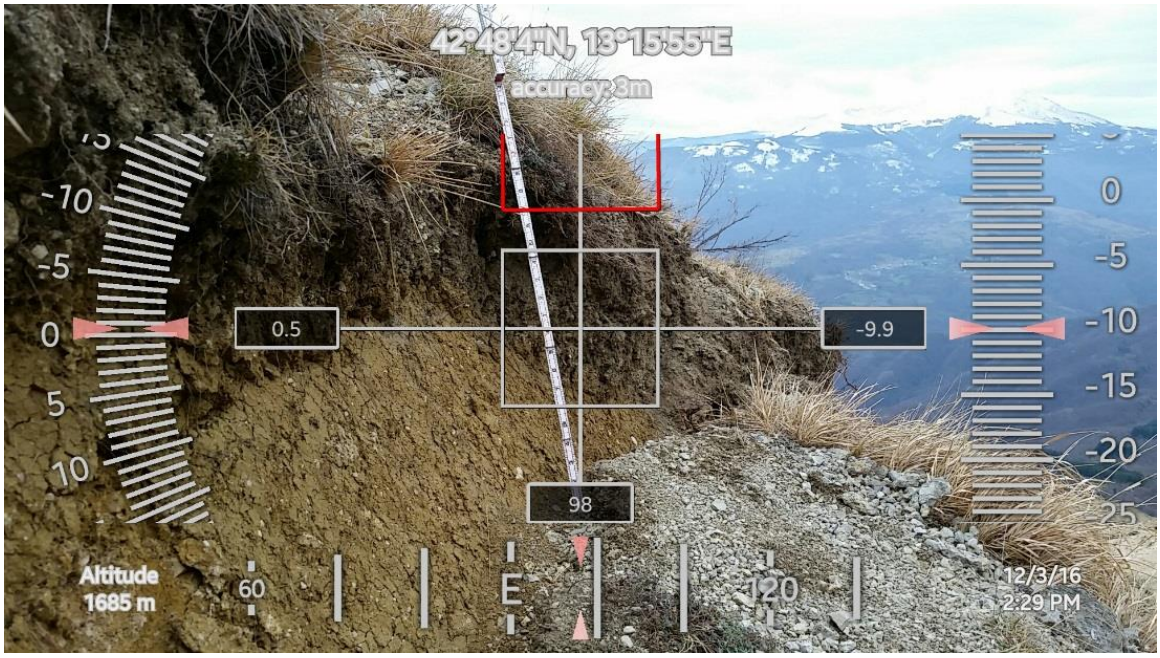
**Figure 2.18**. Fault offset measurement in gulley on south face of Mt. Vettore. Offset measured at 80cm. August offset data nearby is 15cm, indicating October 2016 offset of 65cm.

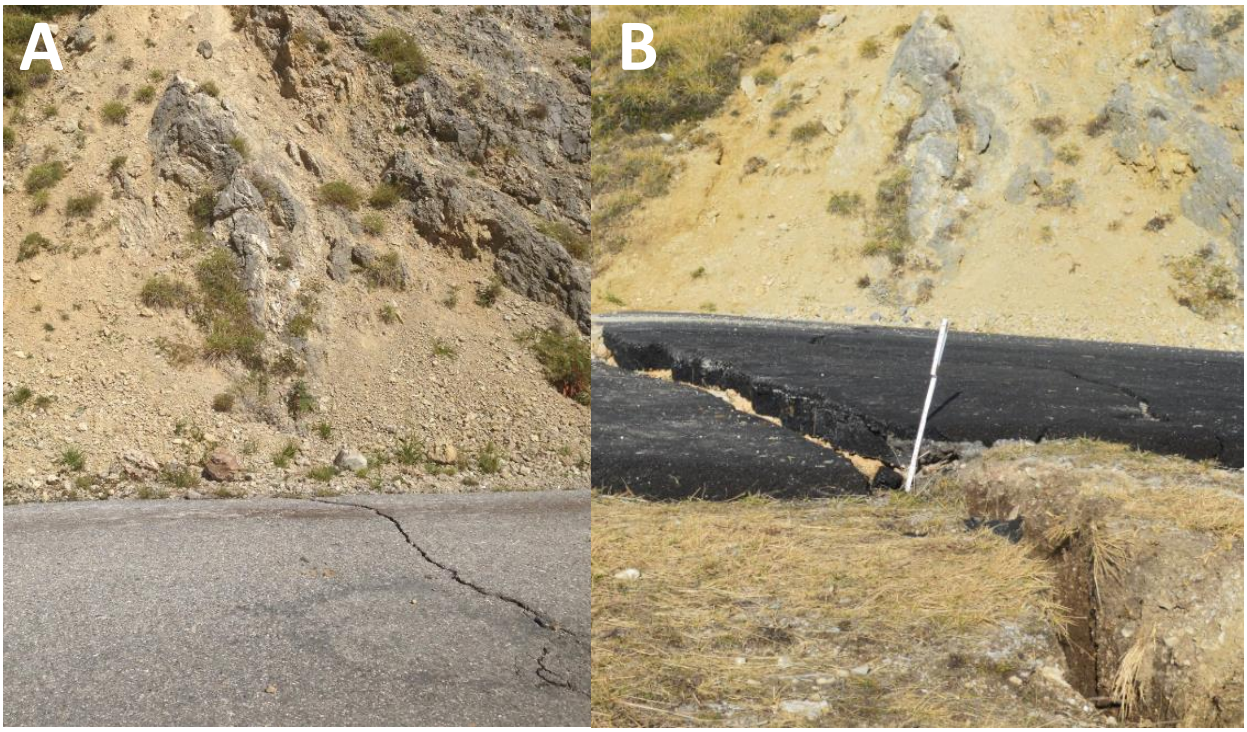
**Figure 2.19**. Fault offset measurement across SR477 on south face of Mt. Vettore. August offset data nearby is 2cm (a). Offset measured at 18cm to 20cm after October (b). Lat = 42.796829, Long = 13.265899.

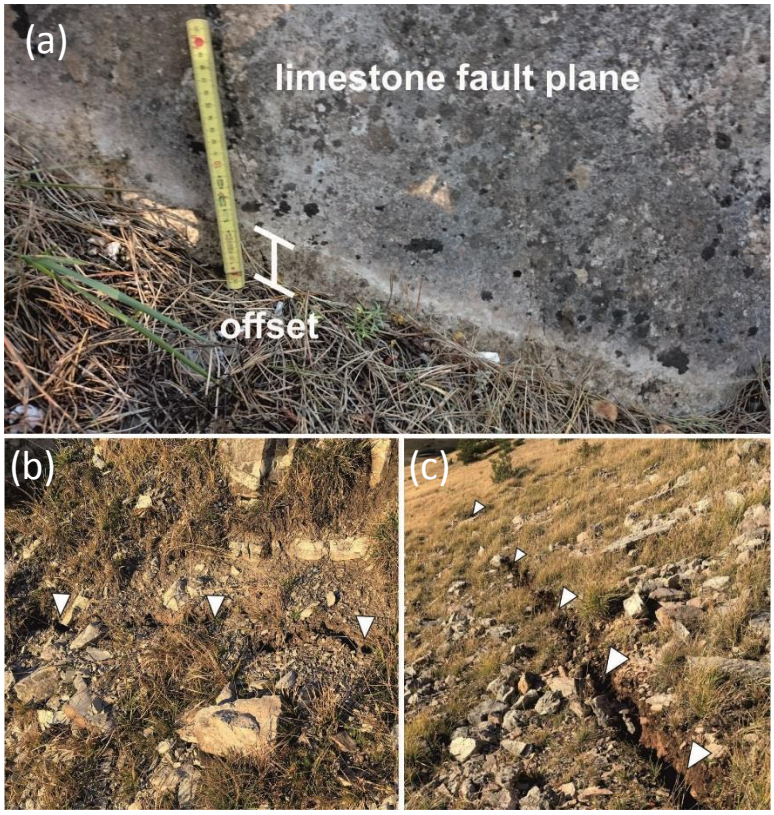
**Figure 2.21**. Fault offset measurements along the south and west faces of the Mt. Vettore Massif showing differences in fault rupture offset through soil versus along the rock fault plane (where visible on the slope).

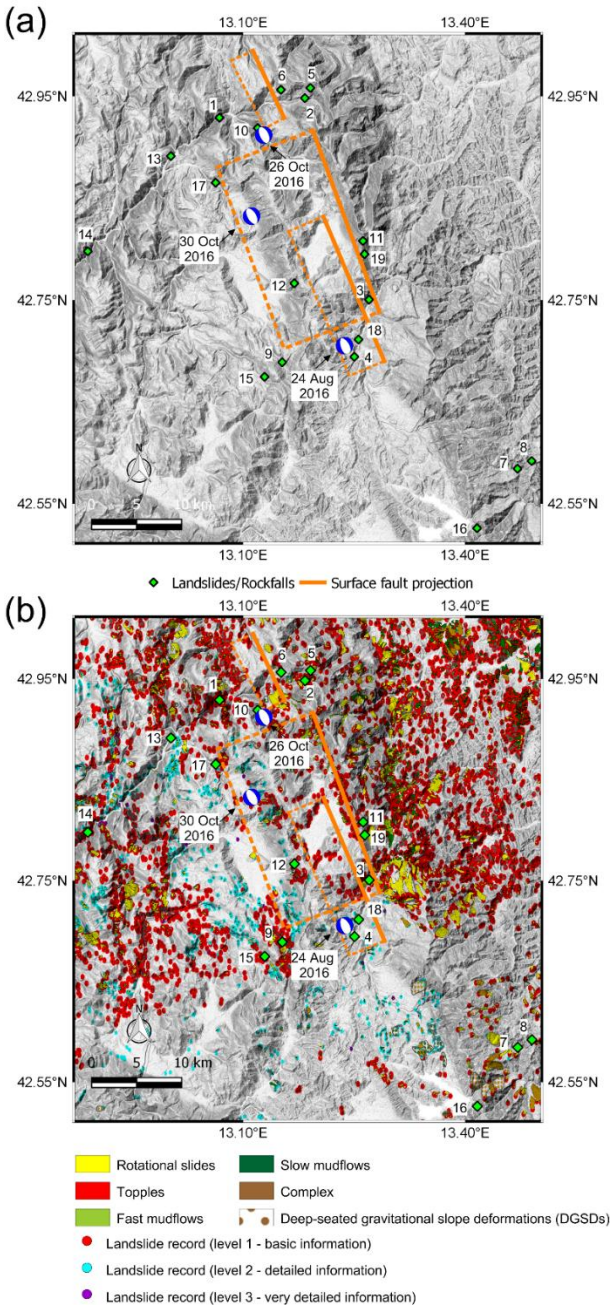
**Figure 4.1**. (a) Map of observed landslides (green diamonds), along with surface fault projections and moment tensors for the three mainshocks; (b) Observed landslides superimposed to the IFFI inventory.

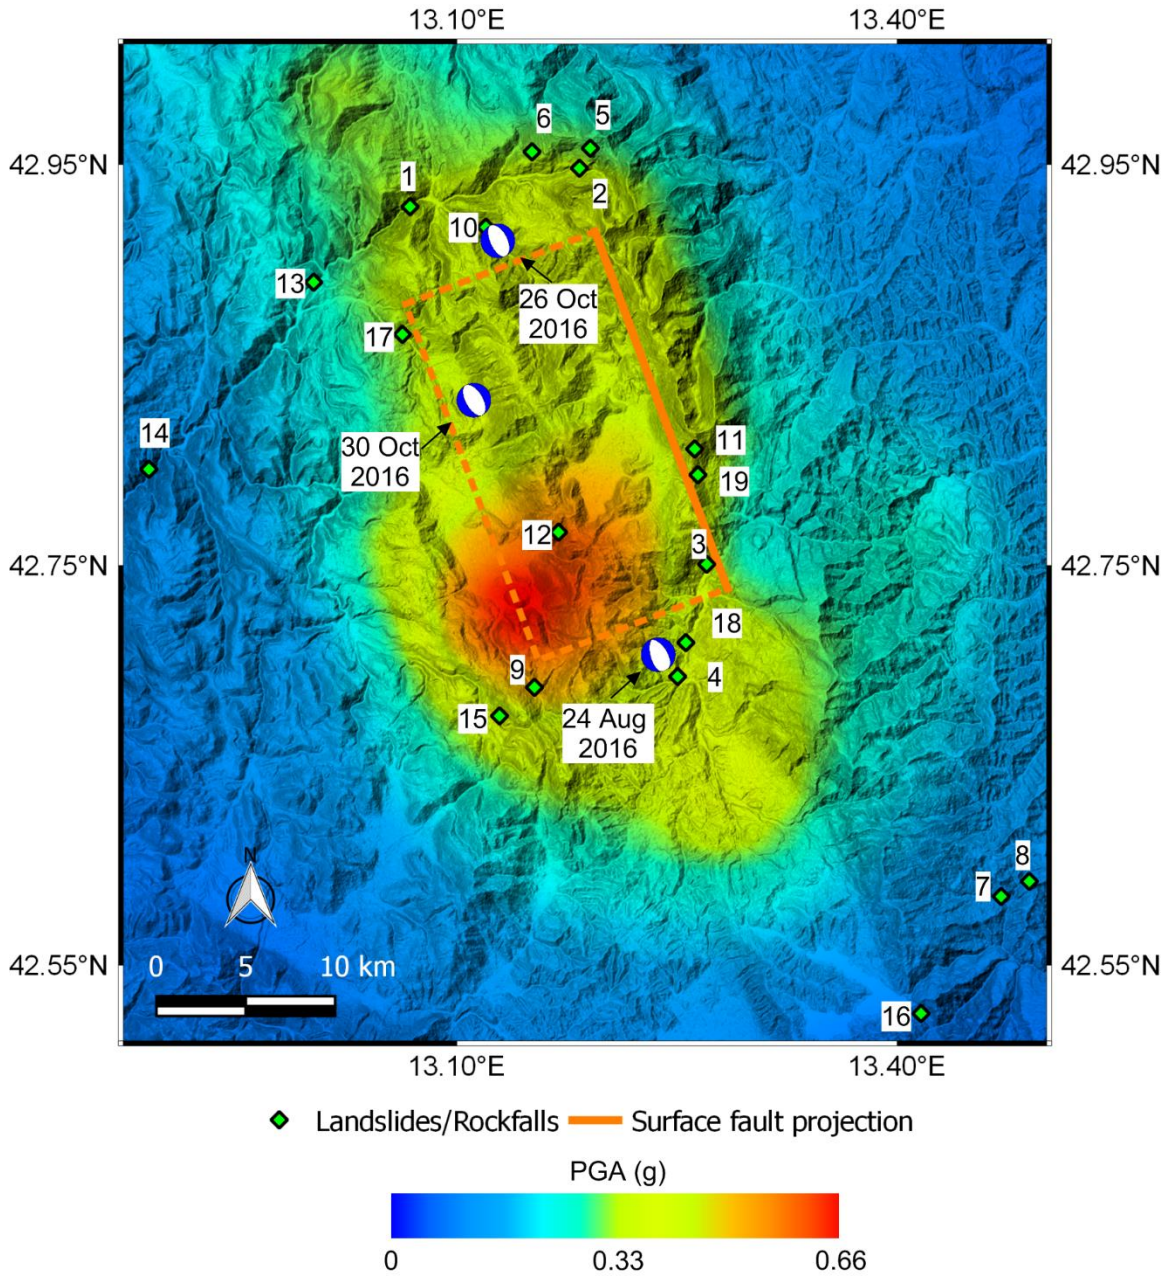
**Figure 4.2**. Location of reconnaissance sites, epicenter locations, and spatial distribution of PGA for the 30 October **M**6.5 earthquake.

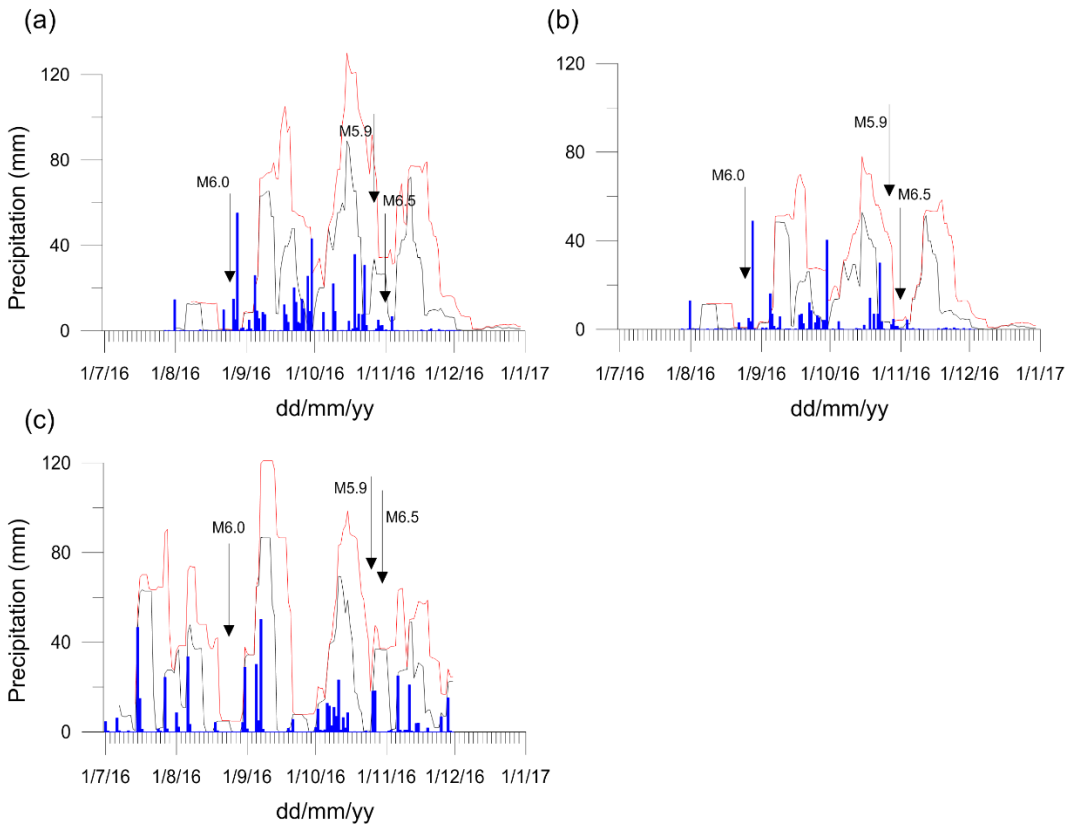
**Figure 4.3**. Daily rainfall (blue bars) and daily rainfall accumulated over one (black line) and two weeks (red line) recorded by (a) Visso, (b) Ponte Tavola (courtesy of Servizio Idrografico - Regione Marche), and (c) Nerito-Crognaleto (courtesy of Servizio Idrografico -Regione Abruzzo) rainfall gauges.

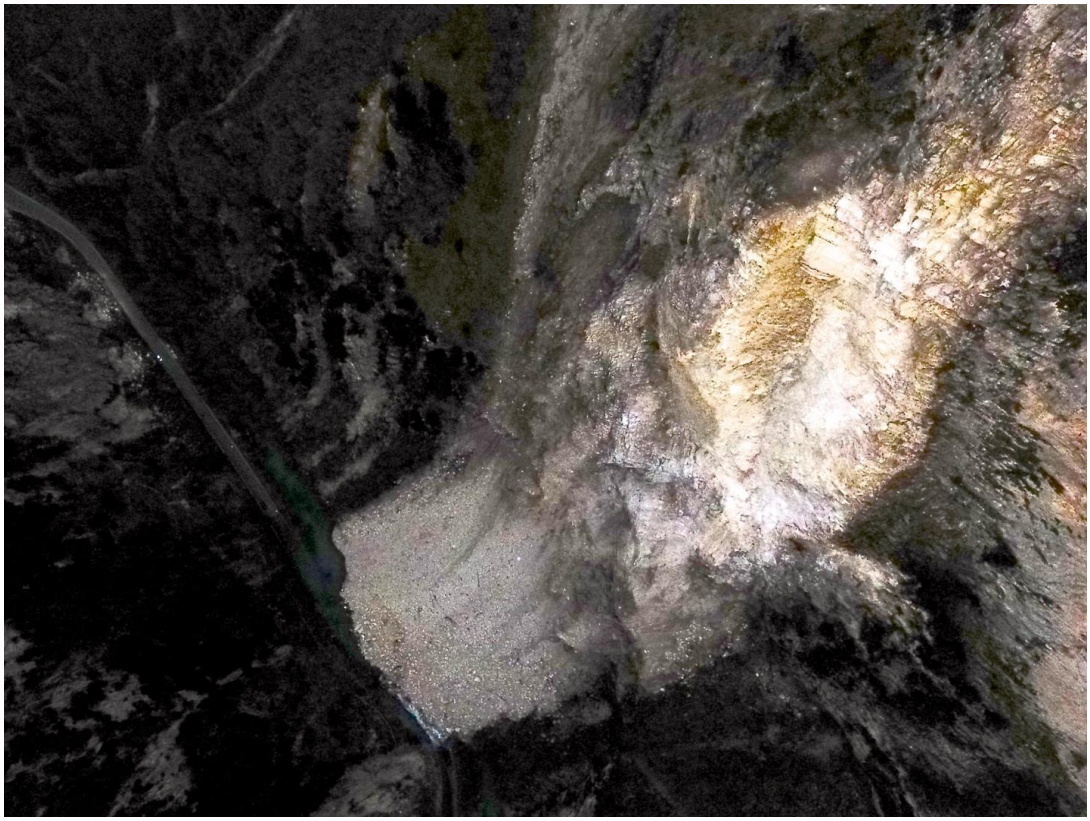
**Figure 4.5**. Nera rock avalanche photographed from the UCLA DJI Phantom 4 drone at an elevation of 400 meters above Route SS209. The primary rock-fall was a wedge that detached on the right side of the image and disintegrated into talus debris as it fell 330 meters to the river valley floor. The limestone bedding is visible in the scar of the wedge detachment

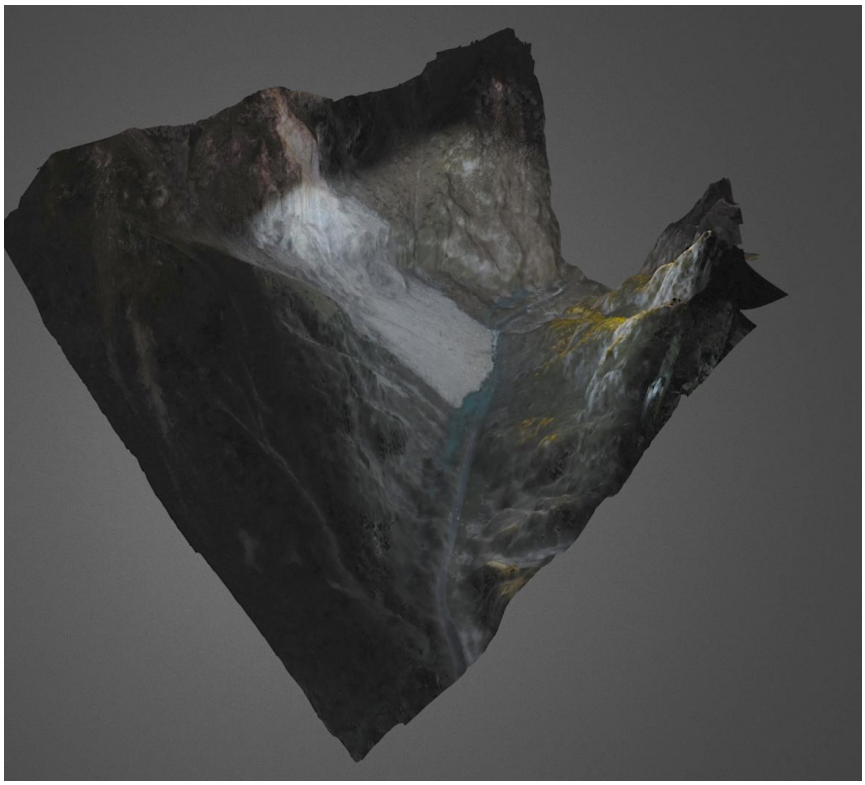
The upper detachment zone can be seen in the SFM imagery of Figure 4.6-4.7. In these images, the bedding is seen with an apparent dip towards the east of 20°-30°, and the wedge is apparently a double joint set orthogonal to the bedding. The failure occurred along the joint sets. Further analysis of the SFM data may resolve the strike and dip of the bedding and the joint sets that resulted in the detachment.

**Figure 4.7**. 3D Structure-from Motion (SFM) model of the Nera river valley at the rockfall. The Nera rock avalanche is seen here from the east (Visso) side of the rockfall. The light color on the midslope is from the setting sunlight on the SfM UAV imagery. Elevation difference from the crest of the headscarp to the river is 330m.

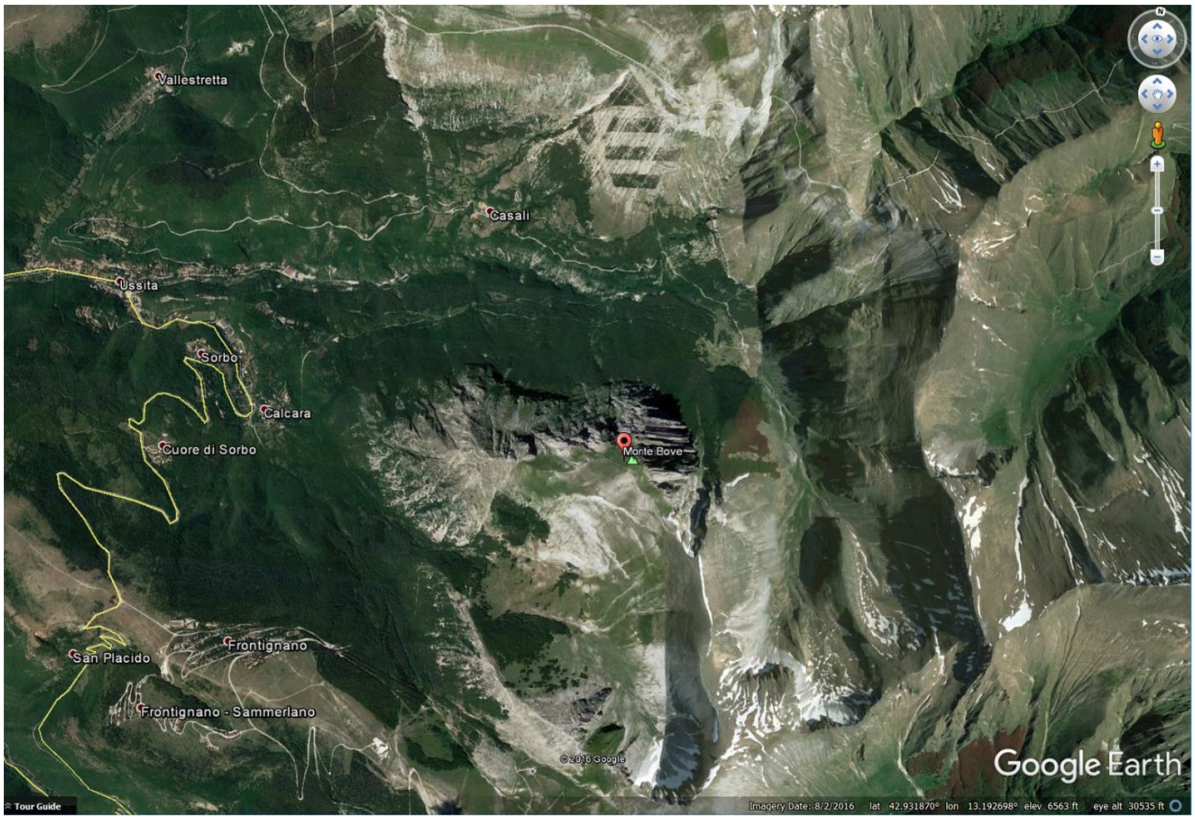
A series of rockfalls was observed along the northern face of Monte Bove, which is prominent mountain peak in the Appenine range that is located approximately 4 km east-southeast of the hamlet of Ussita. A satellite view image of Monte Bove and surrounding hamlets is presented in Figure 4.8**Figure 4.**. Personal communication with the City Engineer of Ussita revealed that no instabilities or rockfalls were observed following the **M**6.1, 24 August event, but all of the visible rockfalls had occurred after the **M**5.9, 26 October event. Interestingly, he mentioned that no new rockfalls on Monte Bove were observed following the **M**6.5, 30 October event. Estimated level-site ground motions at Monte Bove during all three events are shown in Table 4.1.

**Figure 4.8**. Satellite overview image of Monte Bove and surrounding hamlets (courtesy of Google Earth)

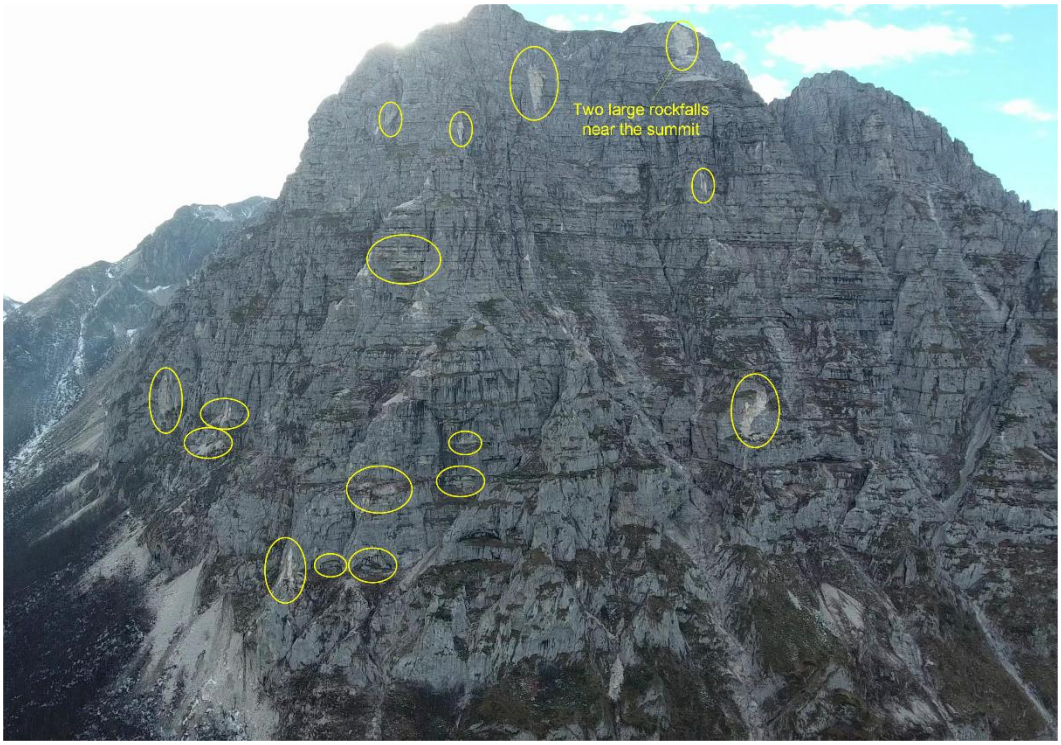
**Figure 4.9**. Phantom 4 UAV image of Monte Bove. Suspected rockfall sources are circled in yellow.

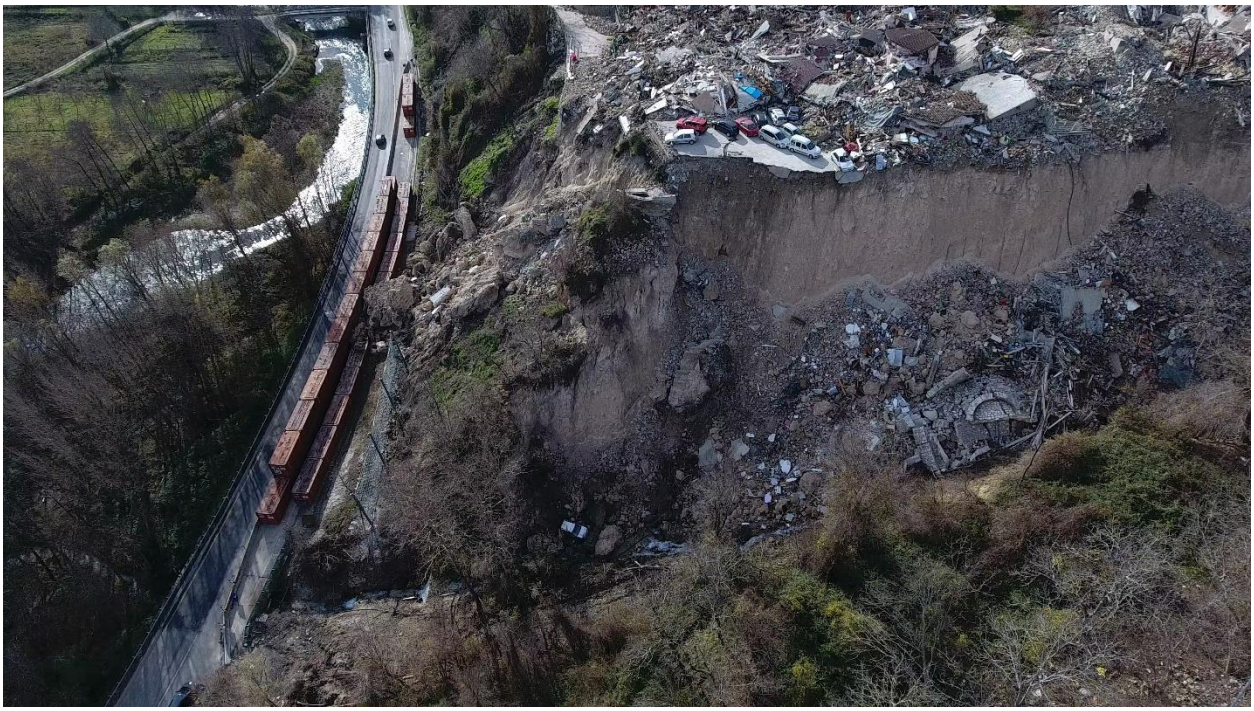
**Figure 4.15**. View of talus behind failed retaining wall by Strada Statale No. 4 (Location 3b).

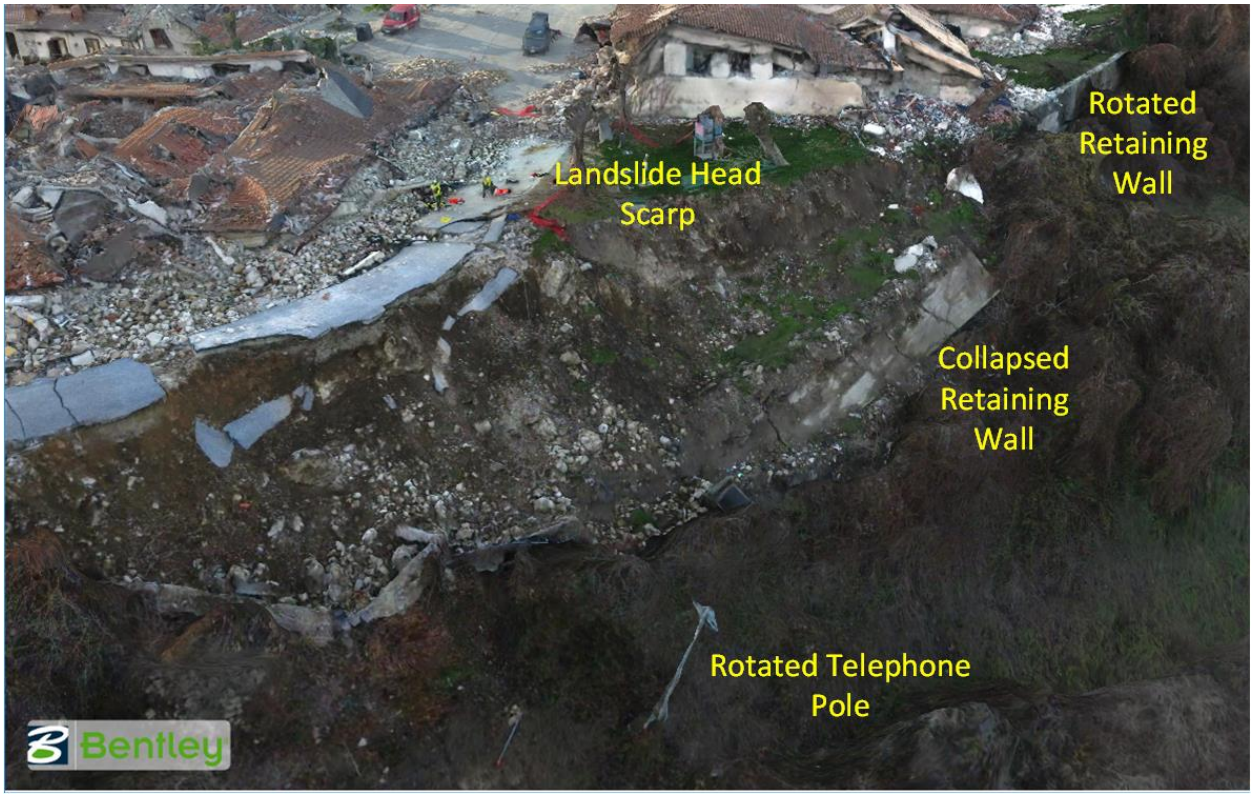
**Figure 4.32.** 3D model screenshot identifying objects of interest with the failed retaining wall and shallow slope failure at Point 4a.

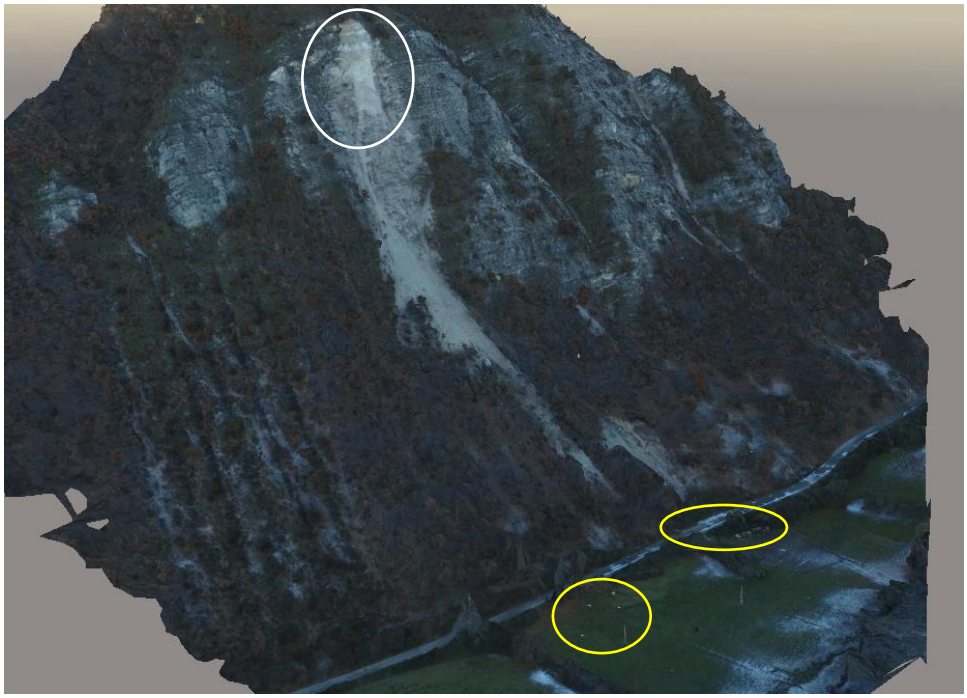
The larger landslide that occurred during the 30 October 2016 earthquake at site 9b was a rock avalanche. The site is shown in Figure 4.59 using a 3D SfM model othrophoto developed from UAV imaging. The source rock face is massive but weathered and jointed limestone is at least 50 m high. The source of the rock avalanche itself is 16 m wide and 32 m high. The slope below the rock face varies from 28° to 32° and is around 57 m from the rock face to the road. A flat field and Via del Passero lay at the bottom of the slope. The source is shown in Figure 4.59 as the light colored part of the rock face. We did not climb the slope to perform a close-up assessment of the rock at Site 9b. However, the limestone boulders that travelled to the base of the slope and out into the field below Via del Passero indicate the geology and rock type. These boulders were 0.75-1.25 m. Figure 4.60 shows the perspective of the rock avalanche from the field, where the runout down the slope is seen through the trees.

**Figure 4.59**. Pescia rockfall site 9b. 3D SfM model from UAV data. Boulders that have rolled into field below the road are circled in yellow. Source is indicated by white circle.

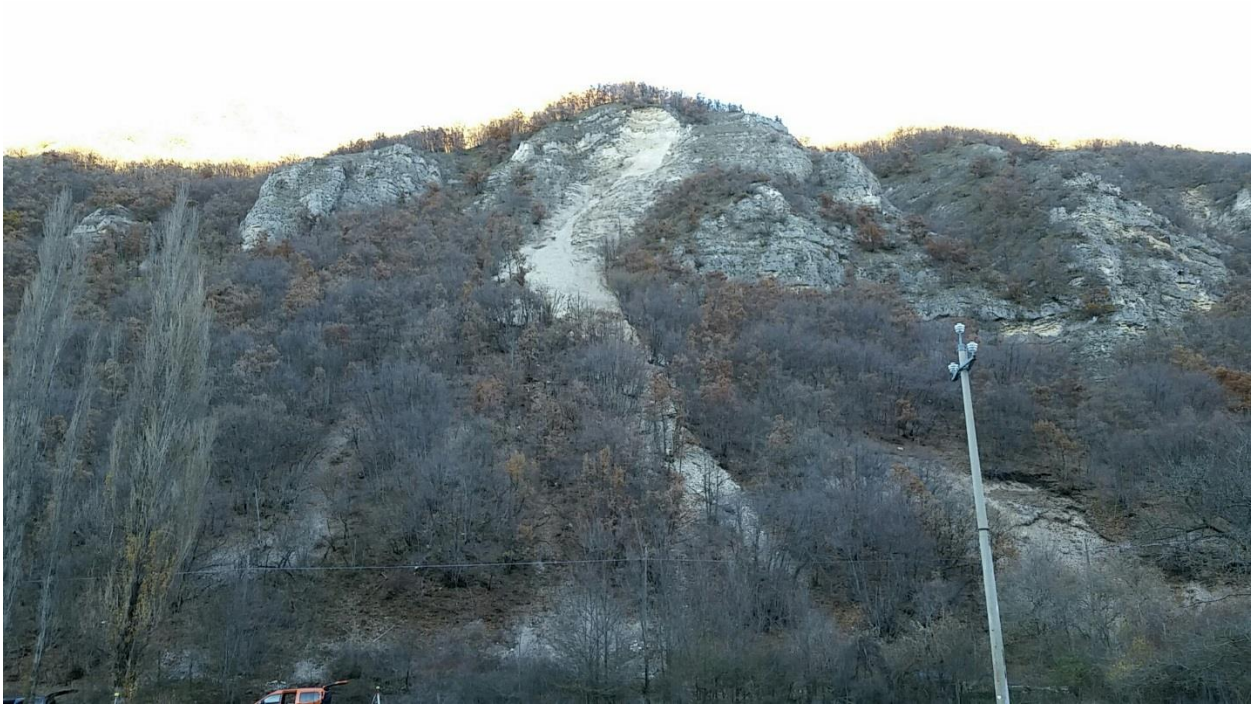
**Figure 4.60**. Pescia rockfall site 9b. Source area at top with runout damage. Not pictured: runout boulders across road and into field, corresponding to approximate 30 degree Fahrboeschung angles.

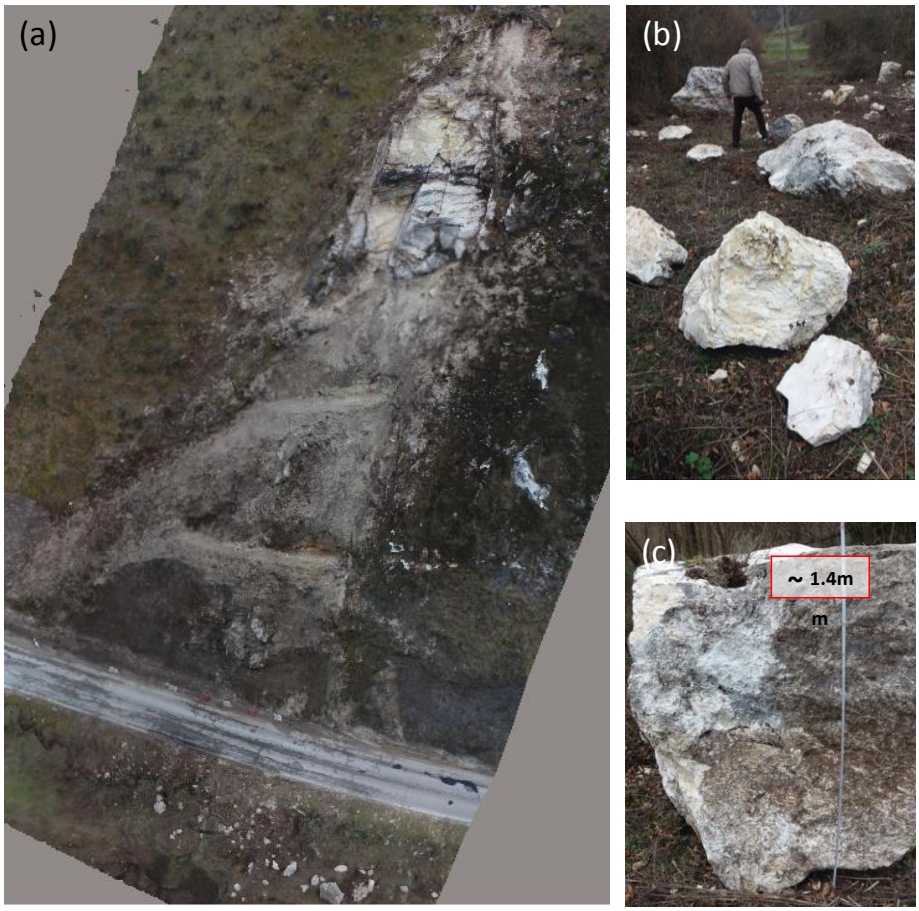
**Figure 4.64**. General oblique view from the drone of the rock slide on the right flank of the Nera valley (km 4 of SP134 motorway); the rock avalanche invaded the motorway and the valley bottom below for a stretch of about 70 m spreading large blocks (b-c).

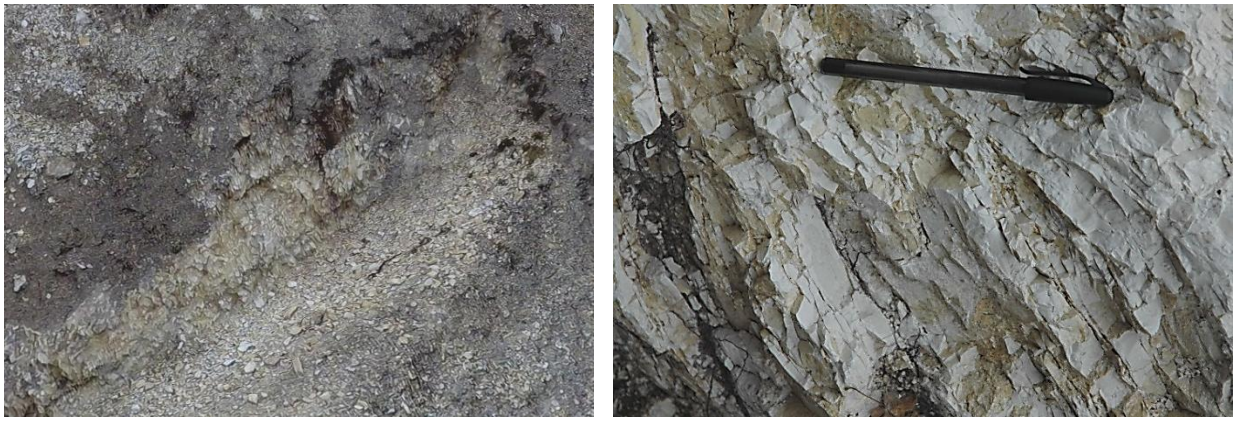
The height of the main slide scar is estimated from the 3D model as 20m. A layer of pervasively fractured rock below the main scar (Figure 4.66a), visible on close-range drone images, and the general ravinement of the lower half of the slope, suggest that the slide mass might extend downward and movement could be more complex. Apparent loosening of the rock mass, the pervasive fracturing of the rock at small scale (Figure 4.66b) indicate that the zone is tectonically disturbed and the slope underlying the slid rock spur was involved in the failure.

**Figure 4.66**. Drone image of a layer of cataclasized limestone located under the main slide scar(a) and detail of a pervasively fractured limestone block fallen from the slope (b).

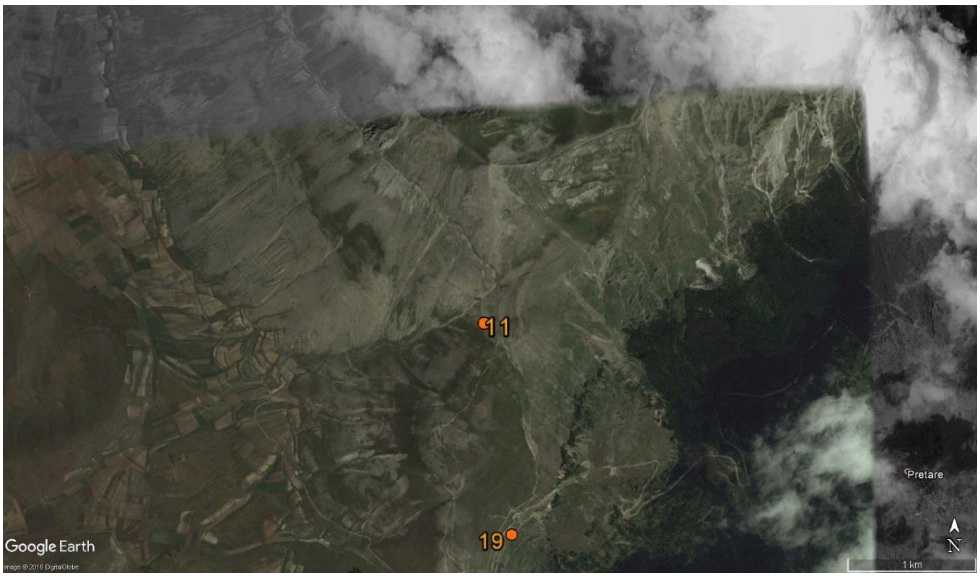
During fault rupture mapping of the west face of the Mt Vettore Massif, we observed many fissures, cracks, and scarps not directly associated with the primary fault rupture trace along the side of the mountain. These fissures, cracks and scarps complicated fault offset mapping and required careful interpretation to ascertain which scarps were faulting and which were from slope instabilities. These additional fissures, cracks, and scarps were limited to the west face of the Massif. None of these were observed on the south face, above road SR477. Figure 4.67 shows the location of these slope instabilities on the Massif (point 11), while the location of road SR477 is shown in Figure 4.67 as point 19.

**Figure 4.67.** Satellite image of Mt. Vettore Massive showing fault alignment and slope displacement sites 11 and 19.

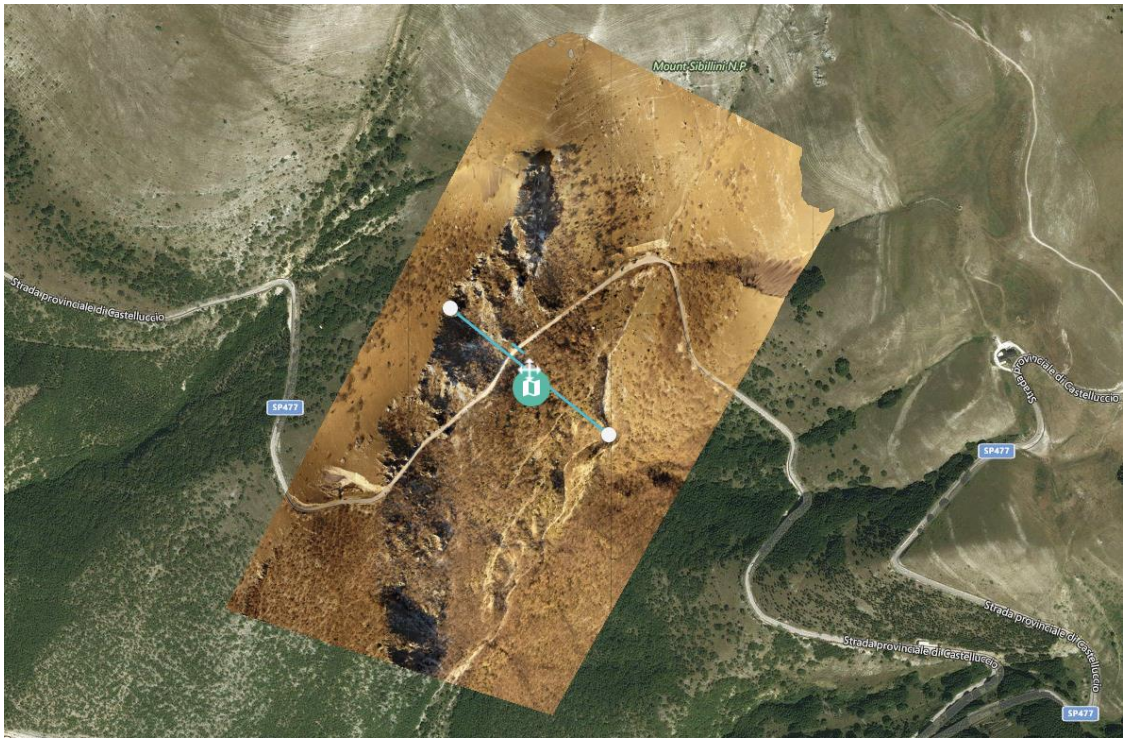
Rockfall in a layered limestone unit occurred along the SP477 route between Castelluccio and Norcia (Figure 4.71), showering the road with large blocks. The rockfall was observed following the 24 August event and again after the October events. All of the rockfalls were apparently the result of isolated blocks of limestone that detached from the outcropping bedrock above the highway. As with the August event, most of these blocks came to rest on the road, but individual boulders crossed the highway and descended a steep ravine. A UAV phantom4 was used to fly the outcrop bridge (Figures 4.72-4.73). Maximum block run out distances were on the order of 375 m, descending a net elevation change of 190-210 m.

**Figure 4.72.** Overlay of the UAV orthomosaic on top of the Google Earth image of SP477, the Castellucio-Norcia highway. Isolated boulders descended from the outcrop NE trending ridge on the left down to a ravine on the right side of the ortho mosaic, a maximum distance of approximately 375 m as indicated by the blue line. No other area along this highway had intense rockfall.

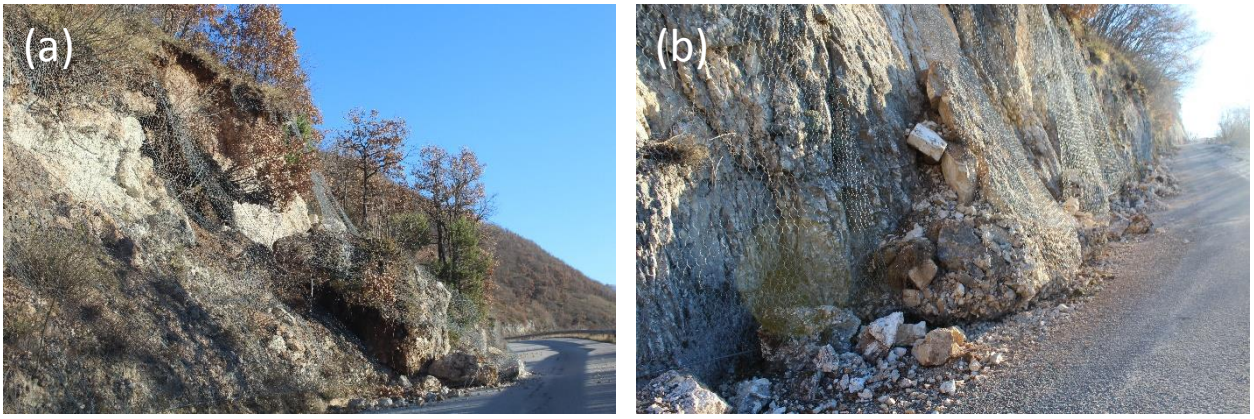
**Figure 4.77.** Debris and boulders captured by the rockfall protection nets.

**Figure 4.78.** Boulders supported by the vegetation.

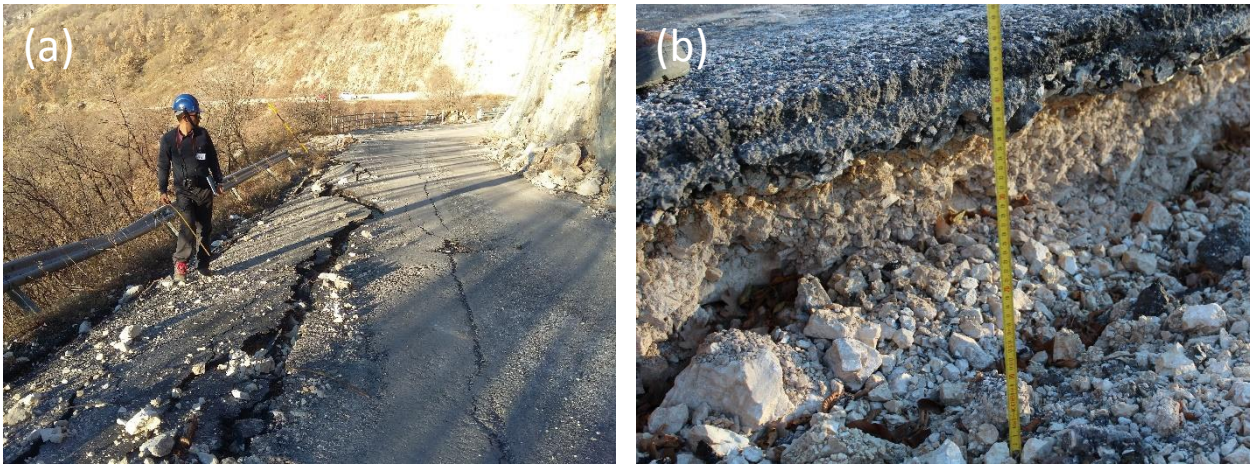
**Figure 4.79.** Fracture along the road, large vertical offset due to fracture and ultimate movement, damaged edge barriers and debris and boulders on the road surface.
