# Engineering Reconnaissance Following the October 2016 Central Italy Earthquakes

## *Version 2*

Geotechnical Extreme Events Reconnaissance Association
Report No. GEER-050D
8 May 2017

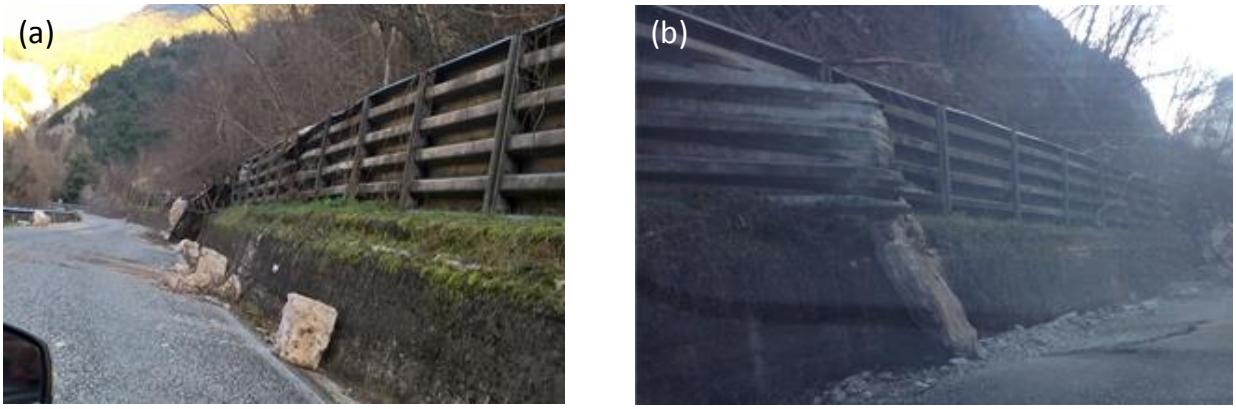
Figure 4.82 shows some of the rockfalls in the calcareous formations located on the left bank of the Nera river that we have identified after the 30 October 2016 earthquake. Many blocks, having a volume ranging from a dozen of cubic centimeters to a few of cubic meters, have been found on the shoulder or across the road. At the time of our reconnaissance, slide debris remained on the road and the highway was still closed.

**Figure 4.82**. Rockfalls along the SP209 between Triponzi and Visso.

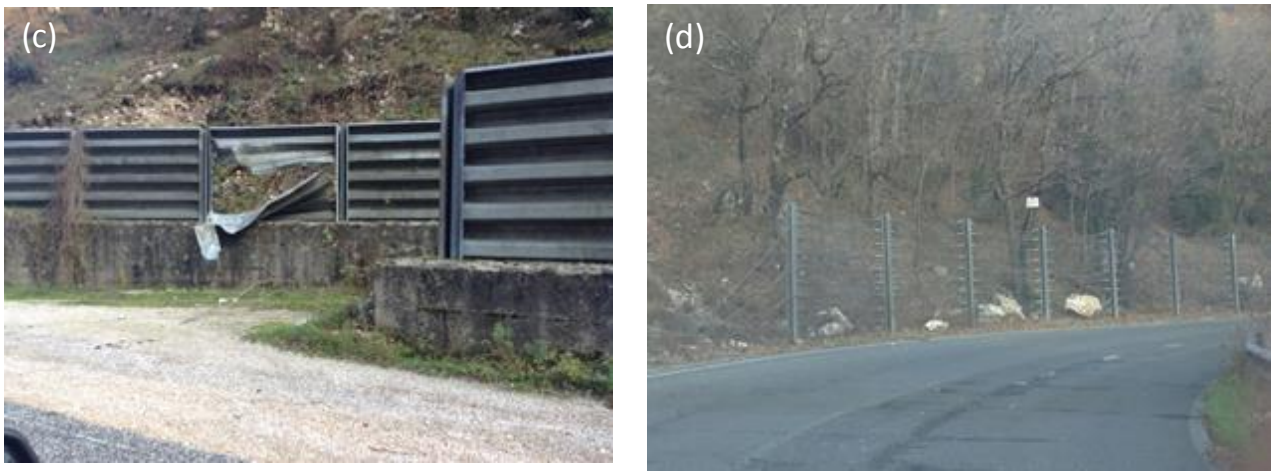
**Figure 4.83**. Slope protection damaged by boulders and rock-blocks.

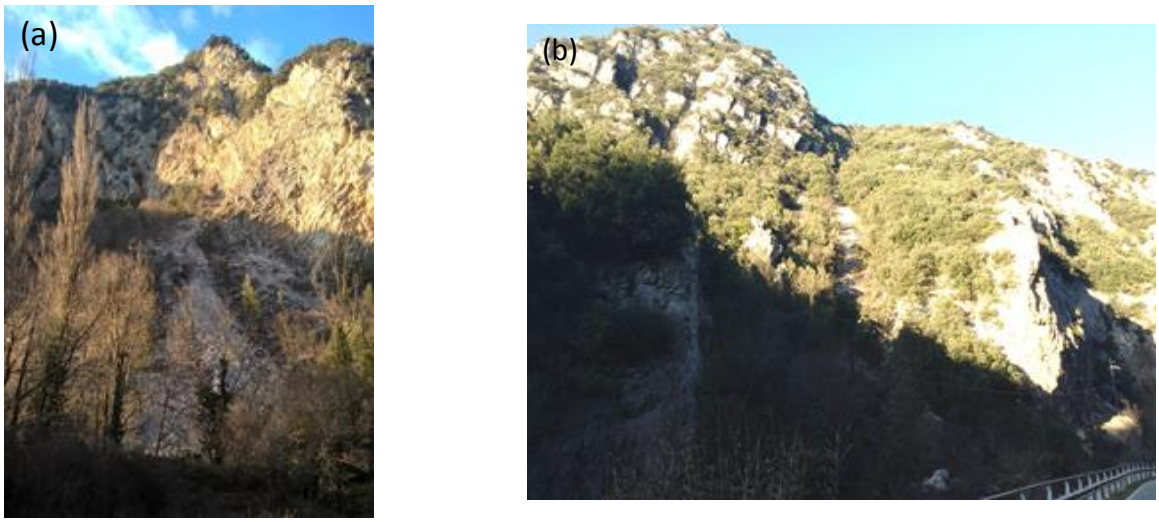
**Figure 4.84**. Debris occurred on the right bank of the Nera river along SP209 (lat 42.9157N, lon 13.0456E).

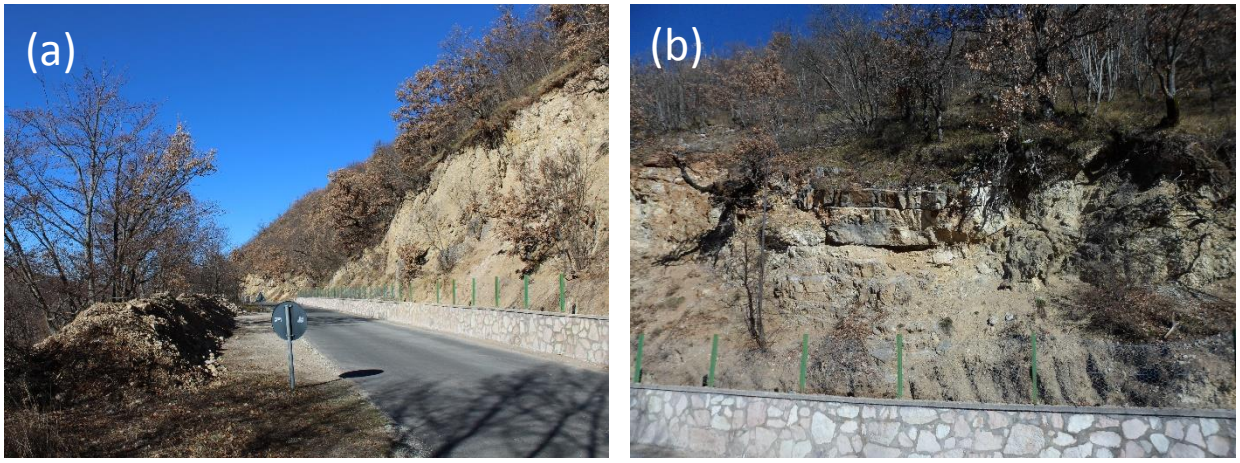
**Figure 4.88.** Landslide between Cittareale and Norcia along the SP746: (a) General view of the area; (b) Zoom on the crown and main body of the scarp.

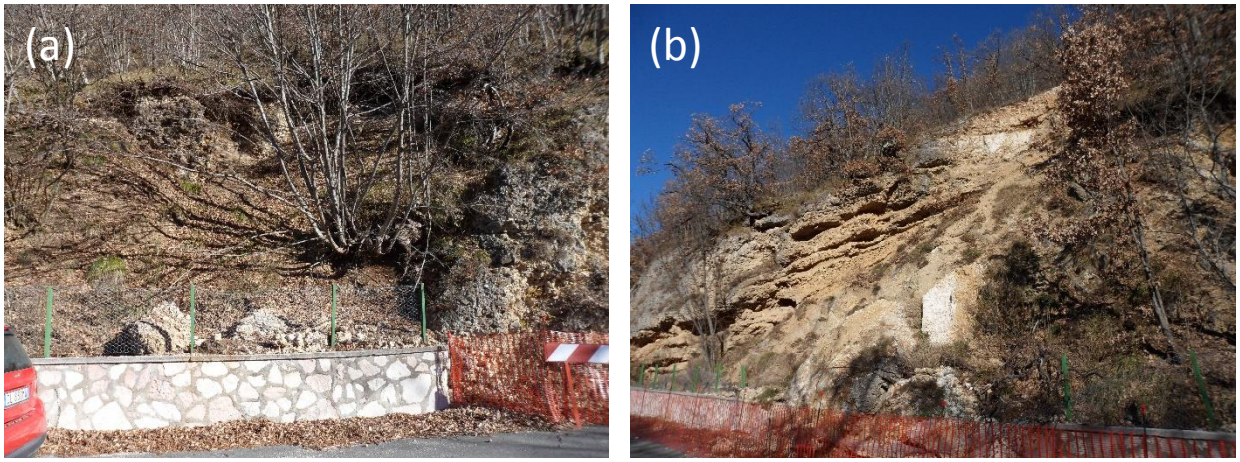
**Figure 4.89.** Failure in calcareous breccia between Cittareale and Norcia along the SP746: from (a) to (e) view of the all facade; (f) rockfall on the road.

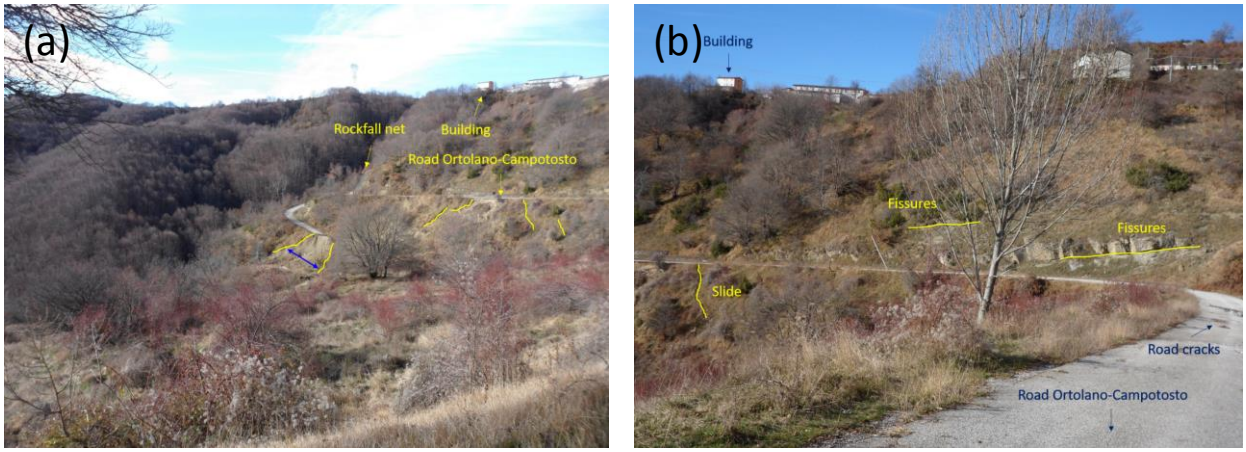
**Figure 4.91.** (a) Overview of the whole longitudinal extent of the landslide area; (b) close up view of the landslide-related features from the road Ortolano-Campotosto.

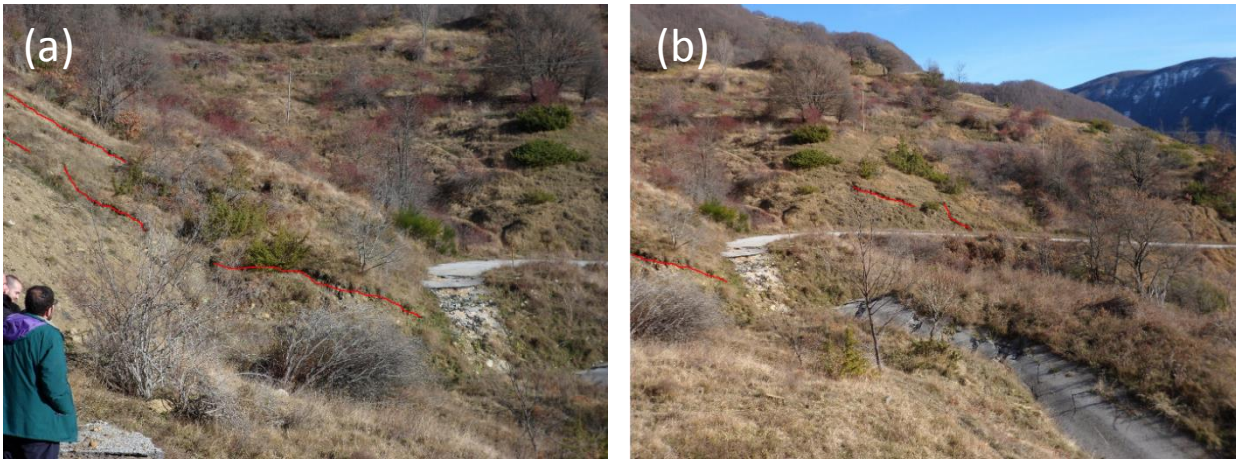
**Figure 4.94.** Fractures on the cut slope.

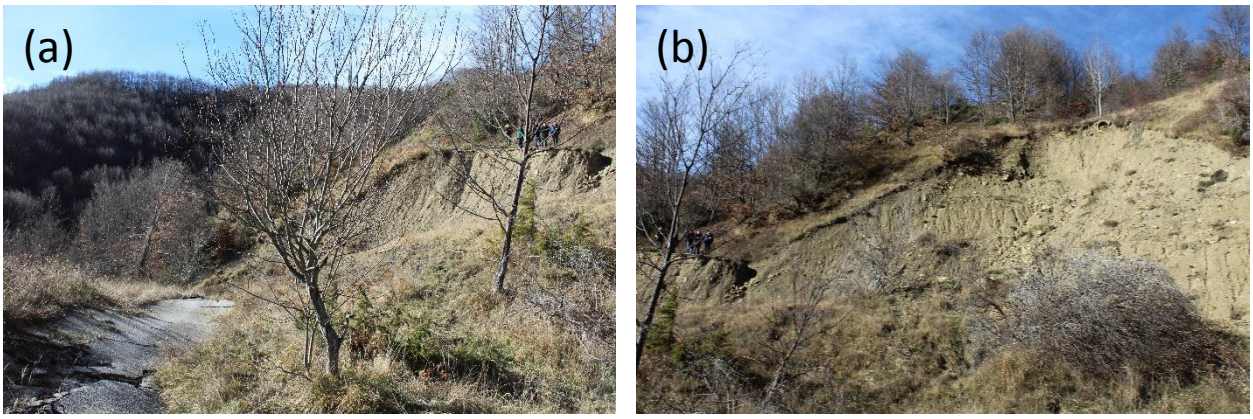
**Figure 4.96.** Minor scarps observed on the cut slope side of the road.

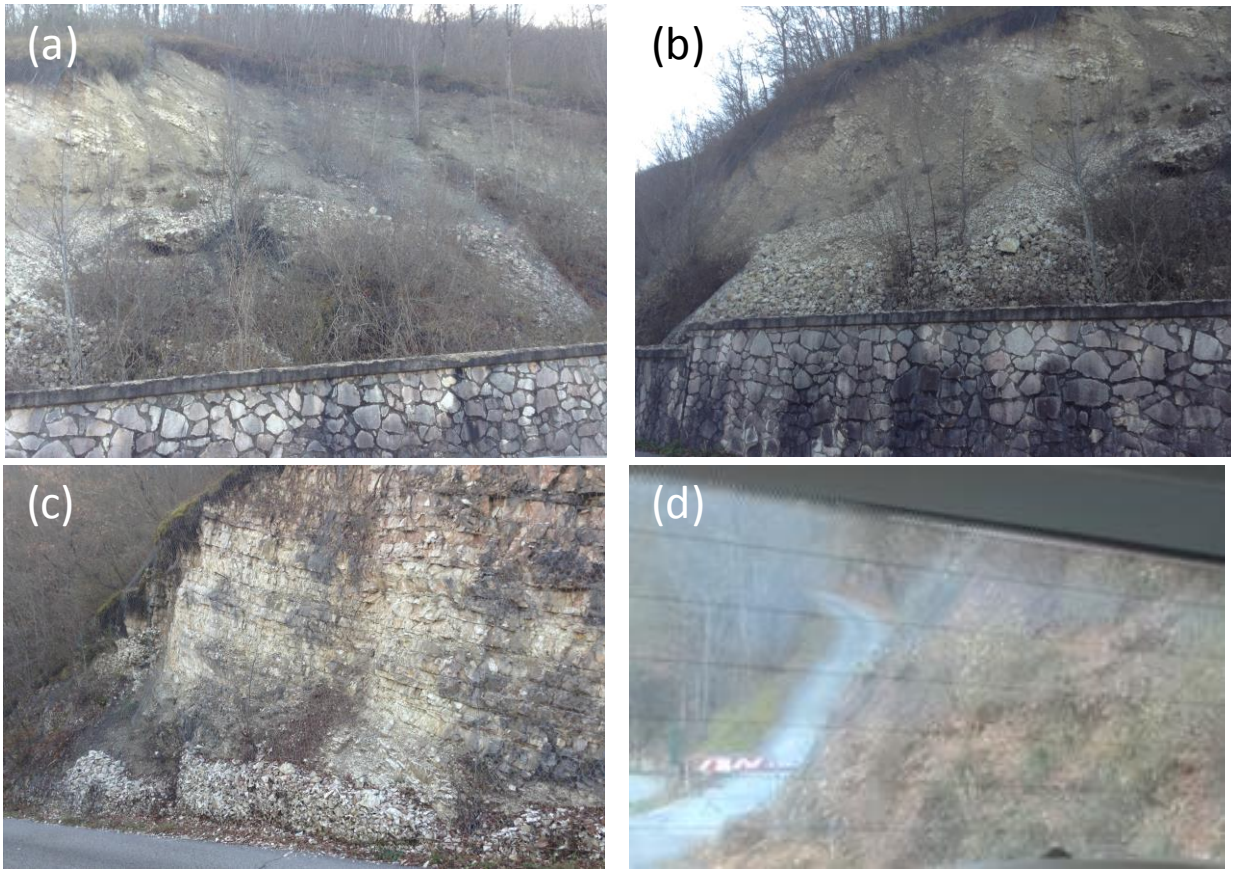
**Figure 4.99**. Observed rockfalls along SP476 (between Piedivalle and Preci).

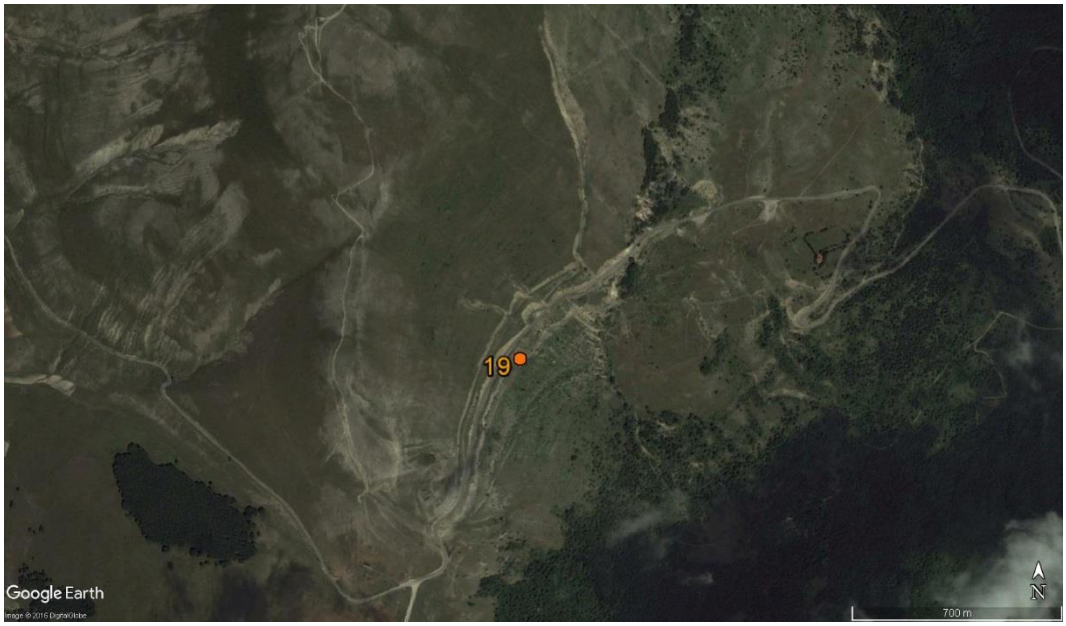
**Figure 4.103**. Location embankment fill damage area next to fault trace zone along SP477 road, Mt Vettore.

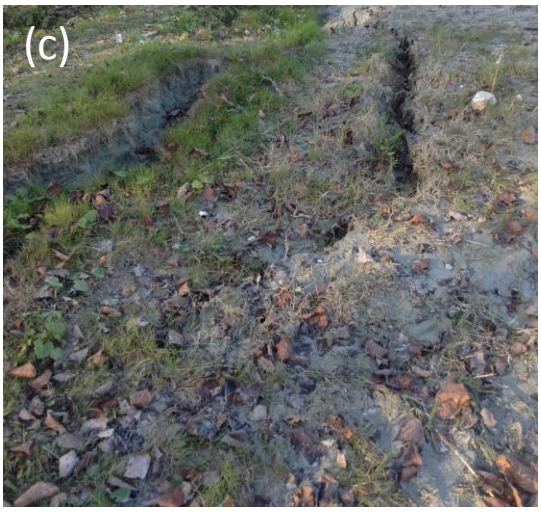
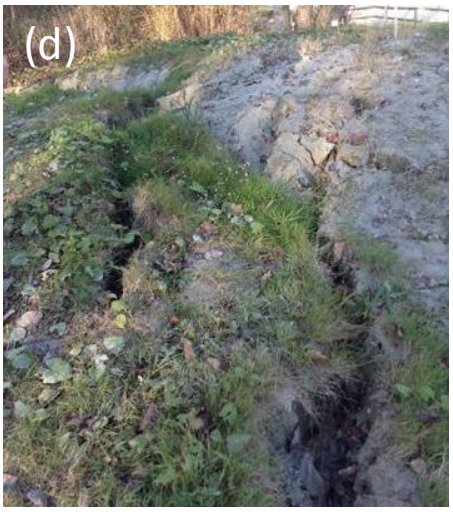
We inspected two mud volcanoes that erupted within one day from the **M**6.5 30 October earthquake event (Figure 5.3): (1) Santa Maria in Paganico (Figures 5.4a-b) and (2) Valle Corvone (Figures 5.4c-d-e-f). In both cases, we observed fresh deposits of ejected material. Both eruptions, are located within 45 km from the epicenter. . During our reconnaissance activities, both mud volcanoes showed a reduced activity, with a small emission of water. We inspected the sites about one month after the INGV reconnaissance mission. We did not detect any new activity or variations in the soil surface conditions in the inspected area as shown in Figure 5.5. As shown in Figure 5.4c-d-e-f, the material erupted by the mud volcano located in Valle Corvone covered a wide area involving both the river and the pavement of the road. This mud volcano is characterized by radial fractures 140 cm long, 38 cm wide and 80 cm deep. This eruption partially blocked the Ete river's course (Figure 5.4f).

**Figure 5.4**. (a) overview of the mud volcano in Santa Maria in Paganico; (b) sampling activities in in Santa Maria in Paganico; (c) crack originated by the mud volcano in Valle Corvone, (d) mud volcano in Valle Corvone, (e) details of a crack in Valle Corvone, (f) close-up view of the material ejected in the Ete Vivo river (Valle Corvone).

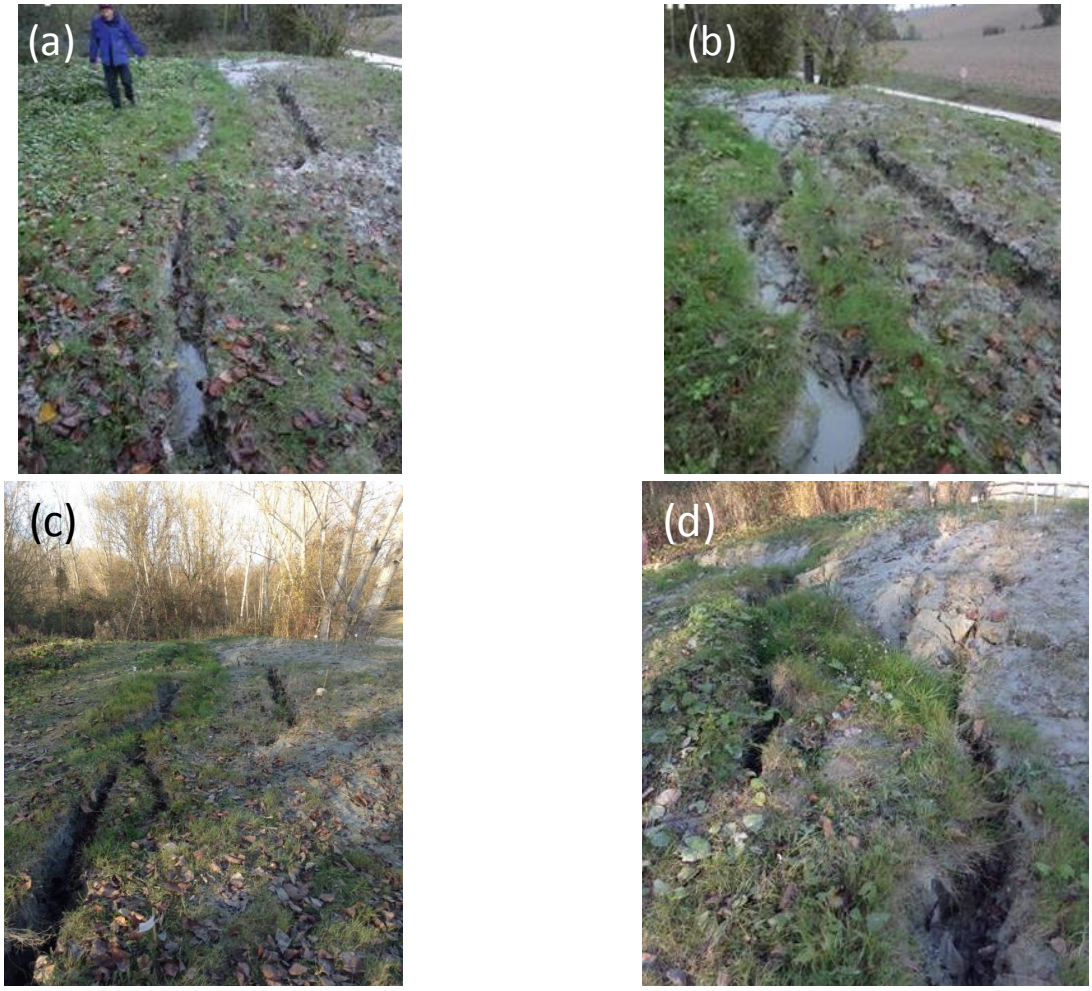
**Figure 5.5**. (a) and (b) photos of the mud volcano in Valle Corvone taken by INGV in November 2016 (INGV, 2016); (c) and (d) photos of the mud volcano in Valle Corvone taken from a common perspective by GEER in December 2016.

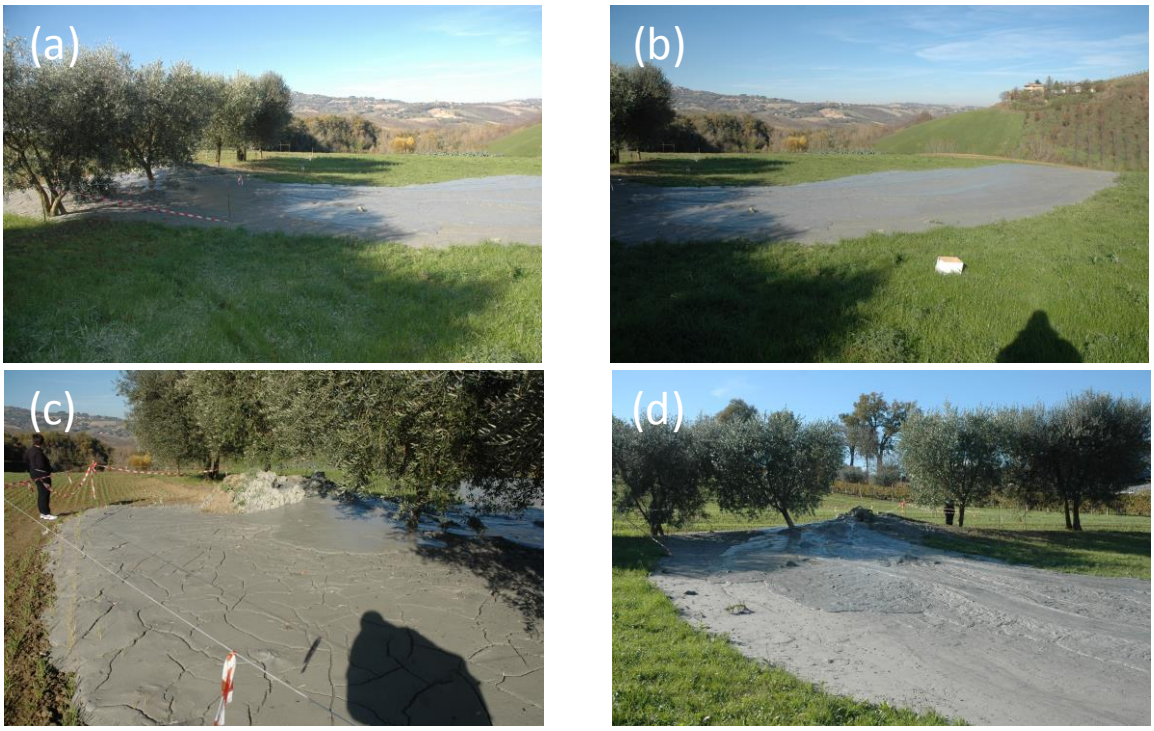
We inspected the newly formed volcano that erupted within one day from the **M**6.5 30 October earthquake event. Figure 5.8 shows the location of this eruption. Figure 5.9 shows photos taken during our reconnaissance. During our reconnaissance activities, the eruption showed a reduced activity, with a small emission of water. We inspected the site about one month after the INGV reconnaissance mission. We observed a substantial increase in the erupted material compared to the INGV reconnaissance (Figure 5.9).

**Figure 5.9**. Overview of the mud new volcano in Santa Vittoria in Matenano.

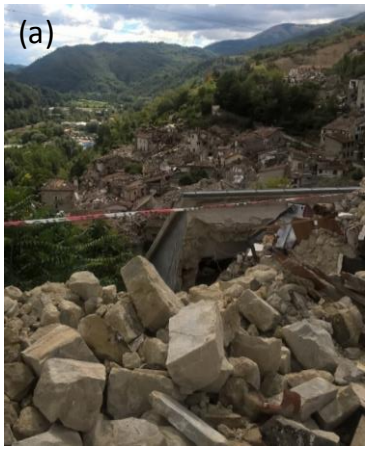
P06

**Figure 6.56.** Comparative pictures of selected structures in Pescara del Tronto after the 24 August event, and after the October events.

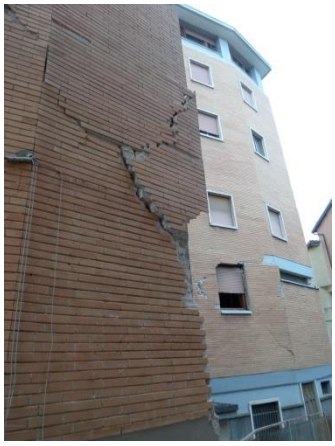
Figure 6.83 and Table 6.11 show locations of representative buildings inspected in the historic center of Camerino, including the red zone. Figure 6.84 shows photographs of these representative structures, which include both masonry and reinforced concrete dwellings two to four stories in height. The average damage level in the inspected zone was D2.

**Figure 6.84.** Representative pictures taken in Camerino (see Table 6.11 for details).

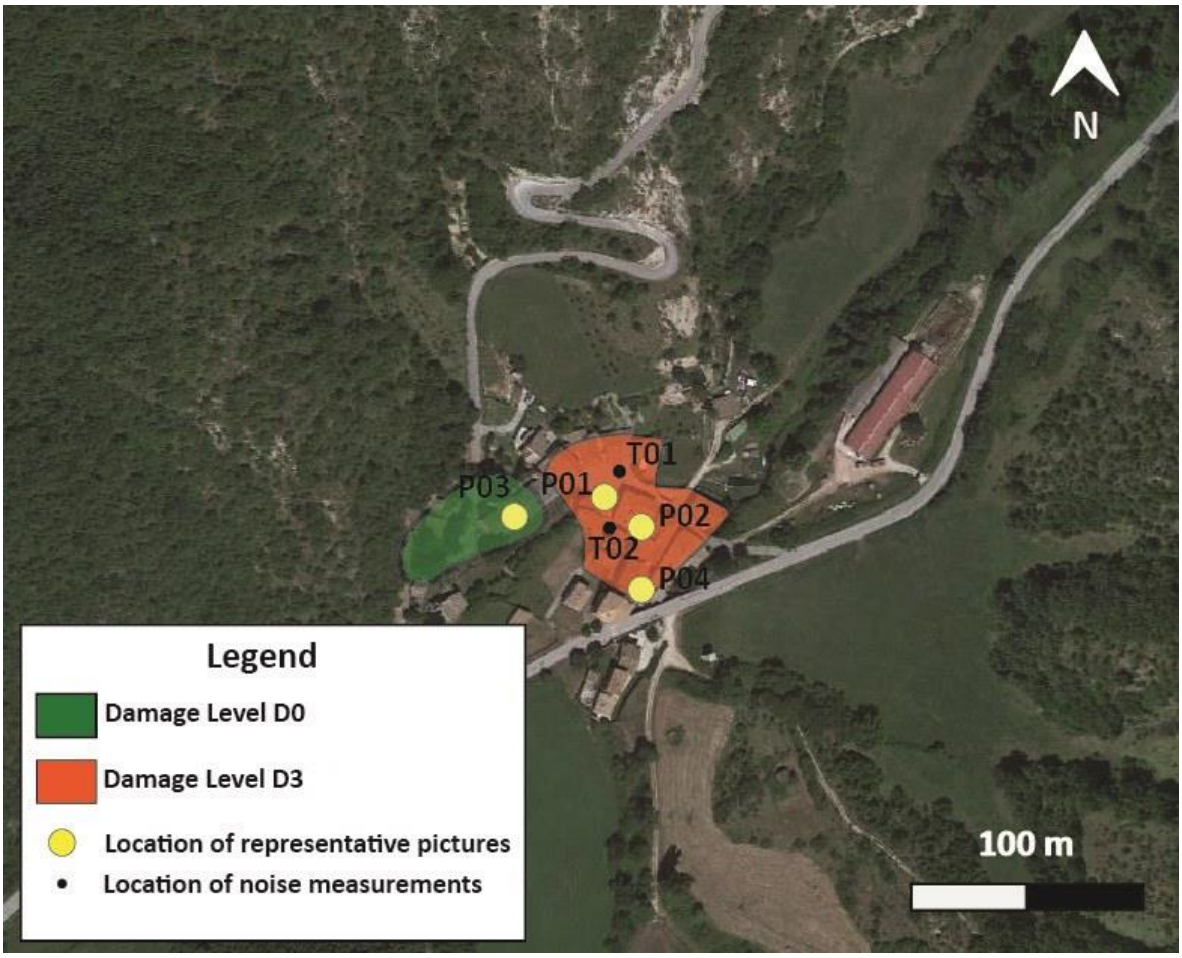
**Figure 6.94.** Locations of representative structures inspected in Fiume (Pieve Torina) and damage zonation (see Table 6.13 for details).

Fiume was significantly damaged by the October events. However, the degree of damage to buildings is strongly variable across the village (Figure 6.94). In particular, the eastern portion, founded on colluvial and alluvial deposits resting on bedrock, experienced high levels of damage (D3, see pictures P01-P02) whereas the western portion located on travertine rock had negligible damage (see P03).

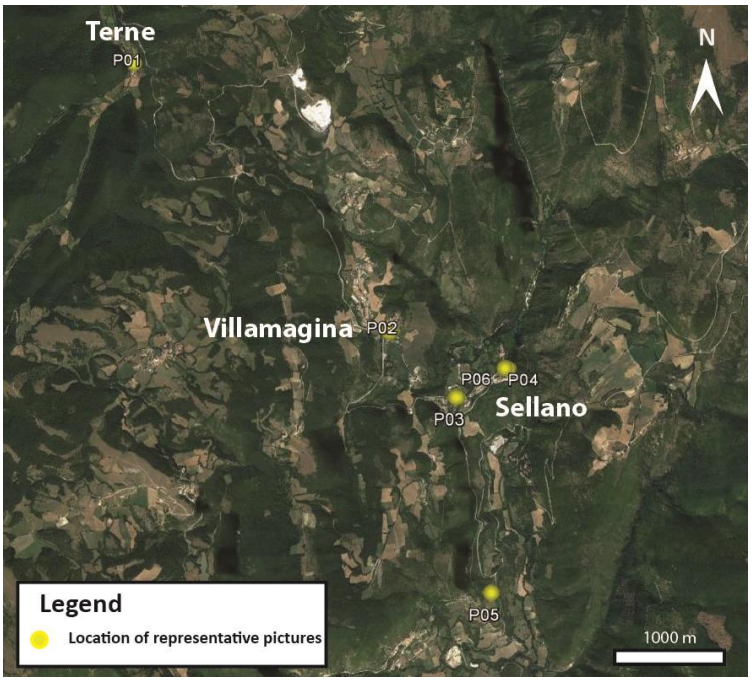
**Figure 6.101.** Locations of representative structures inspected in Sellano and surrounding hamlets (see Table 6.15 for details).

No or negligible damage was observed in the hamlets of Terne and Villamagina (on average D0-D1). Slightly higher damage (D1-D2) was reported in the upper part of Sellano (area of Santa Maria Assunta and Municipio, see P04 and P06).

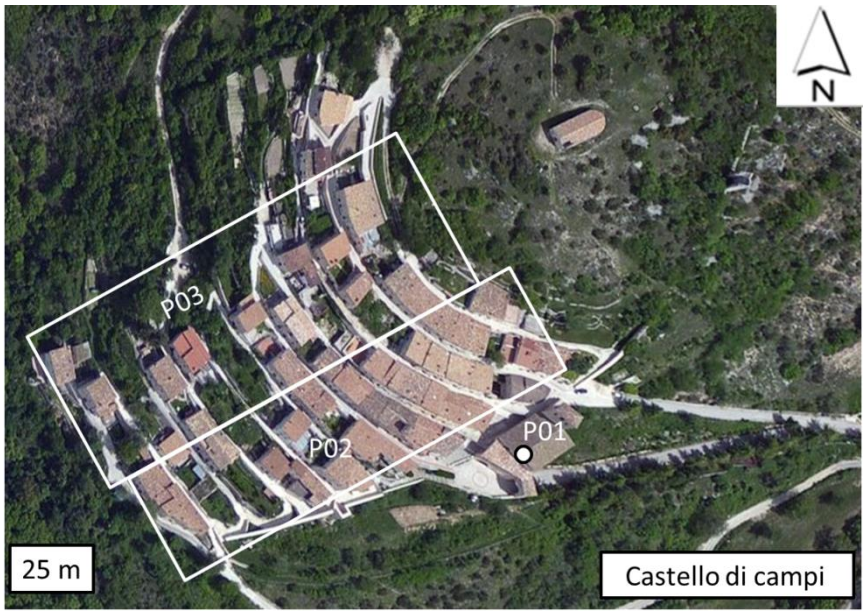
**Figure 6.116.** Locations of the representative structures inspected in Castello di Campi (see Table 6.19 for details).

The village of Castello di Campi (42.853729, 13.100582) belongs to the municipality of Norcia and is about 11 km from the center of Norcia. It has 172 inhabitants according to the ISTAT census of 2001. Table 6.1 shows the ground motions levels. Figure 6.116 shows the locations of inspected buildings, Figure 6.117 shows the building photos. Table 6.19 shows details for inspected buildings. Observed buildings are unreinforced masonry. Damage levels vary from D2 to D3.

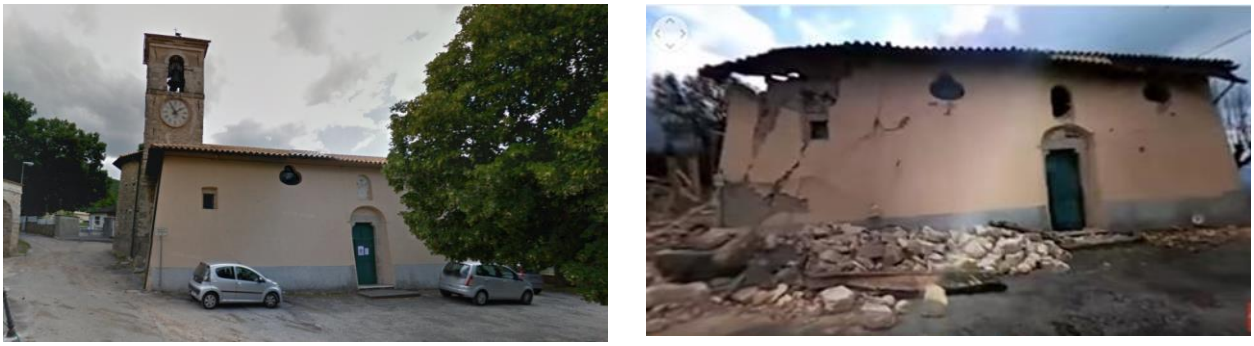
P01. Montesanto street

During our reconnaissance following the 30 October event, we observed extensive damages in almost all the masonry structures (classified as D3-D5) located mainly in the historical center of the town, which was in part not accessible. Some pictures of the damaged buildings in the historical center are shown in Figure 6.127 (source Repubblica.it, last accessed 21 April, 2017). In the new part of the town damages were concentrated on non-structural components of some of the reinforced concrete buildings recently constructed (classified as D2). Figure 6.128 shows multi-epoch pictures (before August and after 30 October, 2017) of selected locations. Table 6.24 summarizes the overall damage level observed in these locations.

**Figure 6.127.** Damaged constructions in the oldest part of San Pellegrino (http://video.repubblica.it/dossier/terremoto-30-ottobre/terremoto-centro-italia-la-distruzione-a-san-pellegrino-di-norcia-dal-drone/257495/257761).
