Post-collapse analysis of Morandi’s Polcevera viaduct in Genoa Italy

# Post Collapse Analysis of Morandi's Polcevera Viaduct in Genoa Italy

Maurizio Morgese [a], Farhad Ansari [b], Marco Domaneschi [c], and Gian Paolo Cimellaro [d]

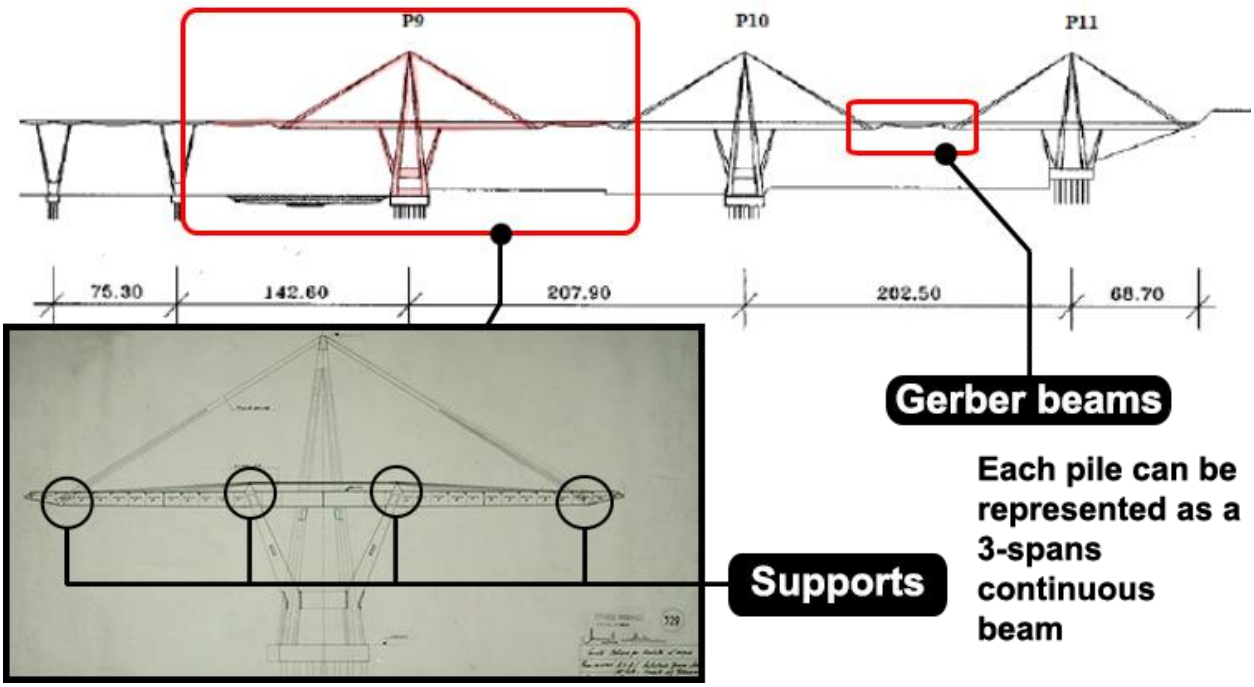
**Figure 3**. Schematic diagram of the Polcevera Viaduct.

In most countries, bridges are usually designed for a service life of 75 years, and in addition to biennial inspections (i.e. in USA), they generally receive an overhaul by mid-life [15]. In the case of the Morandi bridge, one of the three pylons, P11 in Fig. 3, was repaired in 1992, by replacing its corroded cables with new sets of cables. The rest of the pylons did not receive any repairs, which eventually one of them, P9 in Fig. 3, failed and instigated the partial collapse of the bridge [16, 17].

The design had features that were characteristically different from conventional methods, such as the fact that the individual pylon-deck systems of the bridge were only supported by two stays on each side running over the pylons over saddle seats. This design did not allow for redundancy, especially when the stay cables were made of prestressed concrete and difficult to inspect for corrosion. Nevertheless, the bridge lasted for over 50 years, without much maintenance, especially at the cable stays, except at one of the pylons, which did not collapse (P 11 in Fig. 3).

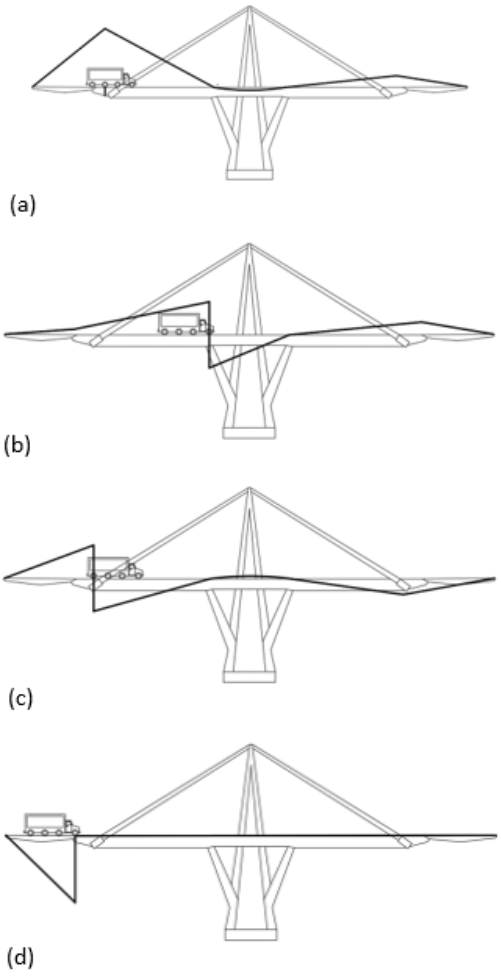
Considering the load path and the reaction influence line at the Gerber beam support in Fig. 14d, partial or full positioning of the truck axles on the Gerber beam would not affect the main girder of the bridge, even though it exerts a large load on the Gerber beam support. Therefore, the influence of the Gerber beam loads on the failure of girder-pylon system was discounted in the present study. Failure of the cable stay as indicated by the forces shown in Fig. 14a was considered as the main culprit for the collapse of the girder-pylon system.

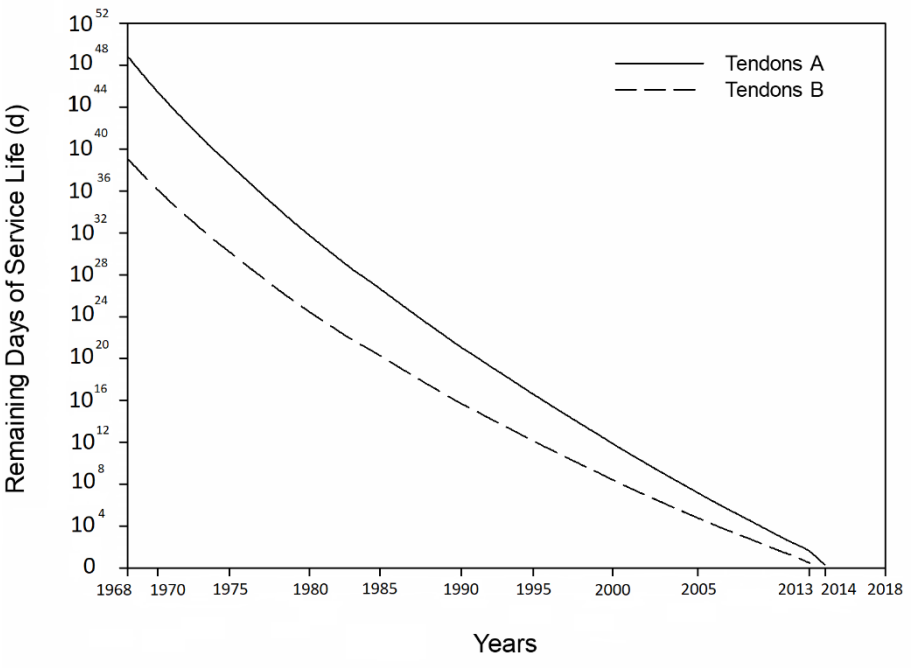
**Figure 16.** Remaining days of service life Tendons A and Tendons B.

Repeating this procedure for every year of bridge service life since its inception, it was possible to compute the remaining days of service life per year as shown in Fig. 16. It is possible to observe as tendons B reach failure in 2013 and tendons A fail in 2014, leading to total collapse. The cumulative damage model based on Palmgren-Miner–law predicted the collapse date of the Morandi bridge 4 years earlier than the actual collapse date of 2018.

A number of different approaches were compared in estimating the remaining life of the bridge, including the cumulative damage law of Palmgren-Miner–law, and the Goodman, Gerber and Soderberg $S_a$-$S_m$ diagrams. The predicted timing of collapse by these models ranged from the year 2014 based on the cumulative damage law, and 2016 by the Gerber and Goodman diagrams.

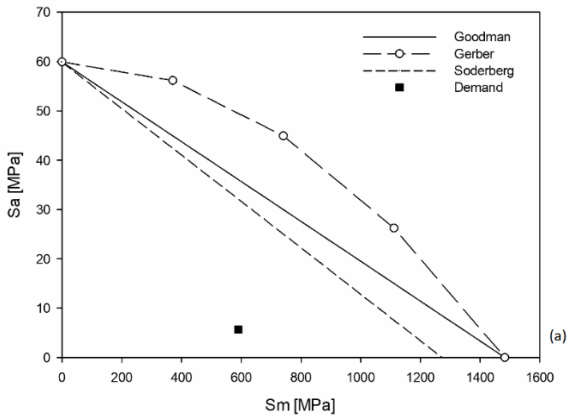
**Figure 17.** Goodman, Gerber and Soderberg surface (a) Tendons A in 2014, (b) Tendons B in 2013.

Fig. 17 corresponds to the Goodman, Gerber, and Soderberg diagrams for the years 2013, and 2014, respectively, the years in which tendons B, and A failed based on the cumulative damage computations of Palmgren-Miner-law. Comparison of the results shown in Fig. 17 reveals the contrast between the timing of stay cable failure predicted by the Palmgren-Miner-law, and the Goodman, Gerber, and Soderberg diagrams. According to these diagrams, the bridge would not collapse in 2014, as predicted by the cumulative damage model. However, As shown by the Gerber, and Goodman diagrams in the subsequent years, shown in Fig. 18, the stay cables A and B fail in 2015, and 2016, respectively. The stay cables would have still remained in service by the Soderberg $S_a$-$S_m$ law, which is less conservative than its counterparts (Gerber, and Goodman).
