16th World Conference on Earthquake Engineering, 16WCEE 2017
Santiago Chile, January 9th to 13th 2017
Paper N° 4999
Registration Code: S-J1478293269

ENGINEERING RECONNAISSANCE FOLLOWING THE AUGUST 24, 2016 M6.0 CENTRAL ITALY EARTHQUAKE

Abstract

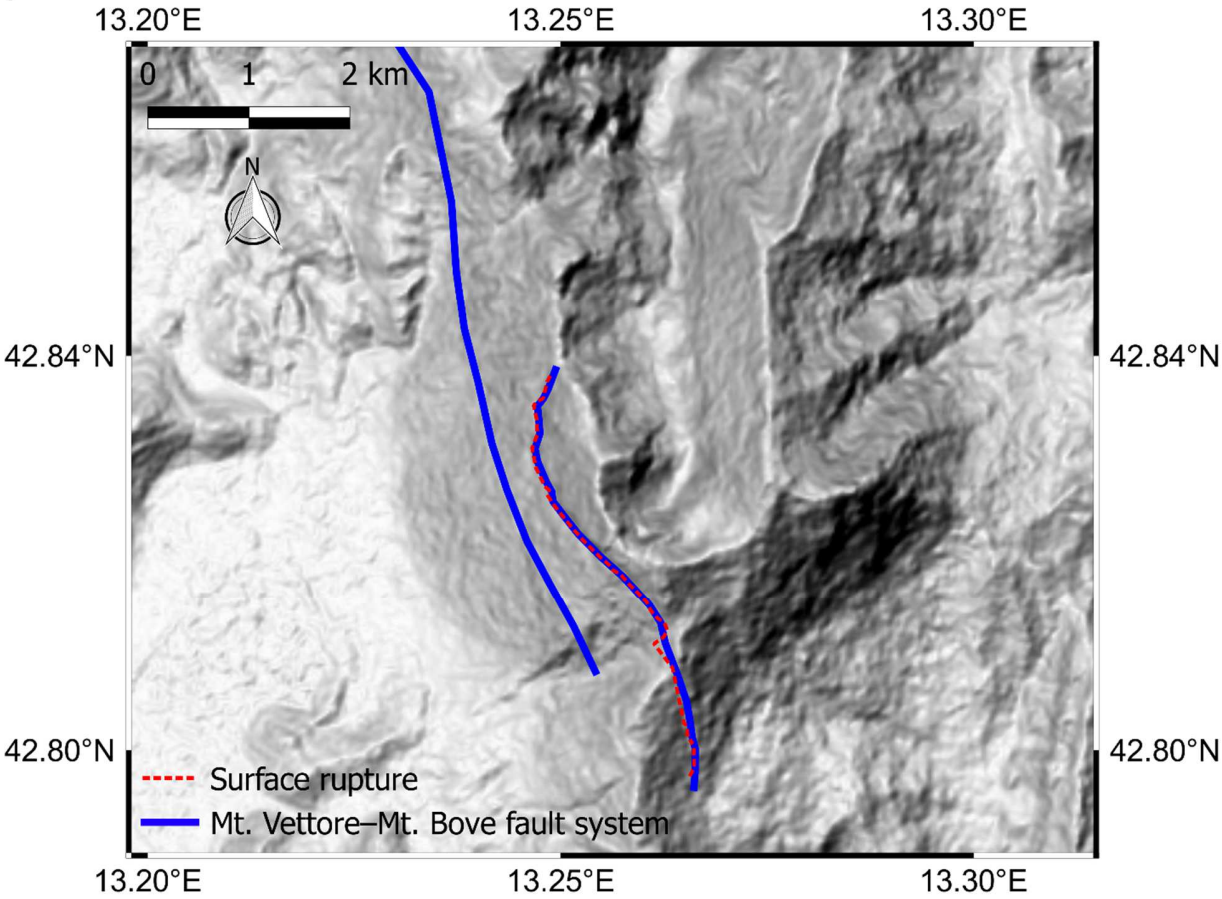
Fig 2 – Detail map of surface fault rupture and pre-event mapping of Mt. Vettore-Mt. Bove fault system (adapted from Pizzi and Galadini, 2009).

Surface rupture occurred over a 4.8 km portion of the Mt. Vettore fault, as shown in Figure 1 and 2. Working with researchers at INGV (especially co-authors Galadini, Gori, and Falcucci), displacements on the primary rupture were measured as generally in the range of 10-25 cm. These displacements were down-dip, generally with no appreciable along-strike component. Figure 3 shows a general view of the fault trace (Figure 3a) and a typical displacement measurement on the fault (Figure 3b). We did not see secondary breaks on the hanging wall. Aerial imagery of the surface rupture is pending.

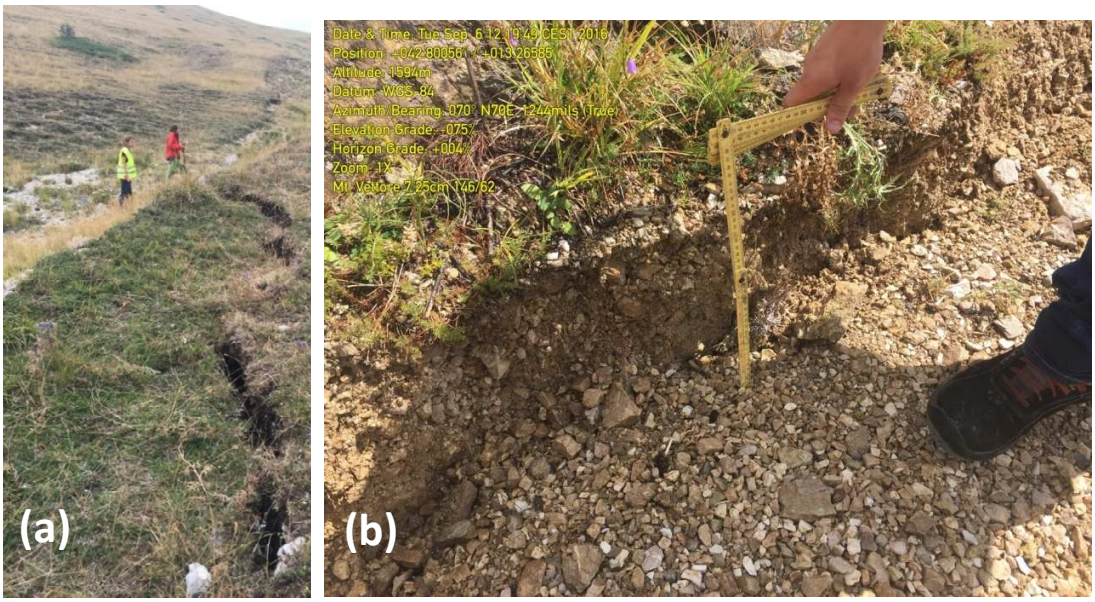
Fig 3 – (a) photographs of surface rupture on trace of Mt. Vettore fault (N42.79953, E13.26634, 5 September 2016) and (b) typical measurement (N42.8056, E13.26585, 6 September 2016).

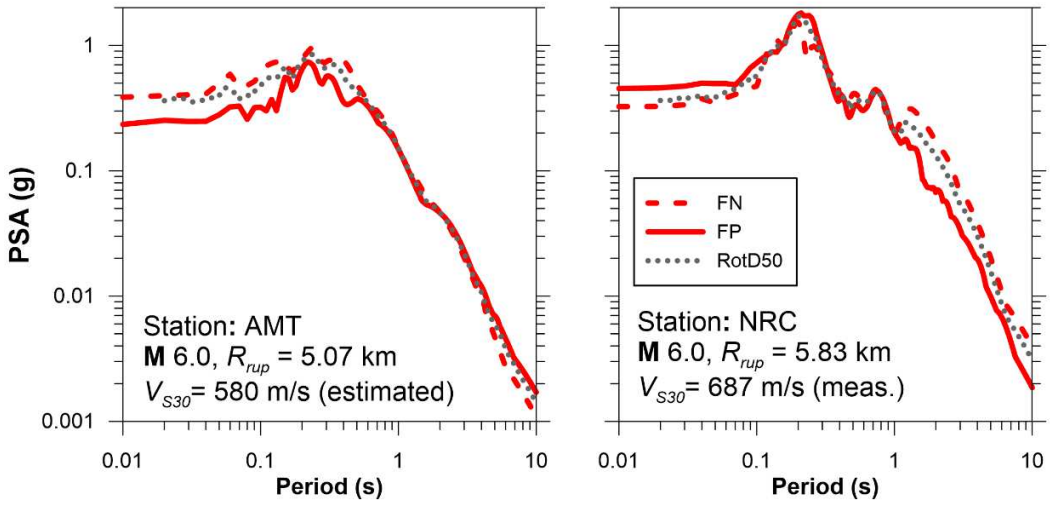
Fig 4 – Mainshock pseudo acceleration response spectra (5% damping) for Amatrice (AMT) and Norcia (NRC) sites. Fault strike taken as 150 deg for computation.

Figure 4 shows pseudo-acceleration response spectra (PSA) from the two stations most proximate to the mainshock rupture plane (AMT and NRC), which are shown in Figure 1. The corrected ground motions have been rotated into fault normal (FN) and fault parallel (FP) components. The two ground motions are of comparable amplitudes (NRC slightly higher), despite substantially different damage levels (details below). The AMT ground motion shows evidence of polarization in the FN direction at short oscillator periods (< 1.0 sec), while the NRC motion is stronger in the FN direction at long periods (> 1.0 sec).

We have visited the AMT and NRC sites. The instrument shelters at neither site appears to have been damaged by the earthquake, and both shelters are small structures unlikely to appreciably affect the recordings. Generally, the damage patterns near the AMT site were also suggestive of stronger shaking in the FN direction, which will be detailed in our Ver 2 report.

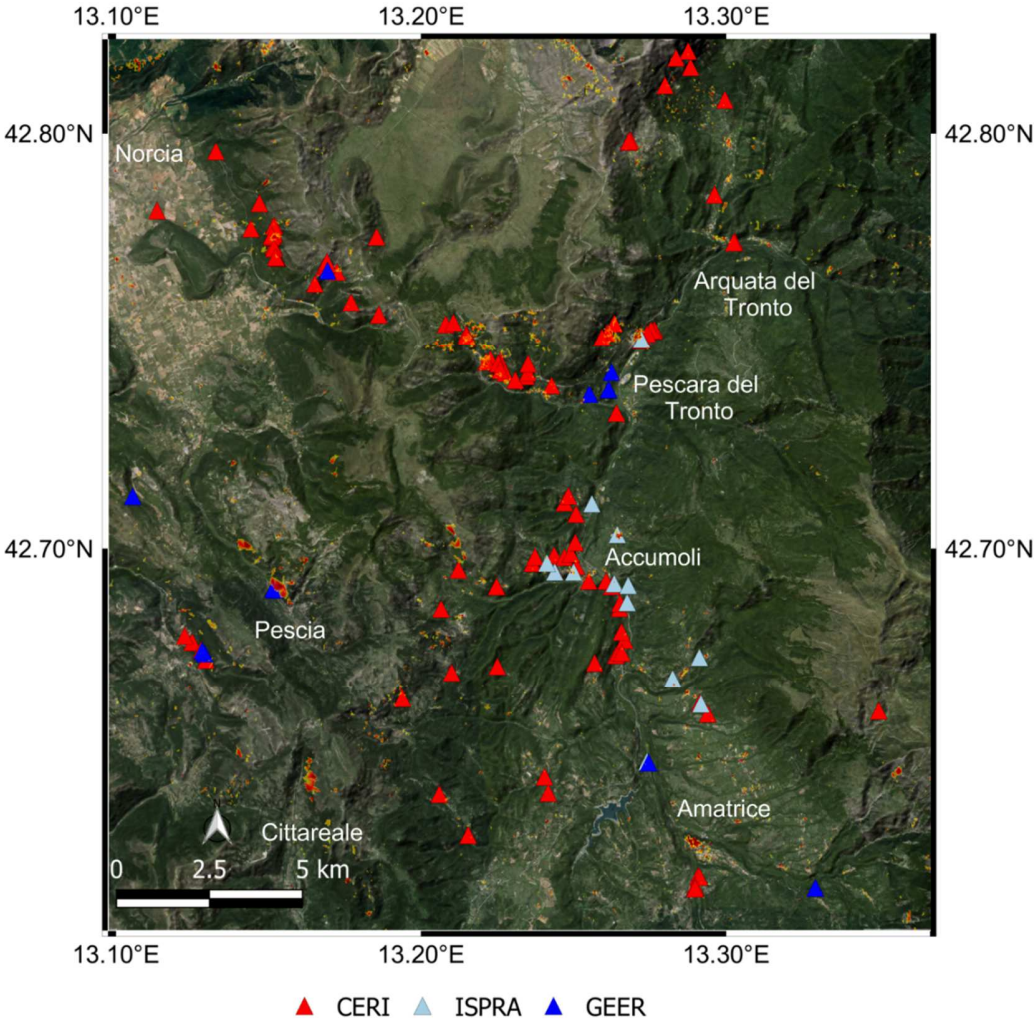
Figure 5 shows locations of known rockfalls and landslides. Prior to deployment of the GEER team, we reviewed reports of rockfalls from ISPRA [7] and CERI [8]. We found a limited number of landslides beyond those identified in the preliminary reports.

We overlaid the ISPRA and CERI locations on a map of multi-epoch (pre- to post-earthquake) deformation based on InSAR coherence changes (Damage proxy maps, ARIA project, JPL-Caltech, available at: http://aria-share.jpl.nasa.gov/), as shown in Figure 5. Our approach to reconnaissance activities was to initially visit sites of mapped deformation, but no prior rockfall observations, followed by more detailed mapping activities for high-value case histories.

Using direct visual observation where possible, in combination with aerial drone based imaging, we found no detectable landslide activity in the high-deformation zones shown in Figure 5 without prior landslides.

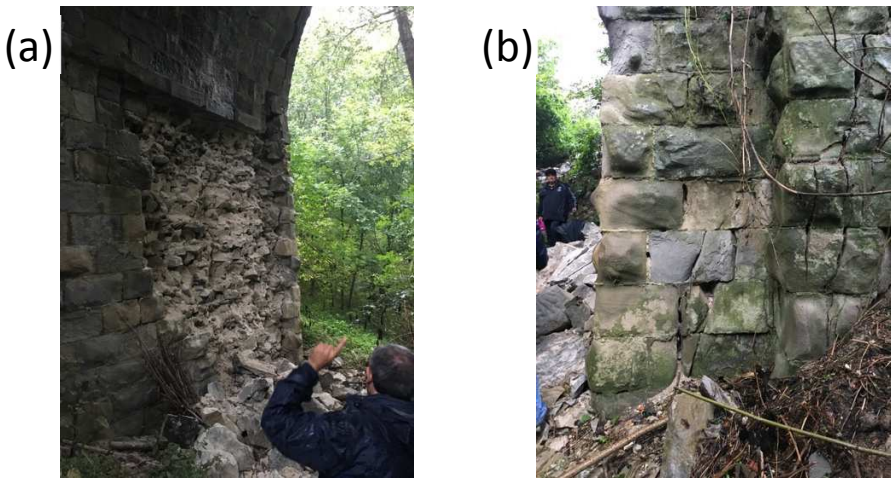
We found no evidence of damage to any of the contemporary bridges. We found damage to two arch masonry bridges at the locations shown in Figure 1. One of these bridges is near the village of Tufo on the Roman-era Trisungo route. The bridge had some cracking and spalling of exterior masonry elements, apparently exacerbated by settlement at the east support of the arch, as shown in Figure 7.

Fig 7 – Roman-era bridge along the Trisungo route (Tufo area – Arquata del Tronto): (a) spalling and (b) cracking of exterior masonry elements. (N42.735389, E13.253611, September 7 2016).

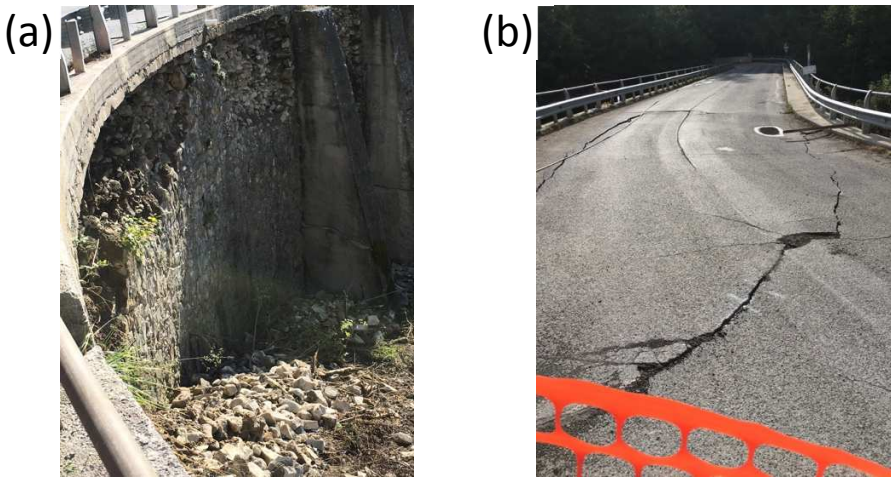
A second damaged bridge is the Ponte a Tre Occhi (Three eyes) near Amatrice, which is a critical lifeline for the access to the village of Amatrice. One of the arches exhibited cracking, but the most severe damage occurred to approach structures of *muratura a sacco* masonry construction, in which portions of the outer layer of masonry were lost, leading to lateral relaxation and settlement of the bridge deck (Figure 8). The bridge remained closed as of the date of our last site visit (8 September 2016).

Fig 8 – Ponte a Tre Occhi (Amatrice): (a) spalling of the outer layer of the masonry and (b) settlement of the road surface. (N42.62067, E13.290278, September 8 2016).
