Surface orange patinas on the limestone of the Batalha Monastery
(Portugal): characterization and decay patterns

Yufan Ding[1,2] · Pedro Redol[3] · Emma Angelini[2] · José Mirão[1,4] · Nick Schiavon[1]

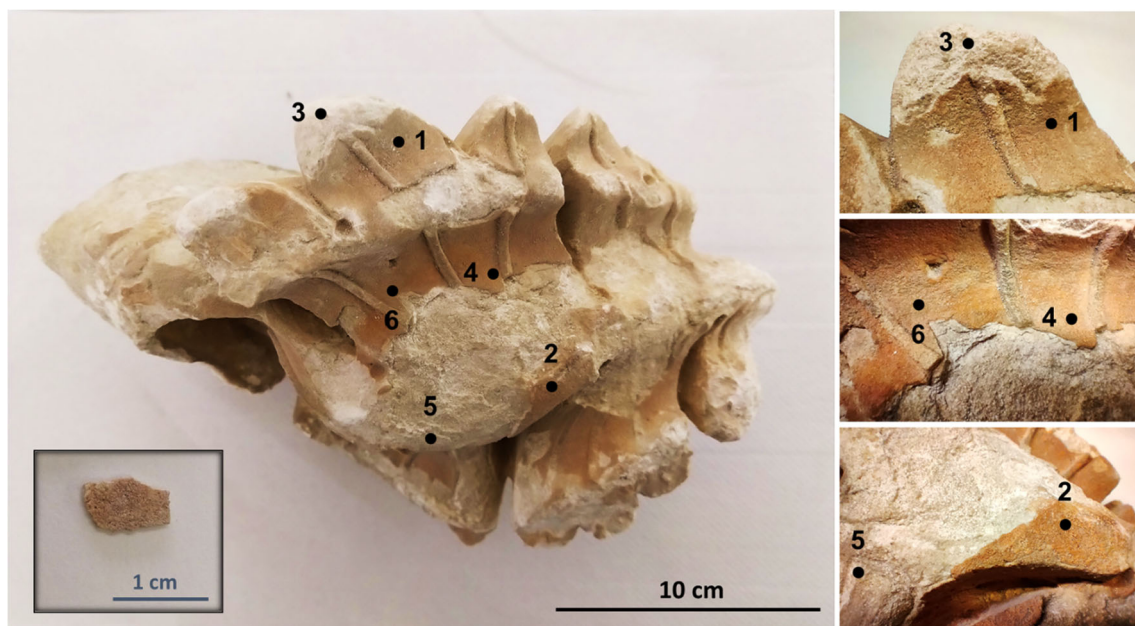
Fig. 2 Ornament "S-116" and the peeled-off surface fragment

μ-X-ray diffraction patterns were acquired on six points of the ornament "S-116" and a peeled-off fragment, as shown in Fig. 2. Points 1, 2, 4, and 6 were acquired on the orange surface patinas, whereas points 3 and 5 were acquired on the substrate where the orange surface had already peeled off with the limestone substrate showing extensive decay. The XRD pattern and peaks are presented in Fig. 5, and a semi-quantitative evaluation is given in Table 1.

The decay pattern of these orange layers on the two samples was also distinct. On the ornament "S-116," the surface layer was flaking; on the white substrate under the peeled-off lamination, higher content of halite was detected. This indicates a typical salt decay process: salt solution evaporated and crystallized at the interface between the coating and the substrate, leading to detachment eventually (Duffy and Perry 1996). In this case, the salt responsible for decay is mainly halite (NaCl); its precipitation leading to salt decay in the monastery may probably derive from ground-moisture capillary rise. Considering the Royal Cloister window tracery, the patina was lost preferentially at the ridges and bulges but was more preserved in flat areas where marks of scratches can also be seen. Three possible explanations can be suggested: (a) the evaporation rate of salt solutions is higher at the geometrically protruded parts due to a larger specific surface area, resulting in higher crystallization pressure inside the stone pores and more severe decay (Rodriguez-Navarro and Doehne 1999); (b) protruded areas endure more mechanical abrasion from

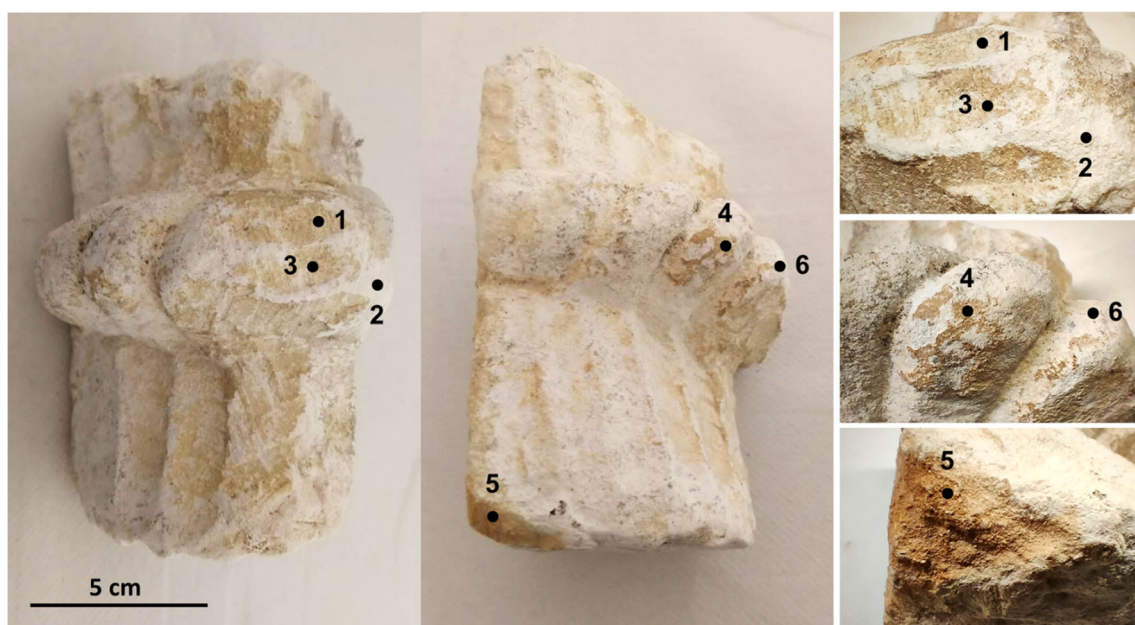
Fig. 3 Window tracery piece from the Royal Cloister of the Monastery

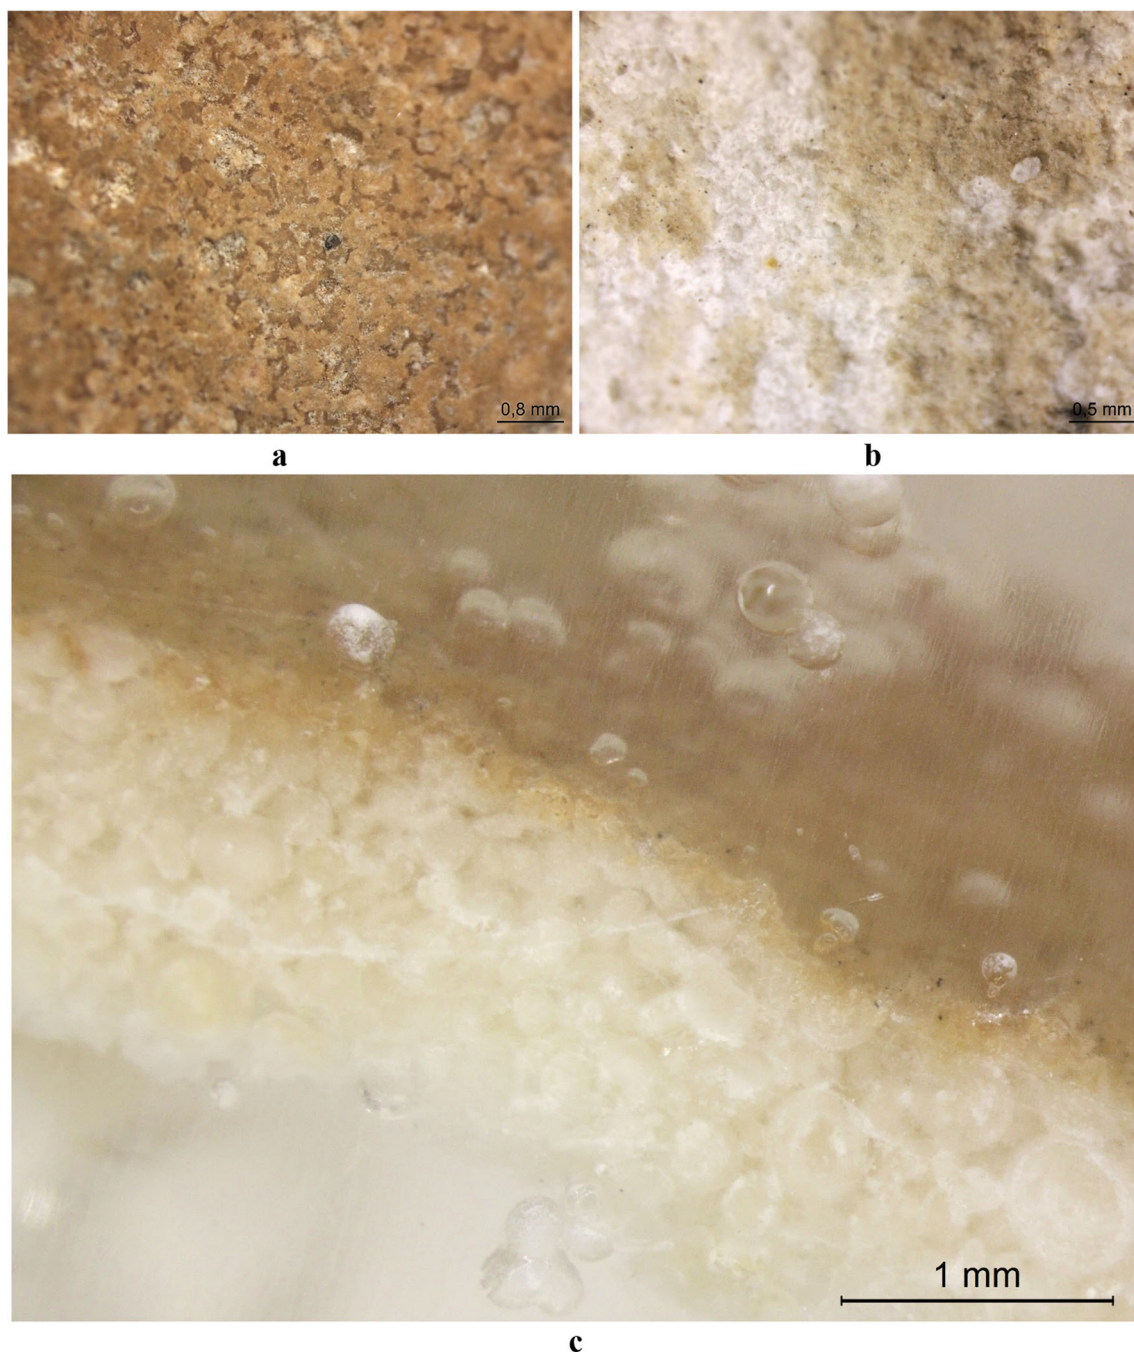
The photographs of the sample S-116 and window tracery piece are presented in Fig. 2 and Fig. 3, respectively. Microscopy was performed on these two samples, and the pictures are shown in Fig. 4. It can be seen that the orange color of the patina on S-116 is more saturated than that of window tracery sample. The patina on the window tracery surface is unevenly distributed, and its color also shows variegation over the area (Fig. 4b). On the contrary, the patina on the ornament S-116 is much more homogenous, and the color is consistent over the patina covered region (Fig. 4a). Cross-section observation revealed that the peeled-off fragment consists of a 0.1~0.2 mm orange layer and 1~1.2 mm oolitic

Fig. 4 Optical microscope photos of **a** sample S-116 surface, **b** the window tracery sample surface, and **c** cross-section of the peeled-off fragment from sample S-116

limestone substrate, and the fragment has thickness of ~1.3 mm (Fig. 4c), implying that the detachment of this coating happens under the limestone surface.

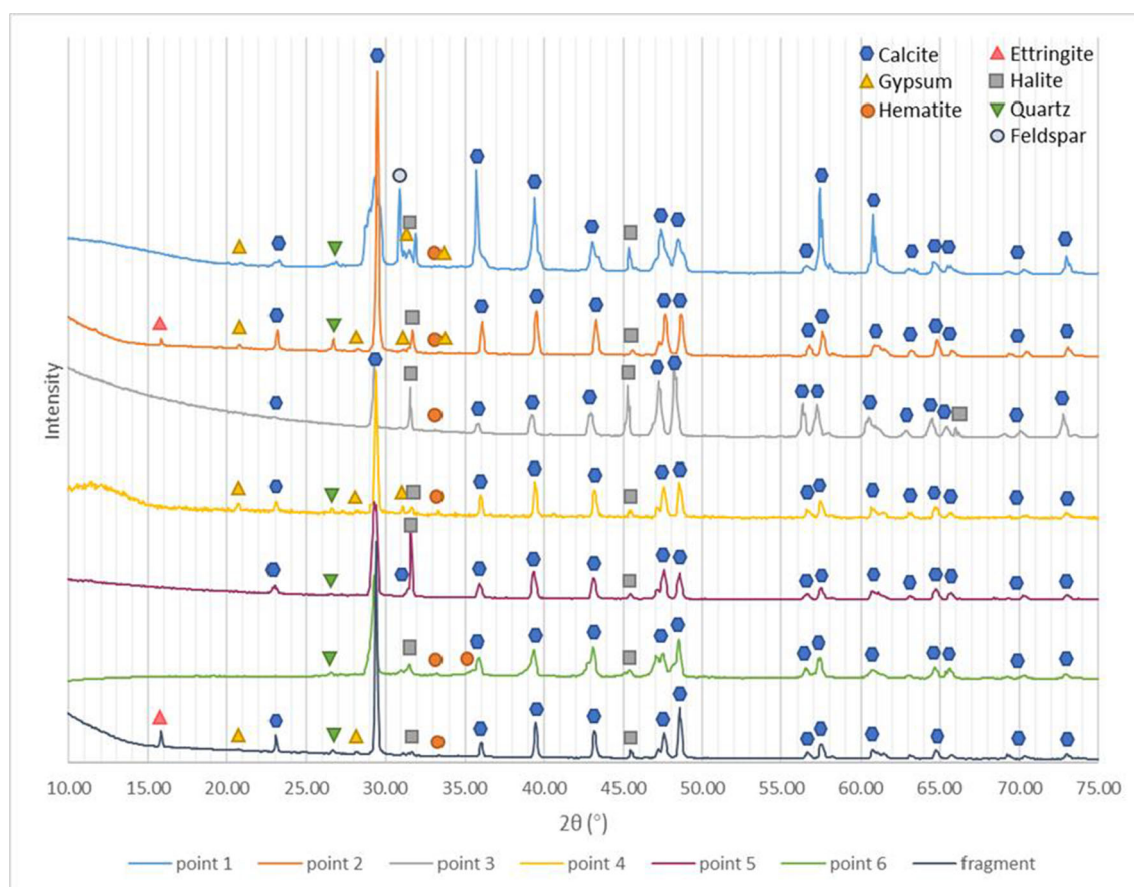
In both samples, the stone substrate is an oolitic limestone consisting mainly of calcite and quartz (Ding et al. 2019): accordingly, peaks of both minerals are seen at all points analyzed. A considerable amount of gypsum can be detected at points 1, 2, 4, and 6 and in the detached fragment, in areas corresponding to the orange surface, while at points 3 and 5 where the coating is completely removed, gypsum is absent. Halite was present in all analyzed spots, with its content being significantly higher at points 3 and 5, indicating that halite was concentrated on the substrate surface under the orange layer. Feldspar peaks (Al-K-silica) were present particularly at point 1, confirming the presence of soil dust deposition in this area. A minor amount of hematite was detected in all orange patinas suggesting the presence of red ochre pigment.

The sporadic presence of ettringite peaks in XRD results is somewhat intriguing. The presence of ettringite could be due to the cementitious materials exposed to sulfate attack: calcium aluminate hydrates and calcium silicate hydrates mixed with lime can react with water and gypsum or other sulfate salts, to produce ettringite $[Ca_6Al_2(SO_4)_3(OH)_{12}\cdot26H_2O]$ and thaumasite $[Ca_3Si(OH)_6(CO_3)(SO_4)\ 12H_2O]$ (Collepardi 1999). The application of cement-based mortar in the Batalha monastery during past restoration interventions (Soares 2001) could therefore explain the presence of ettringite on the ornament surface.

Fig. 5 XRD results of multiple points on ornament "S-116" and the peeled-off fragment

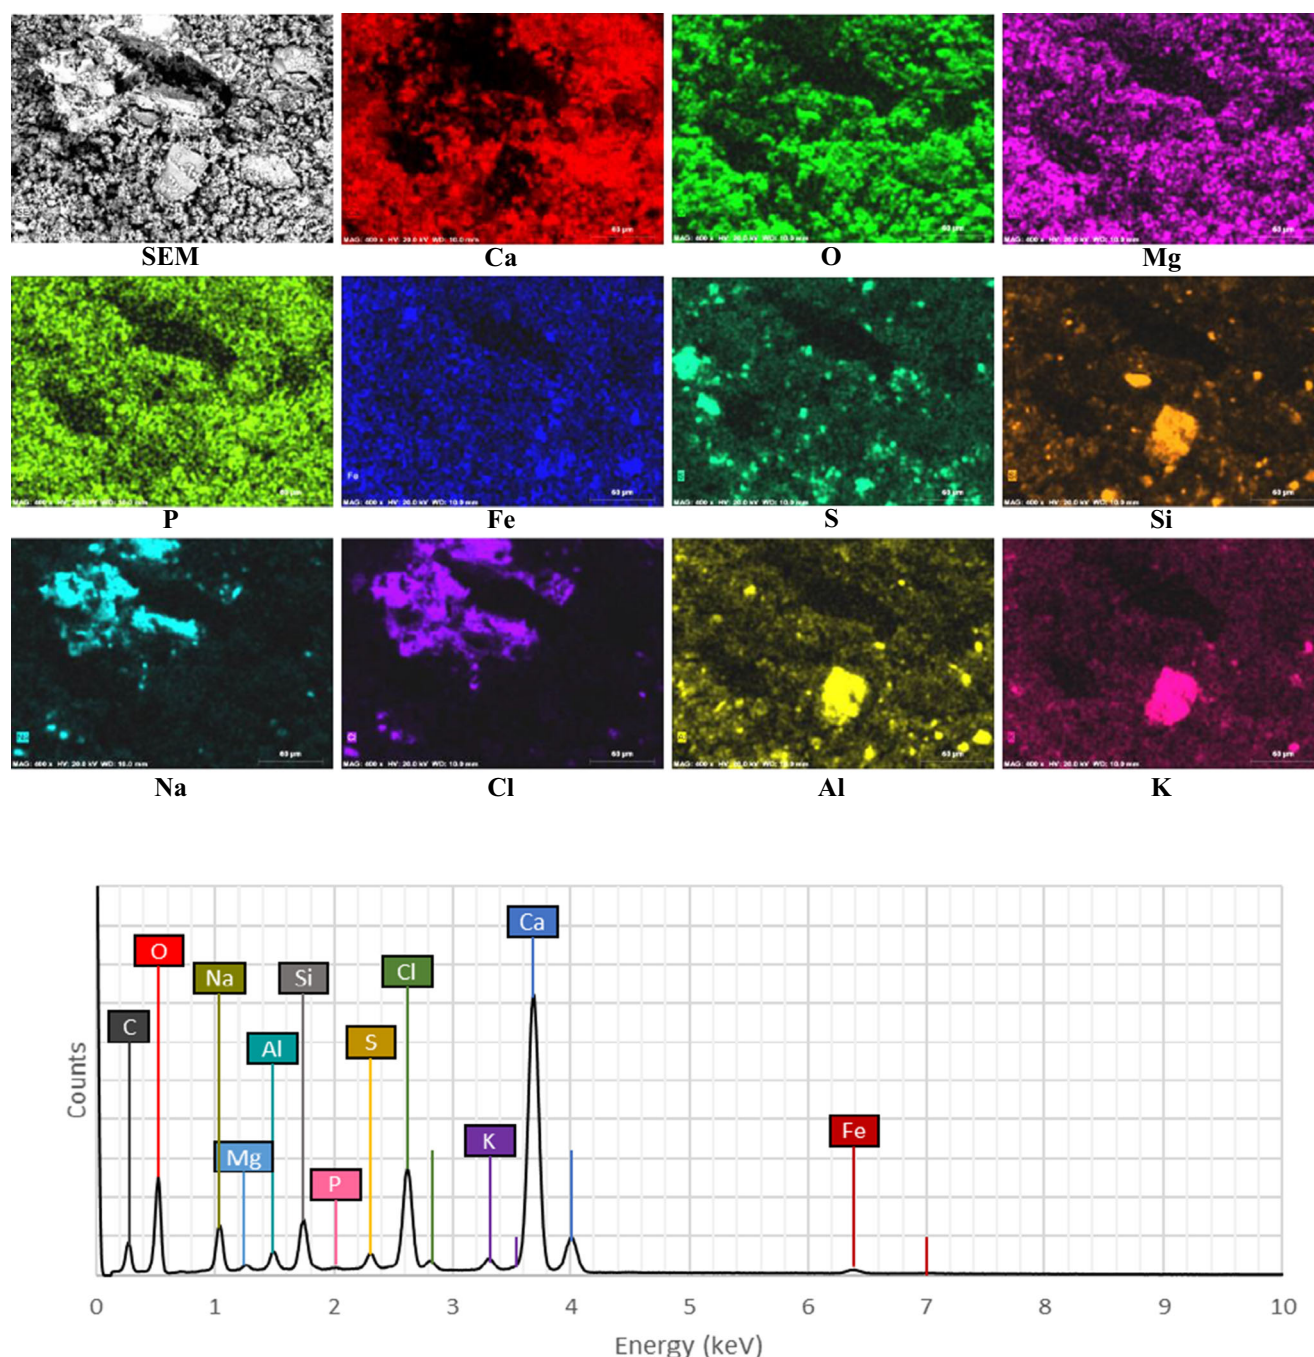
The peeled-off fragment was observed under the VP-SEM+EDS: results are shown in Fig. 6. There is a correlation between the distribution of sodium and chloride, demonstrating the presence of halite (NaCl) grains. Potassium (K), aluminum (Al), and silicon (Si) peaks imply the presence of quartz, feldspar, and clay minerals probably as soil dust. The peak of calcium (Ca) is weak where the NaCl and feldspar/soil dust/clay grains are present, which means halite and alumino-silicates were formed subsequently on the top of the limestone substrate. This could also be seen from the SEM picture; the halite (up left) and feldspar (down central) show a well-formed crystalline habit with relatively large dimension grains (>50 μm), in contrast with the poorly crystallized gypsum grains.

The distribution of iron (Fe) was homogenous over the whole analyzed area, supporting the interpretation of a pigment surface application. On the other hand, hematite is also present as accessory mineral grains in the original limestone. The presence of sulfur (S) is mainly due to gypsum $(CaSO_4\cdot2H_2O)$; its distribution is uniform, and some multi-mineral grains can be seen. By overlapping the distribution of Fe and S (Fig. 7), it can be seen that hematite was likely to be mixed and applied together with gypsum on the uppermost layer. This hypothesis can be supported by the recorded use of red and yellow ochre: in ancient Macedonian paintings, one of the main means of using ochre was to mix them with lime to produce tint plasters which were then applied at the surface of monuments (Perdikatsis and Brecoulaki 2008). Gypsum plaster might have been applied in the lime to achieve faster setting time. Therefore, the color on the ornament "S-116"

**Fig. 6** SEM-EDS element mapping of ornament "S-116" fragment

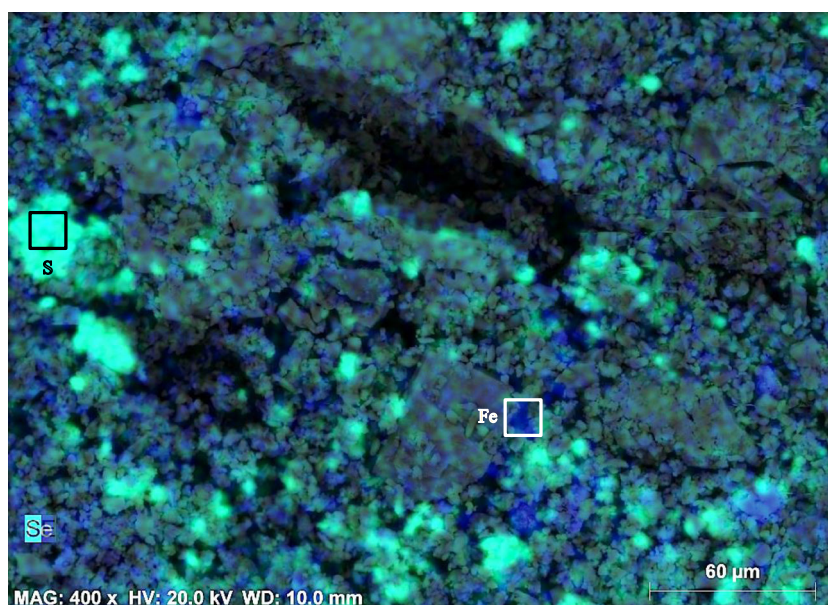
Fig. 7 Overlapped element mapping of Fe (blue) and S (neon green) with the morphology photo

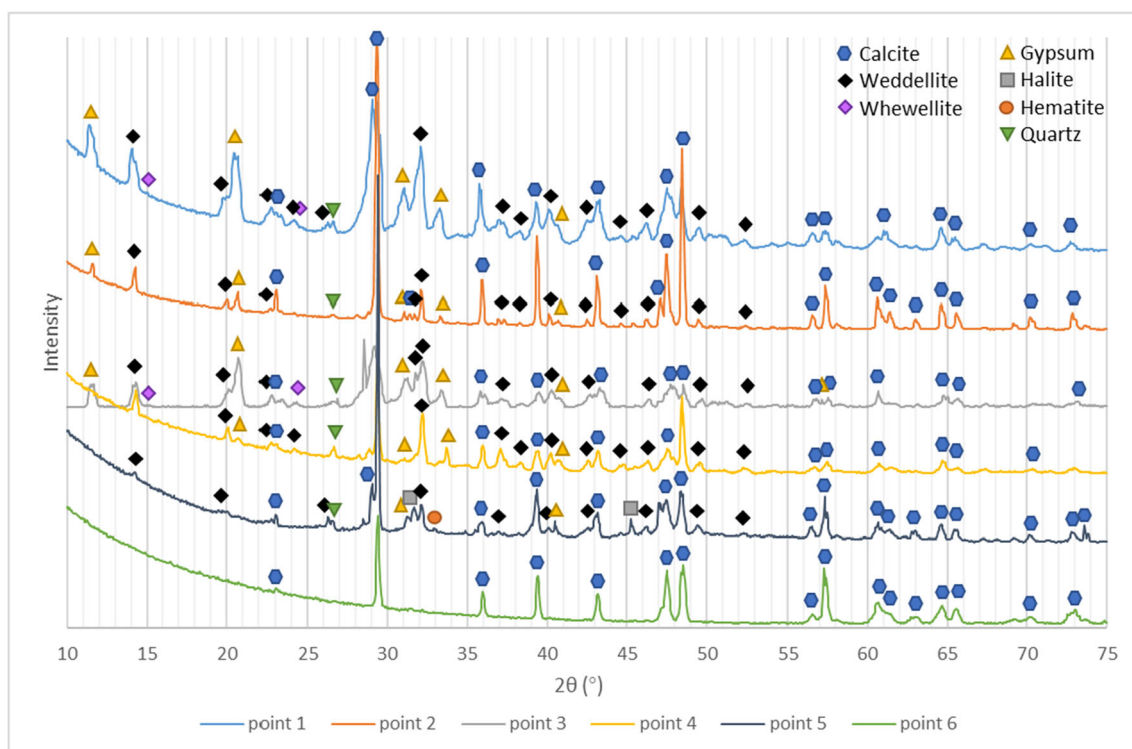
The window tracery sample was analyzed only by micro-XRD to prevent causing any damage. XRD results of multiple points on the Royal Cloister window tracery shows the XRD pattern, and in Table 2, the main minerals are listed together with their semi-quantitative evaluation. At point 1, where an orange surface is still visible, abundant calcium oxalate was present including weddellite and whewellite, together with feldspar and hematite. Gypsum was detected where the orange surface was worn-out and detached revealing the underlying white substrate. In these areas, the main composition was calcite with minor amount of gypsum and calcium oxalate and no detected hematite. Point 3 has a different appearance than

point 1, the surface showing a dark orange color, and the texture being loose and powdery in this area; the XRD results revealed calcite, some weddellite, feldspar, and minor hematite. Halite was present at point 3 and absent at points 1 and 2.

Fig. 8 XRD results of multiple points on the Royal Cloister window tracery

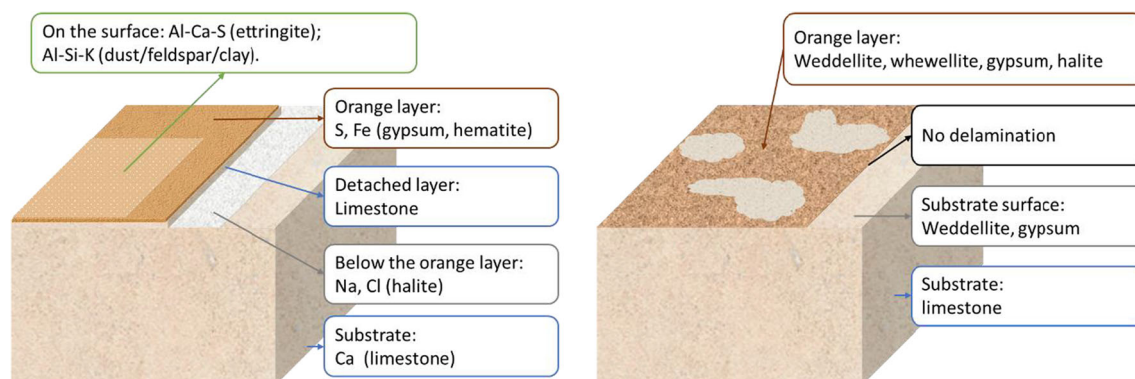
Though both named "orange patinas," there are significant differences between the two samples investigated. Table 3 lists these differences with respect to composition, appearance, and decay patterns. For the ornament "S-116," the orange layer follows the external geometrical shape of the object, for example, the ridging stripes spreading out from the center, which also existed on the substrate. For the Royal Cloister window tracery, the orange patina is closely adherent to the limestone substrate instead of a visible separate layering present on "S-116." And there was an abundant weddellite on the window tracery surface, which was not found on the sample "S-116."

Fig. 9 Sketch of the sample "S-116" (left) and the Window tracery (right)
