INTEGRATING MULTIBAND PHOTOGRAMMETRY, SCANNING, AND GPR FOR BUILT HERITAGE SURVEYS: THE FAÇADES OF CASTELLO DEL VALENTINO

E. Adamopoulos [1,*], C. Colombero [2], C. Comina [3], F. Rinaudo [4], M. Volinia [4], M. Girotto [4], L. Ardissono [1]

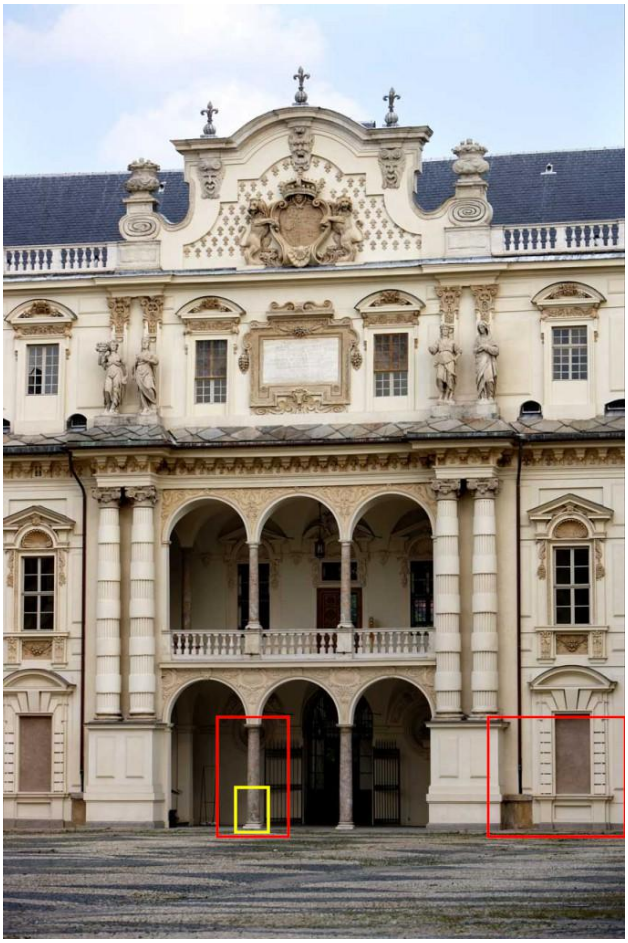
Figure 1. *Castello del Valentino* main (west) façade (modified from https://castellodelvalentino.polito.it). The preliminary surveys are indicated with red and the detailed surveys with yellow color.

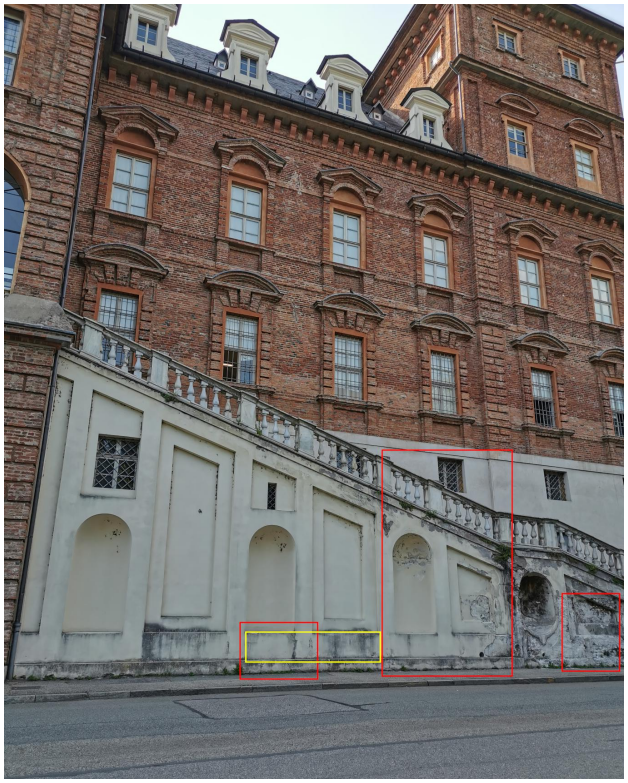
Figure 2. *Castello del Valentino* riverside (east) façade. The preliminary surveys are indicated with red and the detailed surveys with yellow color.

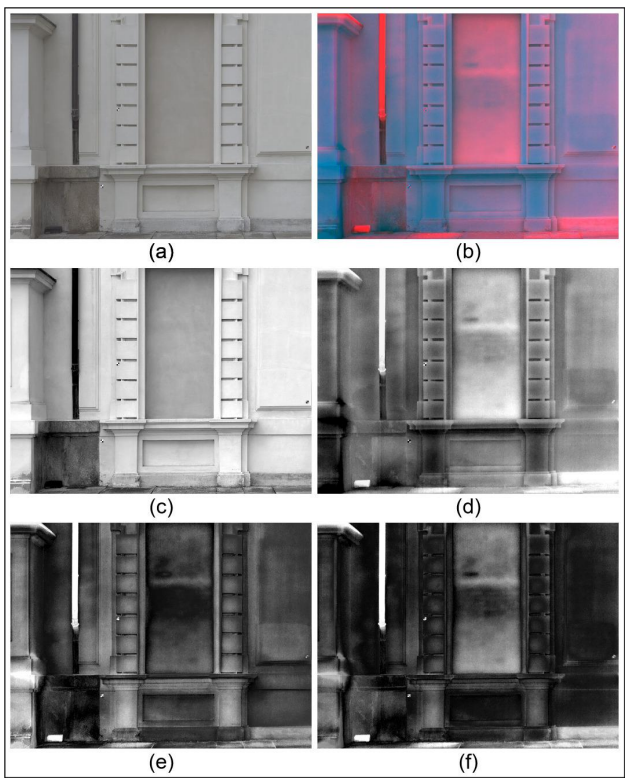
All images were subsequently undistorted (utilizing parameters calculated by calibrating the involved sensors), then rectified by picking points that were either measured directly with the total station or indirectly by TLS, and finally merged with the HyperCube software to create multiband images. The multiband imaging data were analyzed by data reduction, decomposition, and compression methods to create 2D image visualizations that could be more easily interpretable. **Figure 5** shows the results of one of the preliminarily surveyed areas on the main façade, where slight plaster detachments and a few surface cracks are visible through the elaboration of the multiband composites. **Figure 6** shows another surveyed area on the riverside façade where extensive detachments, cracking, and biogenic crusts can be observed.

Figure 5. Castello del Valentino west façade multiband results: (a) cropped VIS image; (b) TIR-NIR-red false-color composite; (c,d) principal component analysis–first and second component; (e,f) Fourier transform.

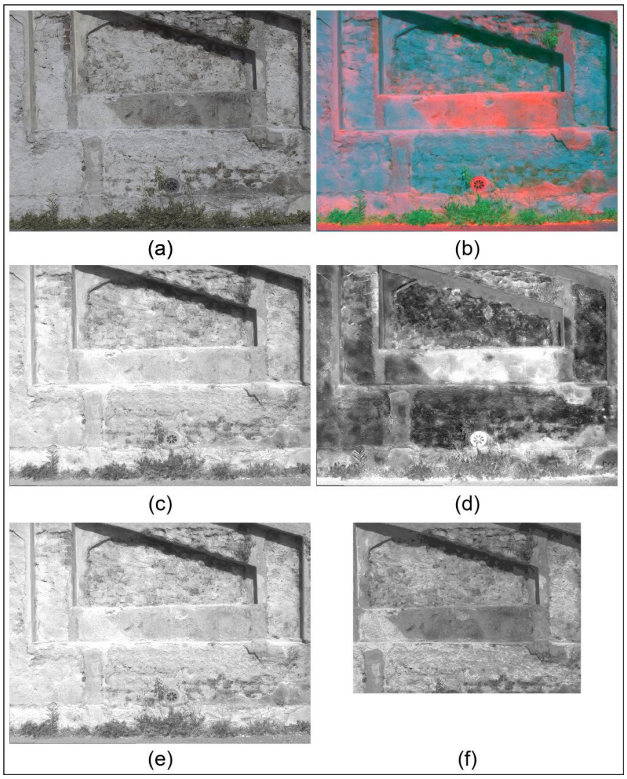
Figure 6. Castello del Valentino riverside façade multiband results: (a) cropped VIS image; (b) TIR-NIR-red false-color composite; (c,d) principal component analysis–first and second component; (e) Fourier transform; (f) quantized image.

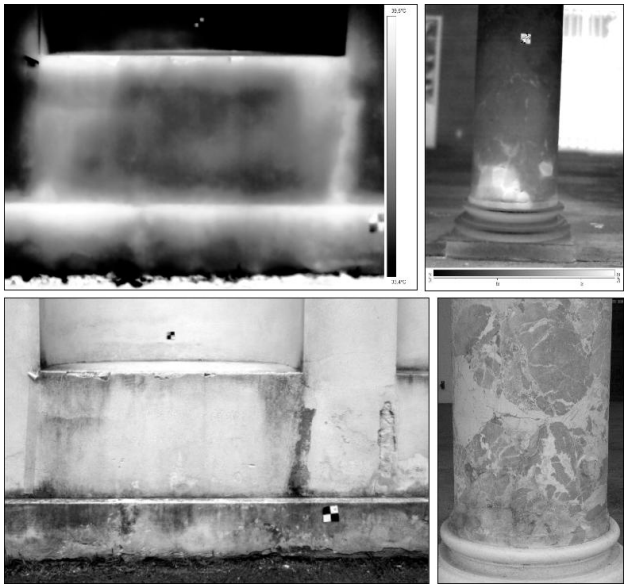
Wide-scale representations and 2D preliminary surveys led to identifying areas of interest for in-depth investigations by integrating higher resolution data and the elaborated GPR measurements. These two presented significant radiometric anomalies in the multiband analysis results (**Figure 7**).

Figure 7. East façade (left), and main façade left column (right) anomalies observed by thermographic imaging and principal component analysis of the multiband data (first components).

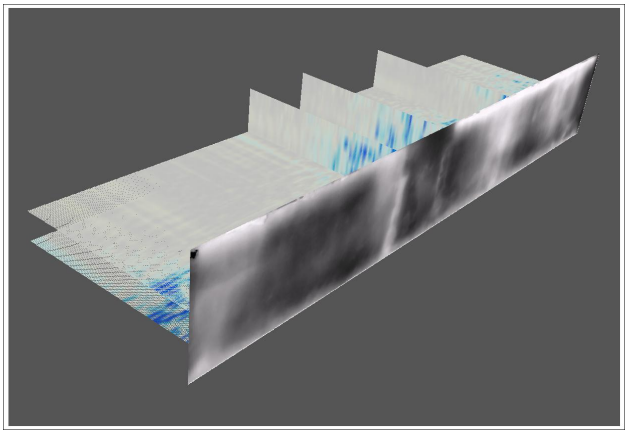
The transdisciplinary results were integrated using the orthophoto-mosaics of visible, NIR, and TIR spectra to create multiband ortho-visualizations, which could be processed with the same approaches as in the preliminary surveys but also had spatial reference. This allowed the relative referencing between radar data (parallel and perpendicular to recorded surfaces), range information, and the other image-based data elaborations (**Figures 8, 9**). A significant correlation was observed for the riverside façades between material losses, high GPR reflection amplitudes, and surface thermal minima, which could be interpreted as high moisture content from water that had permeated the damaged structure's surface layers. Additionally, the cylindrical surface of the column could be developed—after calculating the average diameter from the TLS point cloud—to create a planar result, instead of only ortho-projections of every side of the column (**Figure 10**). This type of visualization made the interpretation of the results easier by facilitating the integration with the GPR data. Anomalies detected by on-site inspection, multiband imagery elaboration, and locating extreme amplitude values overlapped, led to the assumption that the identified volumes on the bottom part of the column corresponded to replacement material (mortar) originating from a previous intervention.

Figure 8. Registering of a thermal orthophoto-mosaic and GPR slices with CloudCompare (riverside façade).

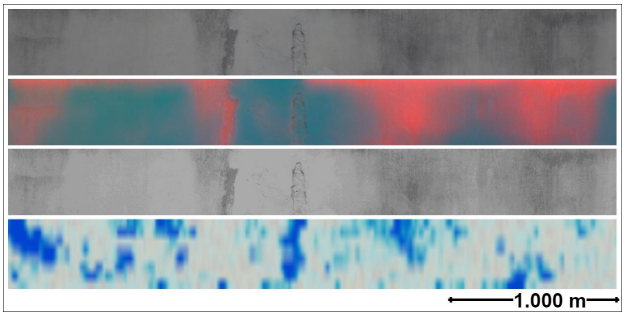
Figure 9. Interdisciplinary interpretation of multiband results (from top to bottom): orthophoto-mosaic, false color TIR-NIR-red composite photo-mosaic, map of surface alterations, and GPR slice parallel to the wall at 6 cm depth (riverside façade).

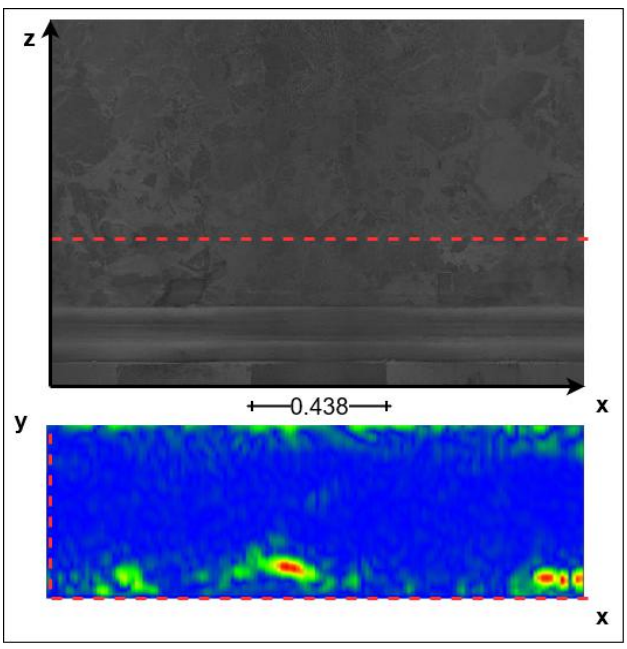
Figure 10. NIR developed photogrammetry-produced orthophoto of the lower left column and GPR slice of the column at h = 0.619 m from the floor (main façade).

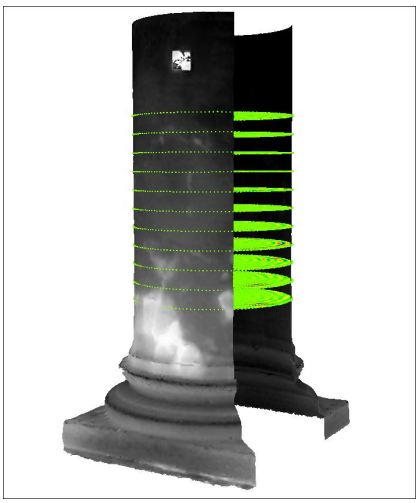
Figure 11. Integration of thermal-textured mesh and GPR grid data for the bottom part of the column.

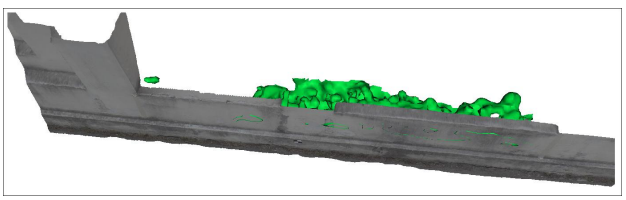
Figure 12. Integration of color-textured mesh and GPR iso-amplitude surfaces for the riverside façade.
