Harmonic Drive Gear Failures in Industrial Robots Applications: An Overview

Andrea Raviola[1], Andrea De Martin[2], Roberto Guida[3], Giovanni Jacazio[4], Stefano Mauro[5] and Massimo Sorli[6]

[1,2,3,4,5]*Politecnico di Torino, Department of Mechanical and Aerospace Engineering, Torino, 10129, Italy*

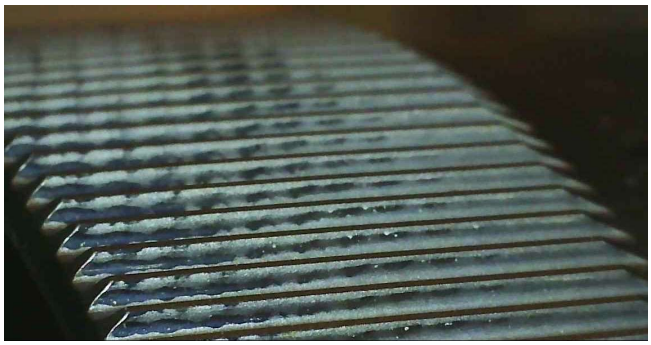
Figure 5. Effect of the coning angle on the flexspline tooth wear.

The damage is greater closer to the FS input than towards the rear cross section. This is caused by the coning angle generated by the insertion of the WG into the FS. This phenomenon is related to the fact that only the input section of the FS is deformed into an ellipse by the WG, while the output one, closer to FS boss, remains circular. This leads to an uneven engagement of the FS and CS teeth along the rotation axis, as schematized in Figure 6.

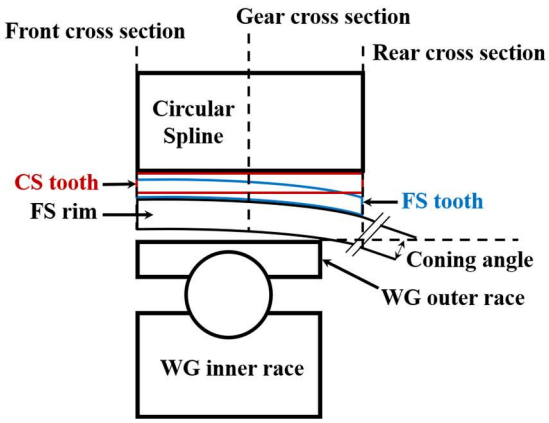
Figure 6. Uneven engagement between flexspline and circular spline caused by the coning angle.

The area closer to the FS front and gear cross sections is fully meshing with the CS, while in the remaining region there is almost no contact. Detailed studies about the FS

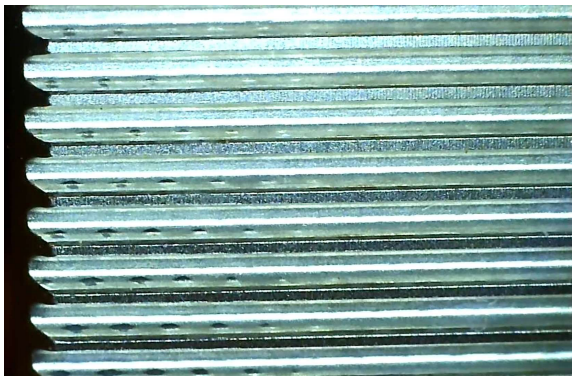
Repetitive stresses, which exceed the material resistance of the tooth surface, could lead to pitting. As for wear, this phenomenon is confined to the tooth region closer to the front and gear cross sections of the FS. The small particles detached from the tooth will mix with the lubricant, degrading it. Since the gearbox uses the same grease for all its components, the damage would spread not only to the FS itself, increasing wear, but also to the elliptical bearing and the contact interface between the WG and the FS. An example of such progressive loss of material is reported in Figure 7.

Figure 7. Pitting of the flexspline teeth detected on the shoulder joint of a UR5 collaborative robot.

Since pitting accelerates wear, it can be detected by analyzing vibration signals of the robot arm or looking for signs of backlash.

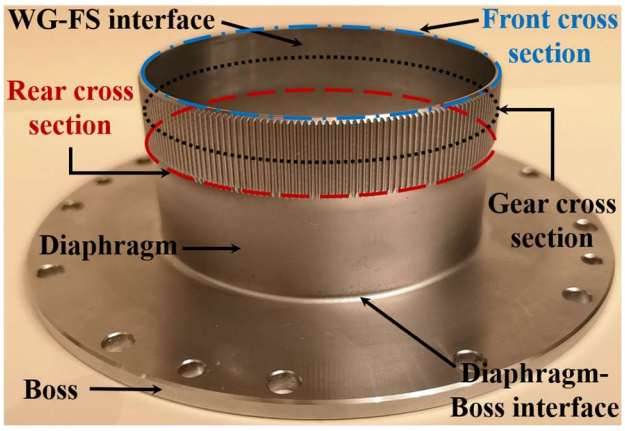
The most common failure mode of a harmonic drive is the FS fatigue fracture (Dong, Zhu, Zhou & Chen, 2012). As reported in Wang (2001), the presence of a crack can be early detected by analyzing the vibration signals of the gearbox. Since crack propagation and its effects differ according to its location, the four most probable regions of crack nucleation: rim, tooth, rear cross section, and diaphragm are analyzed. A schematic representation of the flexspline showing the aforementioned areas is reported in Figure 8.

Figure 8. Flexspline of the harmonic drive used in the shoulder joint of a UR5 collaborative robot.

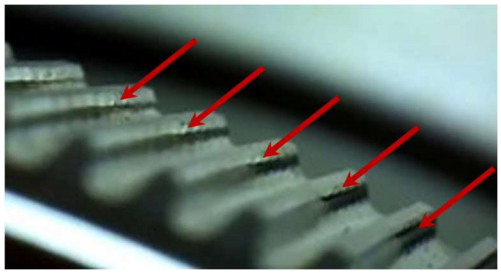
Since the flexspline is subjected to vibrations, especially under heavy loads and high speeds, cracks can also nucleate closer to the tooth tip, as shown in Figure 9.

Figure 9. Flexspline tooth cracks.

This is also related to the fact that, even though the double-arc tooth profile provides the best performances in terms of position accuracy, it is characterized by higher stresses if compared with an involute one (Kayabasi & Erzincanli, 2007).
