Experimental investigation on crack propagation paths in spur gears

F Curà[1], A Mura[1] and L Corsaro[1]

[1] Dimeas Politecnico di Torino, corso Duca degli Abruzzi 24, 10129 Torino, Italy

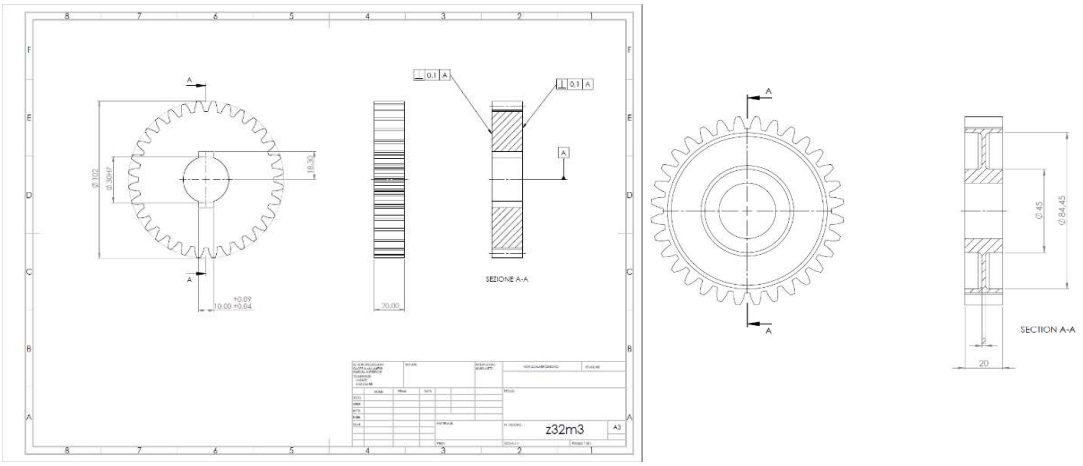
Figure 1. Technical drawings of Gear 1 and Gear 2.

Geometrical parameters of each gear are resumed in Table 1. In particular are shown: pitch diameter (*dp*), face width (*b*), number of teeth (*z*), modulus (*m*), backup ratio (rim dimension respect to the tooth height) (*mb*), web ratio (web thickness respect to the face width) (*mw*) and gear blank factor (C_R) [4]. As an example, technical drawings of Gear 1 and Gear 2 are shown in Figure 1.

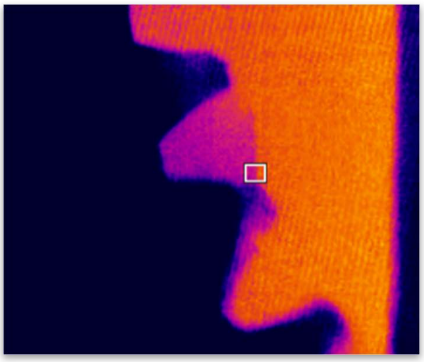
Figure 3. Position of the area.

During bending tests, an IR thermocamera (*IR tech Timage Radiamatic "XT"*) was utilized to monitor the surface thermal profile in the tooth root fillet zone (see Figure 2, right side). The thermal detector was located at a distance of 60 mm from the gear. A reference specimen (see Figure 2, right side) allowed to acquire the environmental temperature during each test. Gears and reference specimen were both covered by black spray paint to generate a surface with an emissivity close to 0,95. Two different thermal profiles were extracted from each thermogram near the root tooth fillet, respectively an *aera* and a *point* of 2x2 pixel (located inside the area close to the crack initiation point). The relative temperature ΔT (difference between the absolute temperature and the temperature of the reference specimen) was computed for Gears. Figure 3 illustrates an example of the area position near the tooth root fillet.

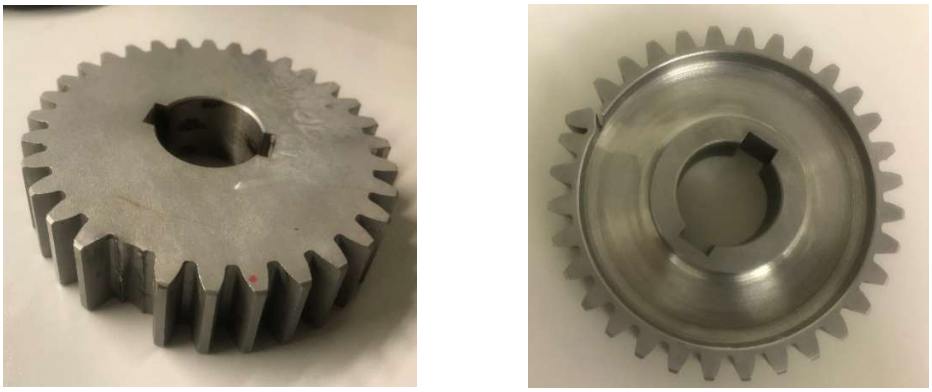
Figure 4. Gear 1 (left) and Gear 2 (right) crack paths.

Figure 4 shows, as an example, Gear 1 and Gear 2 and their failure typologies. As it can be observed, Gear 1 crack path (on the left) corresponds to a classical fail safe condition, while in Gear 2 (on the right) a crack path directed through the rim can be pointed out.

As a matter of fact, geometrical parameters of Gear 2, in particular its backup and web ratio values, were chosen to verify the corresponding catastrophic failure already emphasised by numerical simulations, and now demonstrated by fatigue tests. Rim and web geometries may be related to the well known CR parameter [4] (see Table 1), as a function of both backup ratio and web ratio values. As already indicated in [2], the position of this parameter respectively in the tooth failure zone, in the uncertainty zone or in the rim failure zone of its graph (see Figure 6 [2]) allows us to draw some hypothesis about the possibility of safety or unsafety fracture basing only on the gear geometry.

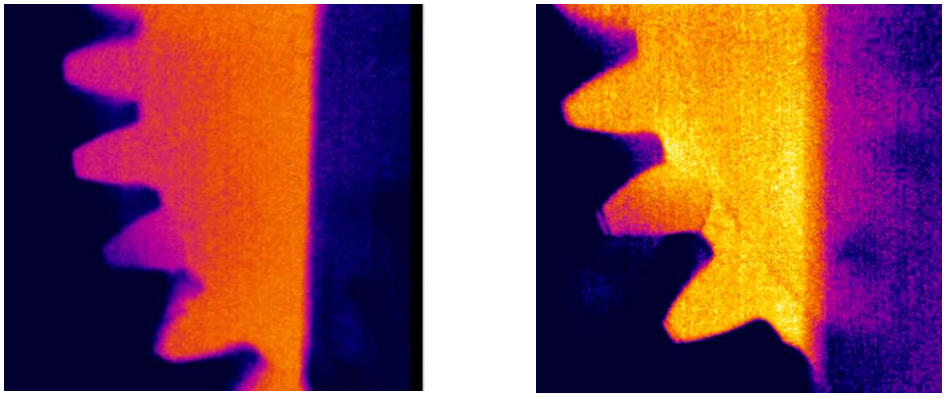
Figure 5. Thermal images of Gear 1 (left) and Gear 2 (right).

Figure 5 shows an example of thermal images recorded during fatigue tests. More in detail, the left image is related to Gear 1 and, as in Figure 4, a crack propagating through the tooth can be appreciated. The right image shows the crack propagating through the rim, as predicted for Gear 2 already in the design phase.

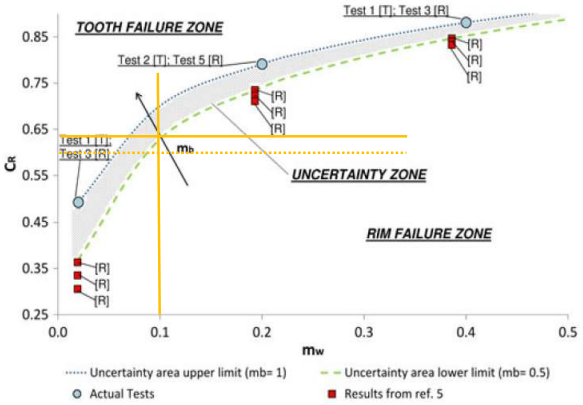
Figure 6. CR factor [2].

Figure 6 points out CR parameter values for Gears 2 and 3, characterised by different back up ratio (m_b) values and with the same web ratio (m_w), driving respectively to fail safe and catastrophic failures. Finally, Figures 7 and 8 show the thermal profiles monitored during the fatigue tests respectively for Gear 1 and Gear 2. In particular, in each Figure is reported the difference temperature ΔT (respect to the ambient temperature or reference specimen) as a function of the number of cycles, referred to both crack nucleation point and to an area around the nucleation point (nucleation area, mean value of temperature).

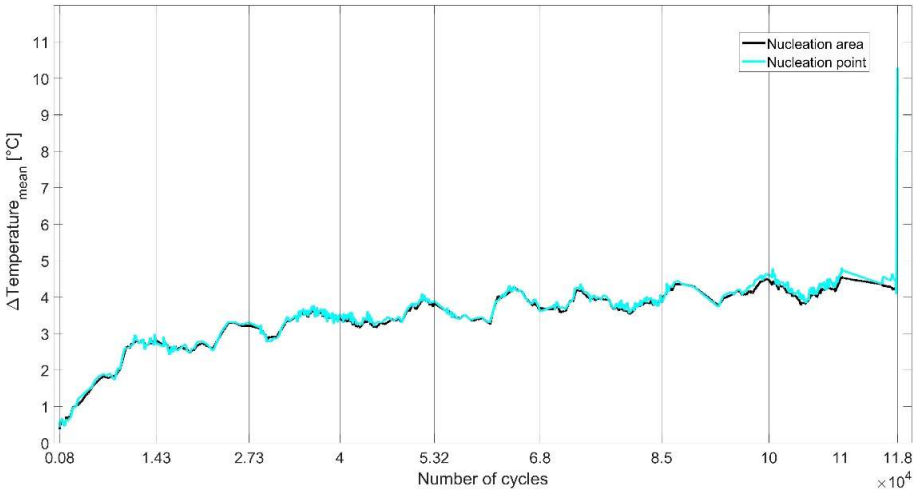
Figure 7. Gear 1 thermal profiles.

From the analysis of these Figures, it can be noted the increase of thermal profiles in the first phase of the test, then a stabilised condition of temperature and, finally, an abrupt variation corresponding to the failure. Nucleation point and area profiles show in both cases identical trends.

The comparison between Figures 7 and 8 shows that the fatigue life of Gear 2 is lower than that of Gear 1 in term of number of cycles (118000 cycles for Gear 1 and 104300 cycles for Gear 2), as expected. Moreover, the relative temperature ΔT level is higher for Gear 1 than for Gear 2. This unexpected result may be interpreted as a strong dissipation flow in the case of Gear 2 within the whole wheel body, due to the high displacements involved in fatigue tests.
