Full-scale testing and analysis of 50-year old prestressed concrete bridge girders

F. Tondolo, D. Sabia, B. Chiaia, A. Quattrone, P. Savino
Department of Structural, Geotechnical and Building Engineering, Politecnico di Torino, Turin, Italy

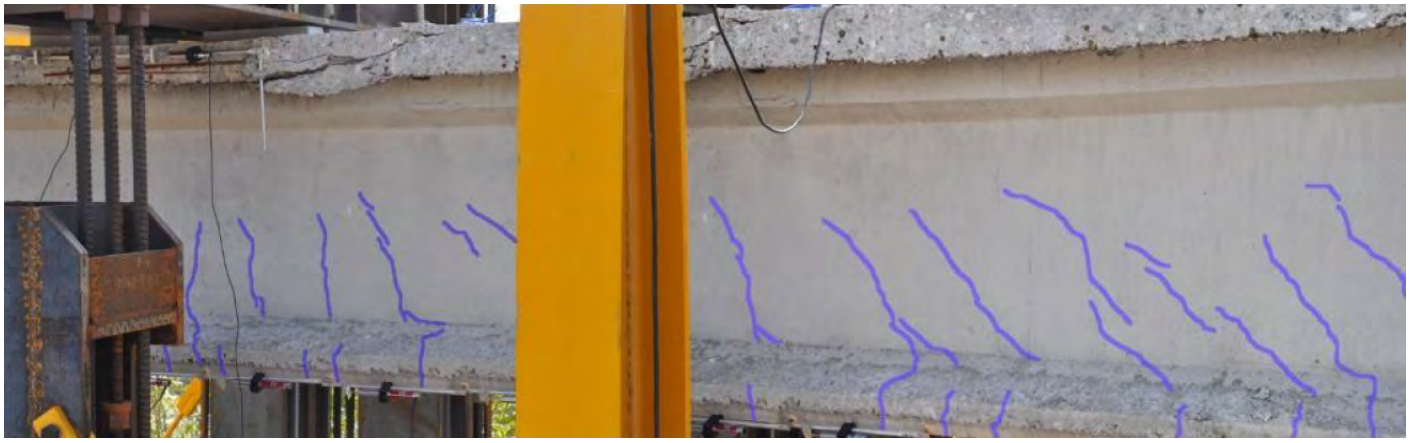
The tests showed that each specimen failed by crushing in compression of the portion close to the midspan in a nonductile flexural mode as reported in Figure 5. Visual observations during the tests highlighted no separation between the precast PC beam and the cast-in place slab, ensured by the shear connectors installed in the precast concrete and integrated with the concrete slab. Diagonal cracks have been detected in the shear span, indicating the interaction between bending and shear. Around the midspan, close to the loading system, the cracks became more vertical and spaced about 26 cm. Figure 6 shows the crack pattern recorded for the B3-P47/46 beam at 75 kN, corresponding to 96% of the failure load, 78 kN, equivalent to a bending moment of 1451 kN·m. The B8-P47/46 showed a failure load of 82 kN corresponding to a bending moment of 1525 kN·m. The B4-P46/47 was

Figure 5. Failure zone: a) B3-P47/46, b) B8-P47/46, c) B4-P47/46.

loaded up to a failure load of about 72 kN, corresponding to an average ultimate failure moment of 1339 kN·m. At the maximum applied load, the B3-P47/46, B8-P47/46 and B4-P47/46 specimen exhibited ultimate midspan deflections of 177 mm, 151 mm and 135 mm, respectively. The Figure 7 show the load-deflection responses of the B3-P47/46, B8-P47/46 and B4-P47/46 beams. The diagram of the first loading cycle on the B3-P47/46 beam was considered reliable up to 30 kN due to technical issues that arose during the test. The curve related to the second cycle loading shows a decrease of load at 75 kN associated to an holding stage in the test for cracking pattern evaluation. The load drop recorded for the B4-P47/46 beam at 72 kN is due to localized crushing close the loading surface.

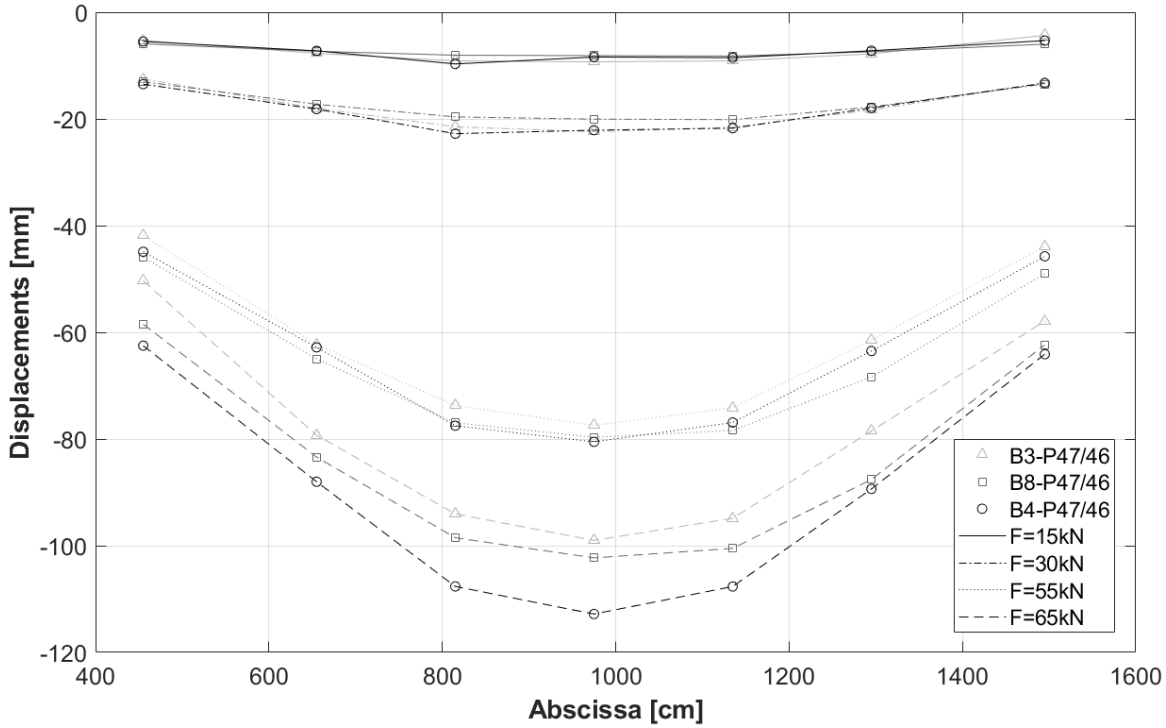
Figure 11. Displacements along the length of the beams.

The Figure 11 shows a comparison of the displacements recorded along the beams at 15 kN, corresponding to the elastic stage, and at three post-cracking levels, 30 kN, 55 kN and 65 kN, respectively. For the B3-P47/46 and B8-P47/46 beams, the displacements recorded up to 30 kN refer to the first loading cycle. The diagram highlights a similar behavior during the first two stages, the elastic and first-cracking phases.

The B4-P47/46 shows a significant stiffness reduction at higher load levels, which caused a considerably larger deflection. Since all these beams were removed from the same deck, homogeneous properties can be assumed for the cast-in situ slab. Accordingly, the different behavior showed under higher loads, could be related to different construction details considered for the precast PC beams. Furthermore, the preliminary non-destructive tests highlighted a worse concrete strength for the B4-P47/46 beam, confirmed by the lower recorded cracking load shown in Figure 8. However, future destructive tests will be crucial for an in-depth analysis of the global mechanical behavior. In detail, it will be necessary defining if the connectors and the roughness at the interface are effective and therefore the specimens actually behave like a composite section.
