Full-scale testing and analysis of 50-year old prestressed concrete bridge girders

F. Tondolo, D. Sabia, B. Chiaia, A. Quattrone, P. Savino
Department of Structural, Geotechnical and Building Engineering, Politecnico di Torino, Turin, Italy

F. Biondini, G. Rosati, M. Anghileri
Department of Civil and Environmental Engineering, Politecnico di Milano, Milan, Italy

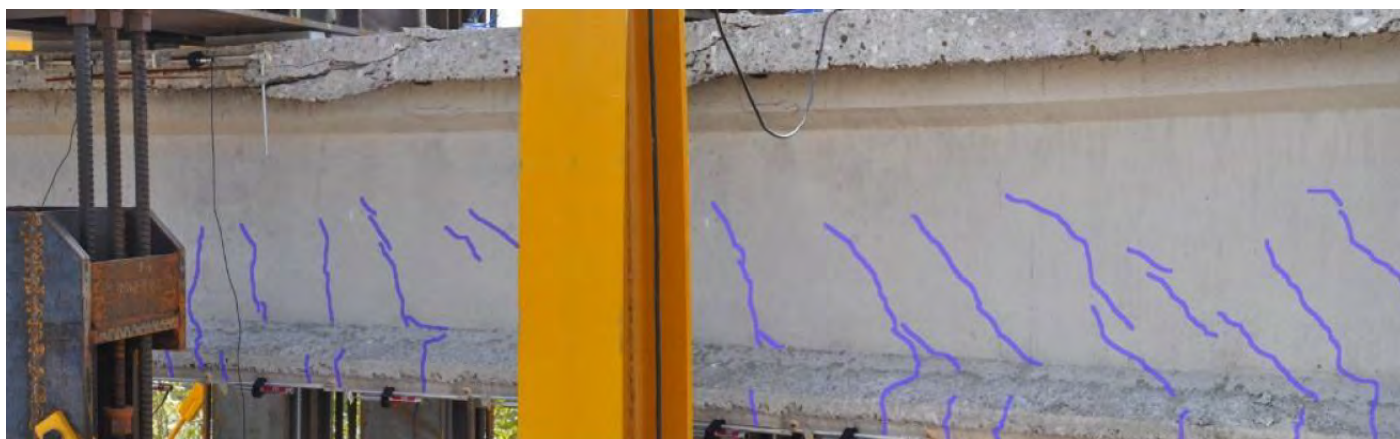
Figure 5. Failure zone: a) B3-P47/46, b) B8-P47/46, c) B4-P47/46.

The tests showed that each specimen failed by crushing in compression of the portion close to the midspan in a nonductile flexural mode as reported in Figure 5. Visual observations during the tests highlighted no separation between the precast PC beam and the cast-in place slab, ensured by the shear connectors installed in the precast concrete and integrated with the concrete slab. Diagonal cracks have been detected in the shear span, indicating the interaction between bending and shear. Around the midspan, close to the loading system, the cracks became more vertical and spaced about 26 cm. Figure 6 shows the crack pattern recorded for the B3-P47/46 beam at 75 kN, corresponding to 96% of the failure load, 78 kN, equivalent to a bending moment of 1451 kN·m. The B8-P47/46

showed a failure load of 82 kN corresponding to a bending moment of 1525 kN·m. The B4-P46/47 was

loaded up to a failure load of about 72 kN, corresponding to an average ultimate failure moment of 1339 kN·m. At the maximum applied load, the B3-P47/46, B8-P47/46 and B4-P47/46 specimen exhibited ultimate midspan deflections of 177 mm, 151 mm and 135 mm, respectively. The Figure 7 show the load-deflection responses of the B3-P47/46, B8-P47/46 and B4-P47/46 beams. The diagram of the first loading cycle on the B3-P47/46 beam was considered reliable up to 30 kN due to technical issues that arose during the test. The curve related to the second cycle loading shows a decrease of load at 75 kN associated to an holding stage in the test for cracking pattern evaluation. The load drop recorded for the B4-P47/46 beam at 72 kN is due to localized crushing close the loading surface.

The visual inspections performed after the loading tests showed the absence of corrosion of the strands exposed after the crushing in the failure zone. Therefore, corrosion is preliminary considered not influencing the ultimate capacity registered in the test.
