A tool for monitoring rockfall protection works and plan the maintenance: the case of the autonomous region of Valle d'Aosta

Maddalena Marchelli*
Marco Paganone**
Davide Bertolo**
Valerio De Biagi***
Daniele Peila*
Stefano Vigna*

* Dipartimento di Ingegneria per l'Ambiente, il Territorio e le Infrastrutture (DIATI). Politecnico di Torino
** Ufficio Geologico, Dipartimento Programmazione, Risorse Idriche e Territorio, Regione Autonoma della Valle d'Aosta, Aosta
*** Dipartimento di Ingegneria Strutturale, Edile e Geotecnica (DISEG). Politecnico di Torino

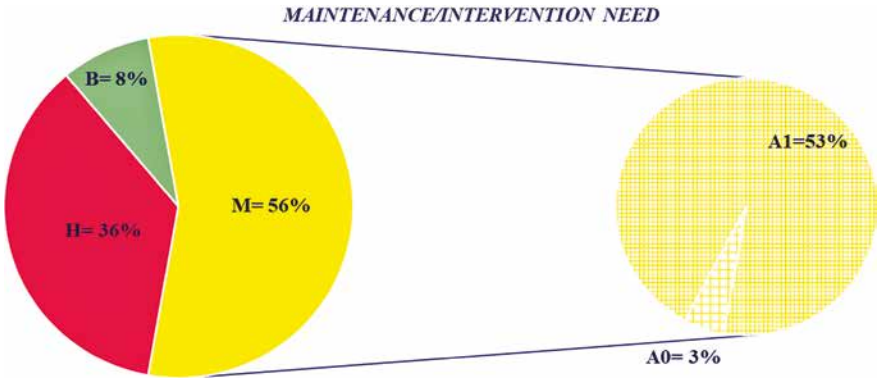
In this section, the results of an example of application are provided. In particular, on July 2022, net fences protecting three sections of the regional roads of Valle d'Aosta Region were inspected, as representative. Neglecting the semi-rigid and the rigid barriers, a sample of 45 net fences has been analysed. Figure 3 displays the obtained results in terms of need of interventions, as reported in Table 4. The great majority of the samples highlights a necessity of maintenance, even though half of the inspected structures is in a medium-high degree of efficiency (i.e. medium level maintenance need). Among

Fig. 3 – Results of the survey in terms of interventions need, as reported in Table 4.

these last, the indicator *A* reveals to affect the ascription of the protective works in the medium level of maintenance need, as for the great majority of the cases, *A* is equal to *A1*, and $P_{tot} < 0.3P_{max}$. No medium-high level of maintenance need is observed, while only 8% has a high degree of efficiency.

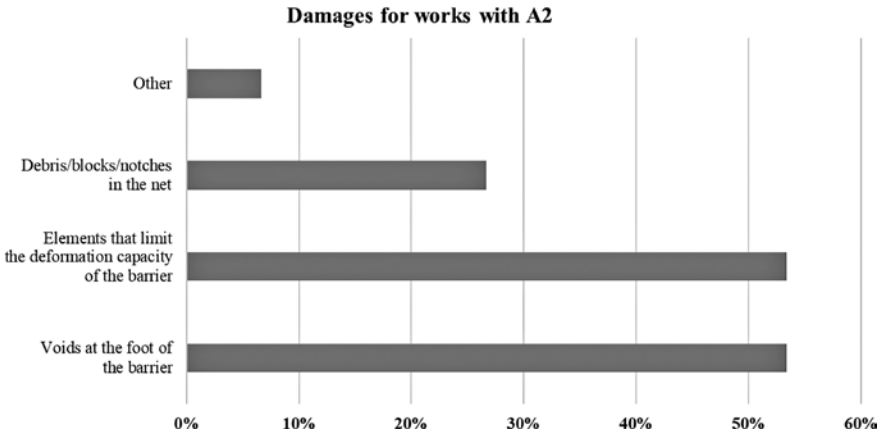
Analysing in detail those net fences that display a high need of interventions, the presence of significant void at the foot of the barrier reveals to be the major issue, together with the presence of elements limiting the deformation capacity of the barrier (Figg. 4 and 5). Both these aspects are highlighted in the 62% of the samples (and in many cases they are observed together), while in 31% the presence of debris/blocks/notches in the net is shown. Considering also P_{tot} values, this indicator is lower or equal 15% in all the cases, revealing that in the great majority the indicator *A* mostly affects the results. This implies that, even though high priority levels of maintenance are required, the maintenance procedures to adopt would involve only a single aspect/damage, i.e. closing the net at the bottom, removing blocks or trees interacting with the net are the only actions required.

Fig. 5 – Histogram of the observed damages, which lead to a state of functionality equal to A2.
