A Preliminary Experimental Study on the Effects of Wear on the Torsional Stiffness of Strain Wave Gears

Andrea Raviola *[ID], **Andrea De Martin** and **Massimo Sorli** [ID]

Department of Mechanical and Aerospace Engineering, Politecnico di Torino, Corso Duca degli Abruzzi 24, 10129 Torino, Italy
* Correspondence: andrea.raviola@polito.it

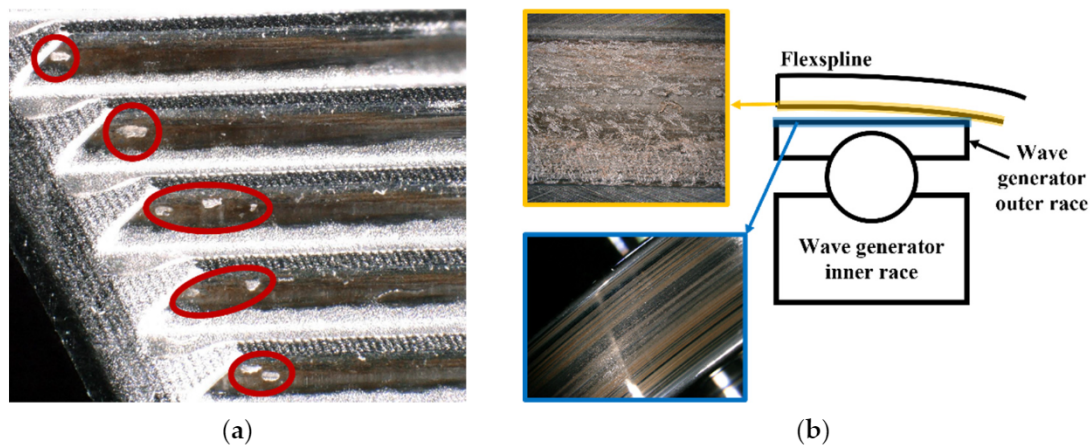
After testing, all gears were fully disassembled and inspected to better understand their health status and to investigate the root cause of their performance drop. From pictures in Figures 4 and 5, it can be seen how, despite being subjected to the same load history, the outcome is highly dependent on the supplier. For gear A, signs of pitting, highlighted with red circles in Figure 4a, started appearing on the flexspline teeth, while adhesive wear between the wave generator outer race and the flexspline inner surface [19] is visible in Figure 4b. On the contrary, the circular spline and the wave generator inner race barely presented any visible damage. Similar outcomes are reported in [15].

Figure 4. (**a**) Pitting on the flexspline teeth of gear A. (**b**) Adhesive wear marks on the wave generator and the flexspline of gear A.

Based on the microscope pictures reported in Figure 4, it can be supposed that, for gear A, the changes among the hysteresis curves of Figure 6a are mostly related to the damaged WG–FS interface. The resulting sliding between the wave generator and the flexspline is likely to be the cause of the wavy trend of the hysteresis curve within ±20% of the highest torque reached during testing [11]. So, over time, the curve not only tends to rotate counterclockwise, showing a behavior typical of a cyclic softening, but also deforms and expands. This is visible from the first plot of Figure 6b, where both hysteresis loss and area increase. In more detail, it can be noted that the damage caused by wear is higher in the first half of the test (samples 1–3), with a +117% increment in the hysteresis loss, than in the second one (samples 3–5), where it settles around +11%. This shows that the majority of the damage appeared in the first half of the test campaign. On the contrary, an almost stable behavior of the gear is present in the second half, leading to three almost overlapped

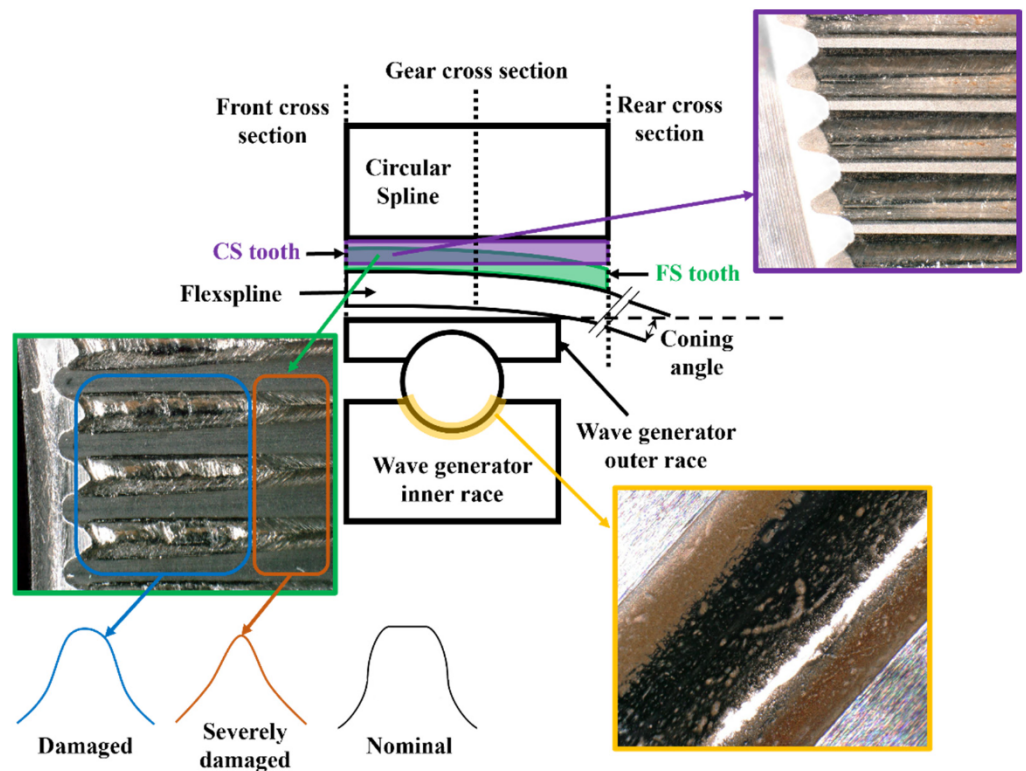
**Figure 5.** Effect of wear on the components of the strain wave gear B.

Different is the case of gear B, which shows higher accumulated damage. From pictures reported in Figure 5, it can be seen that, while the CS teeth present almost no wear marks, the FS ones are severely damaged. In addition, despite gear A, the wave generator inner race presents signs of fretting wear on both sides of the raceway.

As explained in [10], the different distribution of the tooth damage is related to the presence of the coning angle caused by the deformation of the flexspline while meshing with the circular spline. This also affects the gear lubrication which, if poor, highly reduces the life of the component [20]. However, in contrast with the results reported in [10], the damage accumulated along the length of the FS teeth is higher in proximity to the gear cross-section. This suggests the presence of higher contact forces in the middle section of the toothing, probably caused by the bending stiffness of both the FS cup and the WG outer ring, the presence of the WG spheres, and the axial forces acting on the elliptical bearing in the direction of the flexspline diaphragm [21].

The high damage faced by the flexspline teeth depicted in Figure 5 reduces the amount of simultaneously meshing teeth, leading to a S-shaped profile of the hysteresis curve. The high stretching of the curve, especially at low torques, is an indicator of the severity of the damage experienced by the FS teeth, which are not able to properly transmit torque through the system. This is also visible in Figure 7b, where the final value of the hysteresis loss is more than six times higher (+532%) than the one at the initial conditions, while the overall increment in both minimum and maximum torsion is about +141%. However, in contrast with gear A, the highest variations of hysteresis loss and area, respectively +184% and +54%, are nearer the end of the test campaign (samples 3–5) than the first half (+121% and +36%). In general, such different behavior between the two tested gears can be associated with the reduction in the number of meshing teeth. According to [29], in strain wave gears, the higher the number of meshing pairs, the greater the gear torsional stiffness. Nevertheless, the change in the shape of the FS teeth generates backlash in the transmission, requiring the gear higher torsion to transmit the desired torque. As depicted in Figure 4a, the toothing of gear A is still in good condition, while most of the damage is located at the WG–FS interface. The different evolution over time of the hysteresis curves between the two gears, together with the microscope examination of the damaged components, suggests the possibility of detecting the root cause of the failure mode. For both gears A and B, the accumulated damage caused by wear makes the hysteresis curve change, leading to mechanical relaxation and to a drop in the overall gear torsional stiffness. Since the hysteresis curve expresses a relationship between the input and the output of the device, the obtained values represent the overall gear torsional stiffness K. According to [30], this quantity can be also expressed as a series of three terms, leading to:

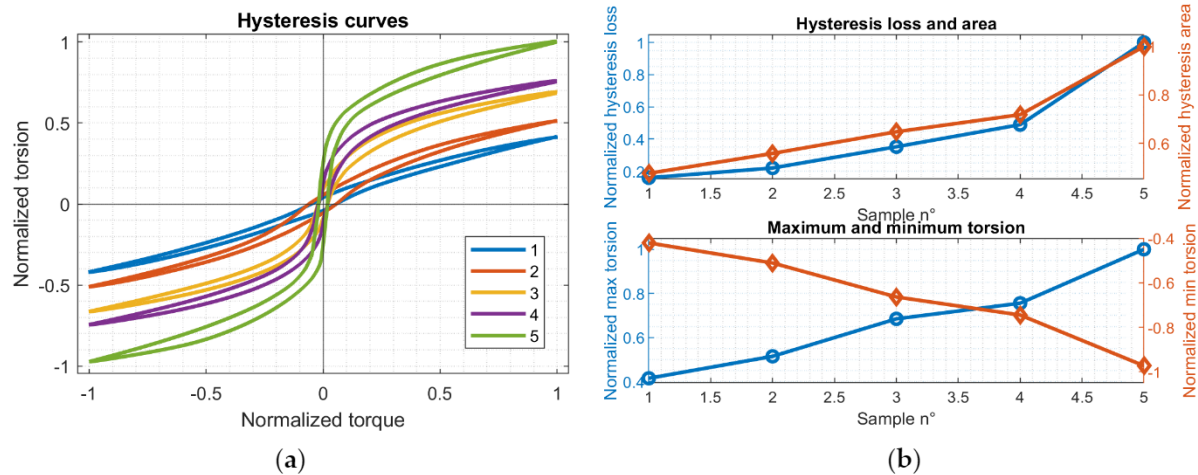
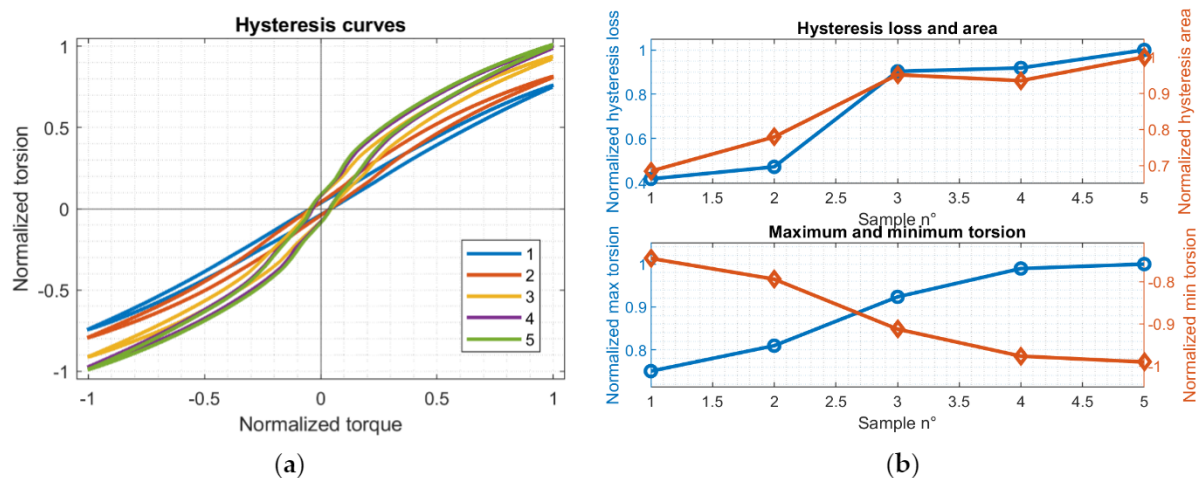
Figure 6. (**a**) Evolution of the hysteresis curve of gear A over time normalized with respect to the measurements in sample 5. (**b**) Trends of the hysteresis loss, area, and minimum and maximum torsion of gear A over time normalized with respect to the measurements in sample 5.

hysteresis curves. The drop in the gear performance is also visible in Figure 6b through the increment of about 33% in both the minimum and the maximum gear torsion between initial and final working conditions, with a major variation (+23%) in the first half of the test for both directions of the applied load.

likely the cause of the drop of between 20% and 28% of the maximum measured torsion, which corresponds to an average torque of about 12% of the maximum reached in the hysteresis curves in Figure 6a. This hypothesis is supported by the fact that the stiffness decrement is quite steep, leading to the assumption that it was caused by a sliding between the wave generator outer race and the flexspline inner surface.

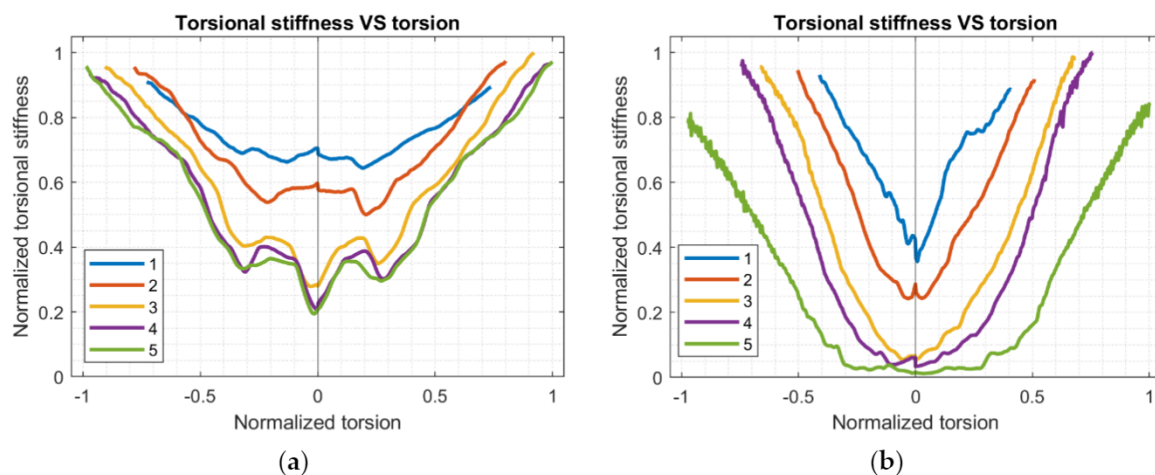
Figure 8. (**a**) Trends of the torsional stiffness as a function of torsion of gear A over time normalized with respect to the measurements in sample 5. (**b**) Trends of the torsional stiffness as a function of torsion of gear B over time normalized with respect to the measurements in sample 5.

Even though gears A and B show different behaviors, in both cases, the curves tend to shift towards the external region and the bottom of the graph. In the first scenario, the same level of the gear torsional stiffness is reached with an increasing value of torsion. This is caused by a degradation in the FS–CS meshing, which, over time, requires a higher torsion to transmit the same torque. Instead, the translation towards the bottom highlights a progressive reduction in the torsional stiffness under the same configuration of the gear. Such a difference is higher at low values of torsion, where there are fewer teeth simultaneously engaging. As an example, at zero torsion, the last measurement (sample 5) shows a stiffness value about 69% lower than the one during the nominal operating conditions for gear A, while the reduction is about 96% for gear B. The catastrophic drop in gear B, caused by the backlash between the teeth, goes on until about 30% of the maximum measured torsion, while the first consistent increment in the gear stiffness only appears at about 40% of it. It should be pointed out that, for the same torsion measurement, the maximum values of gear torsional were reached in nominal operating conditions.

As already mentioned, the different reduction in the torsional stiffness faced by gear A is related to the better status of its toothing. However, the damaged WG–FS interface is
