Dynamic Characterisation and Seismic Vulnerability Assessment of Existing Masonry Port Structures

Dynamic characterisation and seismic vulnerability assessment of existing masonry port structures

Raffaele Tarantini[1], Alessandro Cardoni[1], Sebastiano Marasco[1], Jacopo Merlin[1], Enrico Pribaz[2], Gianluca Rupolo[2], Marco Domaneschi[1], Gian Paolo Cimellaro[1],

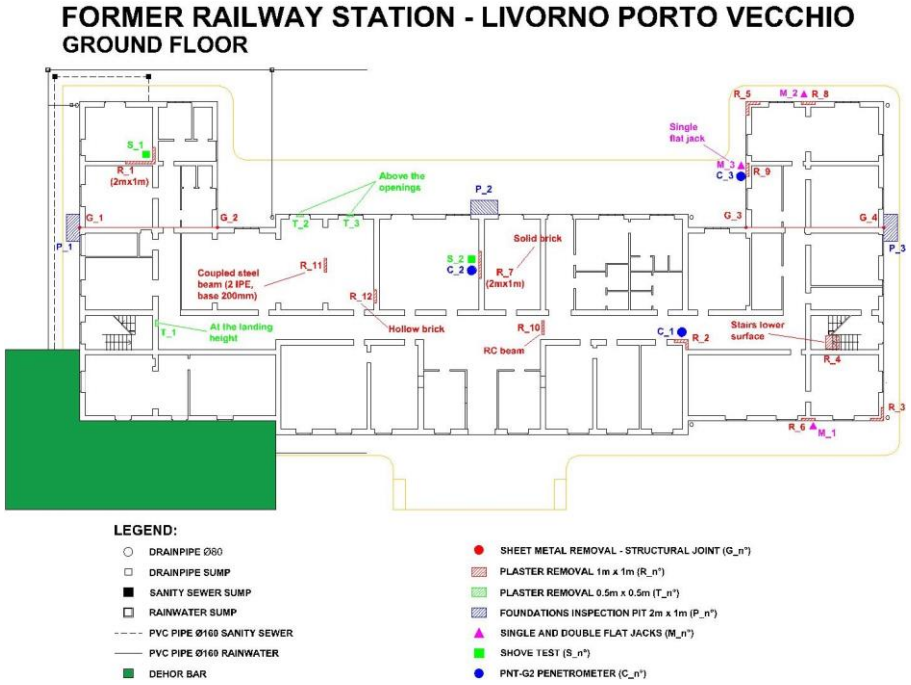
Fig. 3. Testing and investigation plan.

In the first place, visual investigations were carried out that made it possible to examine the wall texture and its degree of interlocking, to analyse the cracking pattern and to evaluate the state of general damage to the structure. Based on these investigations, several tests, including non-destructive (thermography, sclerometer, cover meter) and minor-destructive ones (single and double flat jacks, shove test, penetrometer), were planned in order to assess the mechanical properties of the constituent materials, as shown in Fig. 3 [1-3].

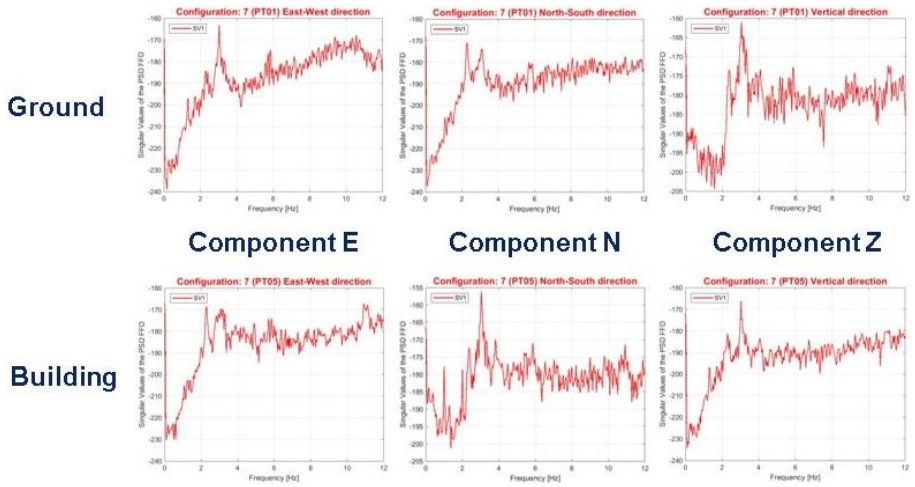
Fig. 7. Ground vs. building accelerometers.

Although not necessary in the case of dynamic output-only identification, a ground sensor was also installed during the tests. By analysing the PSDs of the signals from individual accelerometers, an unexpected discovery was made. The 3.5Hz tone is simultaneously present both for the accelerometers positioned on the structure and on the ground (Fig. 7), and in all 3 instrumental directions. This reasonably means that it

is not referred to the structure but depends on the frequency component of an external input source. In light of what was discovered, it was not possible to identify the modal parameters of the structure and therefore to calibrate the subsequent structural model.

This work lends itself to being a starting point for further studies, which involve the development of more refined structural models that include the soil-structure interaction (e.g., Winkler soil model).

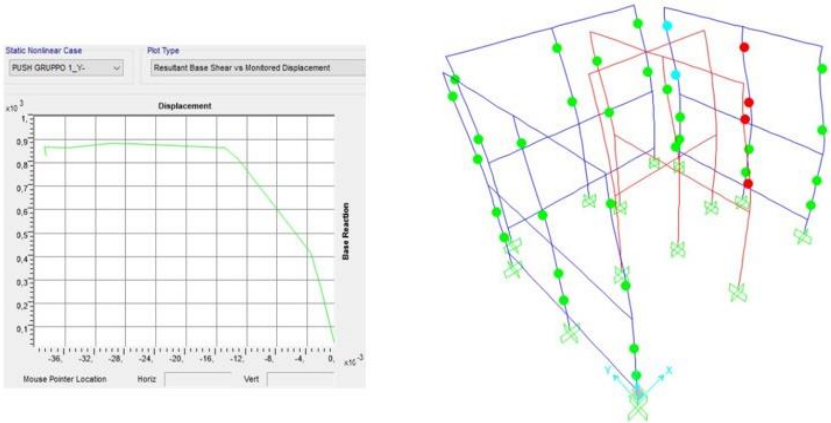
Fig. 10. MDOF capacity curve and plastic hinges evolution.

In Fig. 10, an example of capacity curve of the MDOF system is depicted, expressed as a function of the shear at the base and the displacement of one or more control points, with a representation of the activated plastic hinges.

The compute indices of all the blocks result higher than unit: i.e., 1.06 for Blocks 1 and 5, and 1.20 for Blocks 2,3,4; with a Demand PGA of 0.1814 g. Thus, the structural model complies with the safety requirements set by the NTC2018 with regard to seismic actions.
