DAMAGE PATTERN ANALYSIS OF THE BASILICA DI COLLEMAGGIO USING AEM MICRO-MODELING

Cosimo Pellecchia[1], Alessandro Cardoni[1], Gian Paolo Cimellaro[1], Ahmed Amir Khalil[2]

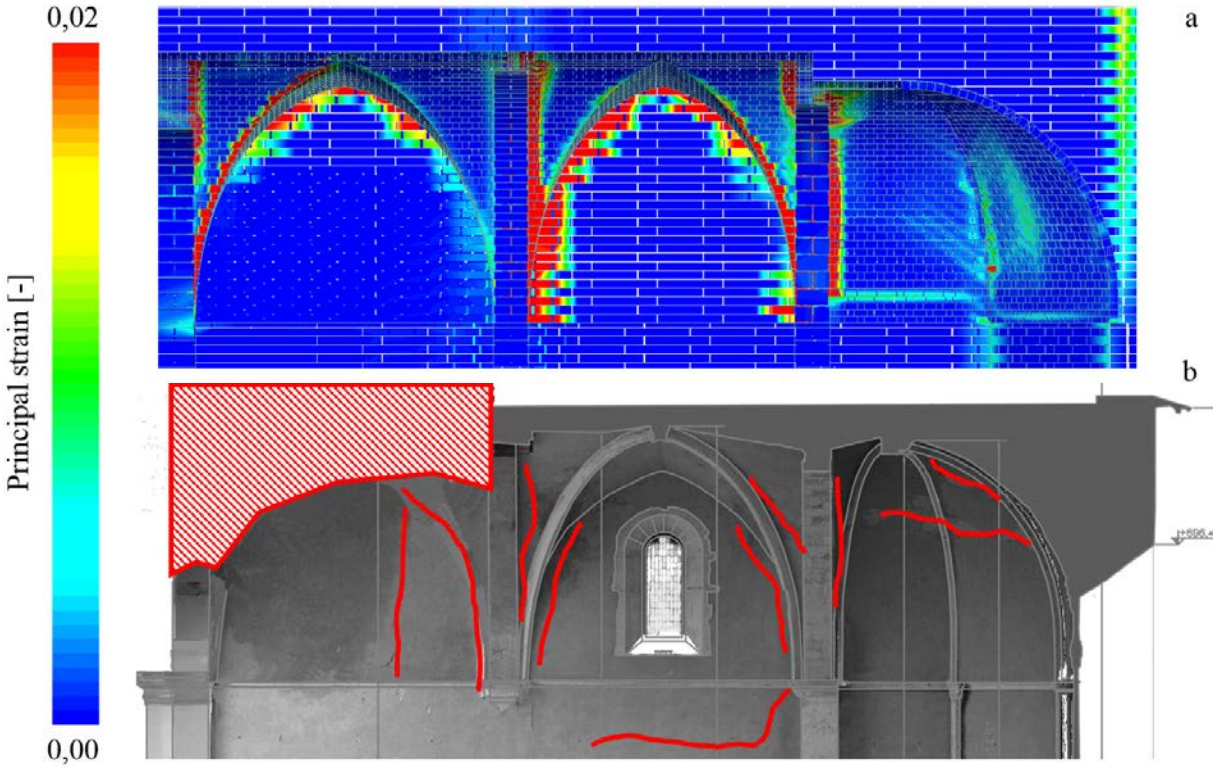
A comparison between the crack pattern derived from the numerical analysis and the actual distribution of cracks observed after the 2009 L'Aquila earthquake is depicted in Figure 9. It was observed that first principal strain of 0.02 is a good criterion to identify cracking in the masonry structure.

Figure 9: Comparison between the analysis results (a) and actual distribution of cracks observed after the 2009 L'Aquila earthquake (b); orthophoto reproduced with permission from [21]

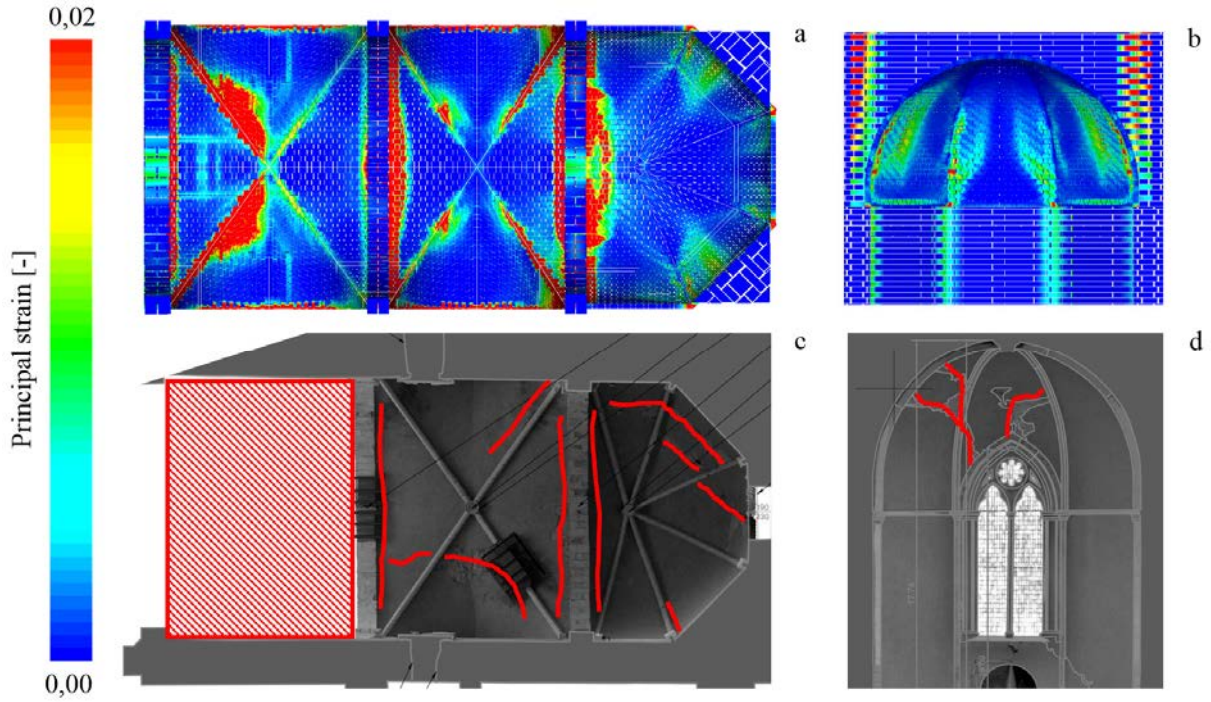
The analysis results showed good accordance with the actual damage state observed after the shock, except for the collapse of the first of the choir's vault (Figure 10).

Figure 10: Comparison between the analysis results (bottom view, a, and side view, b) and actual distribution of cracks observed after the 2009 L'Aquila earthquake (bottom view, c, and side view, d); orthophoto reproduced with permission from [21]

However, it is worth noticing that the numerical model did not include the collapsed portion of the transept, which could have induced the subsequent collapse of the choir's vault.

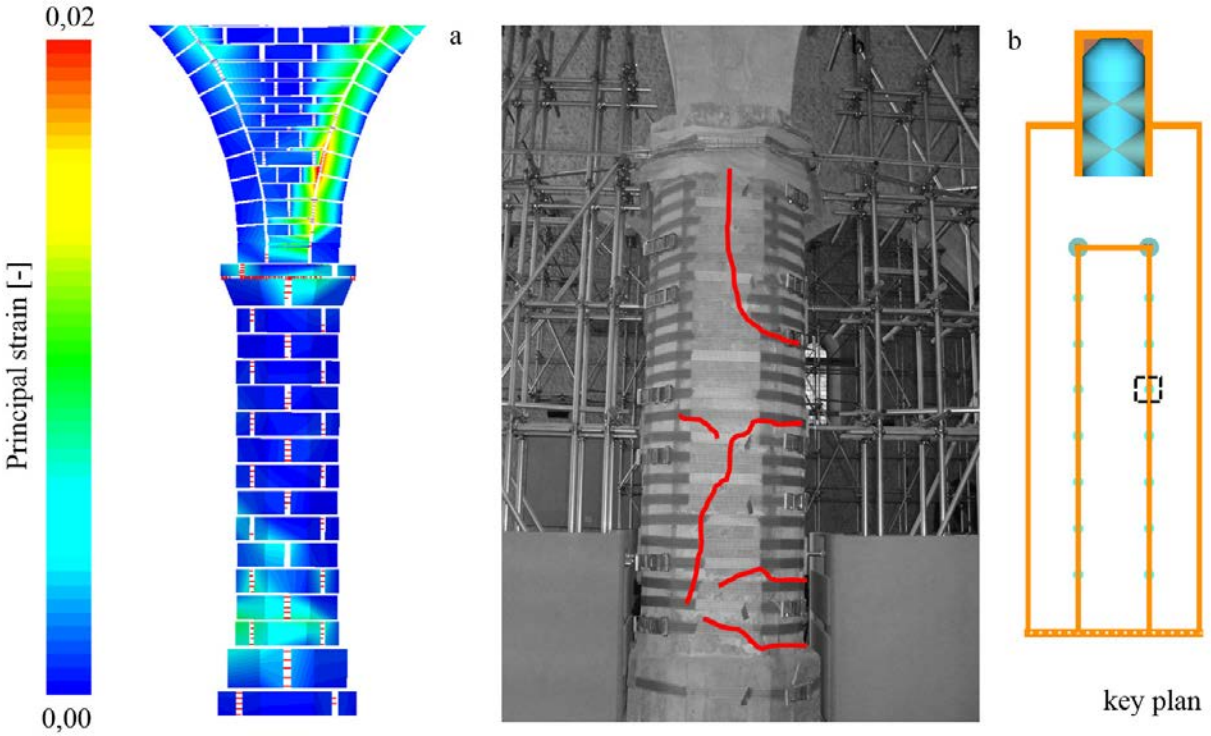
Figure 11: Comparison between the analysis results (a) and actual distribution of cracks observed after the 2009 L'Aquila earthquake (b) in one of the nave's columns.

Finally, a good accordance between the actual damage and the analysis results was also found in observing the springs in a crack state (Figure 11, a, red color) resulting from the analysis in comparison with the actual cracks in one of the nave's column (Figure 11, b).
